RECALL CAMPAIGN BULLETIN

VOLUNTARY SAFETY RECALL CAMPAIGN 2016 MURANO HYBRID AND 2014-2015 PATHFINDER HYBRID; HYBRID POWERTRAIN CONTROL MODULE REPROGRAM

CAMPAIGN ID #: R21B5
APPLIED VEHICLES: 2016 Murano Hybrid (Z52H)
2014-2015 Pathfinder Hybrid (R52H)

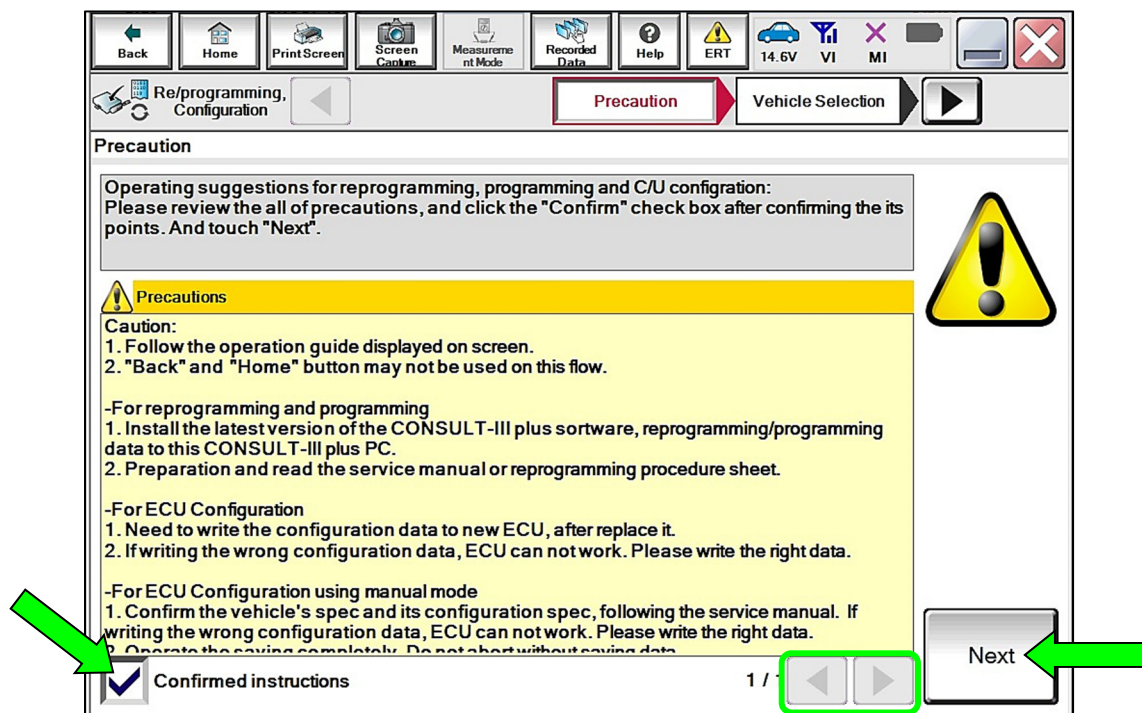
Figure 2

5. Check the box to confirm the precaution instructions have been read, and then select Next.

NOTE: Use the arrows (if needed) to view and read all precautions.

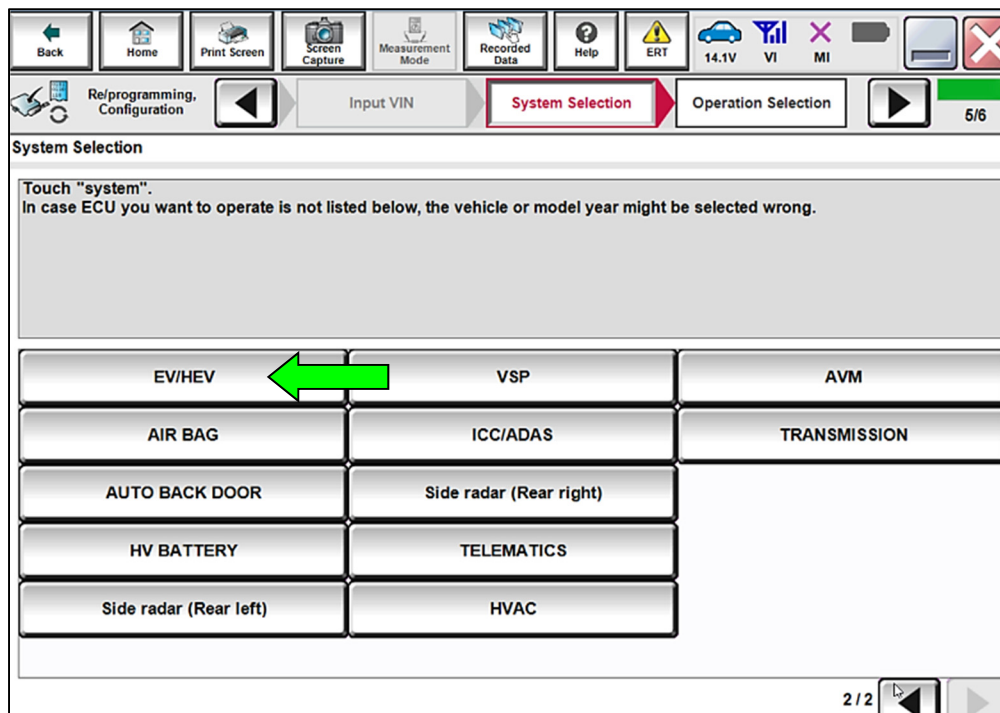
Figure 6

- Select **EV/HEV**.

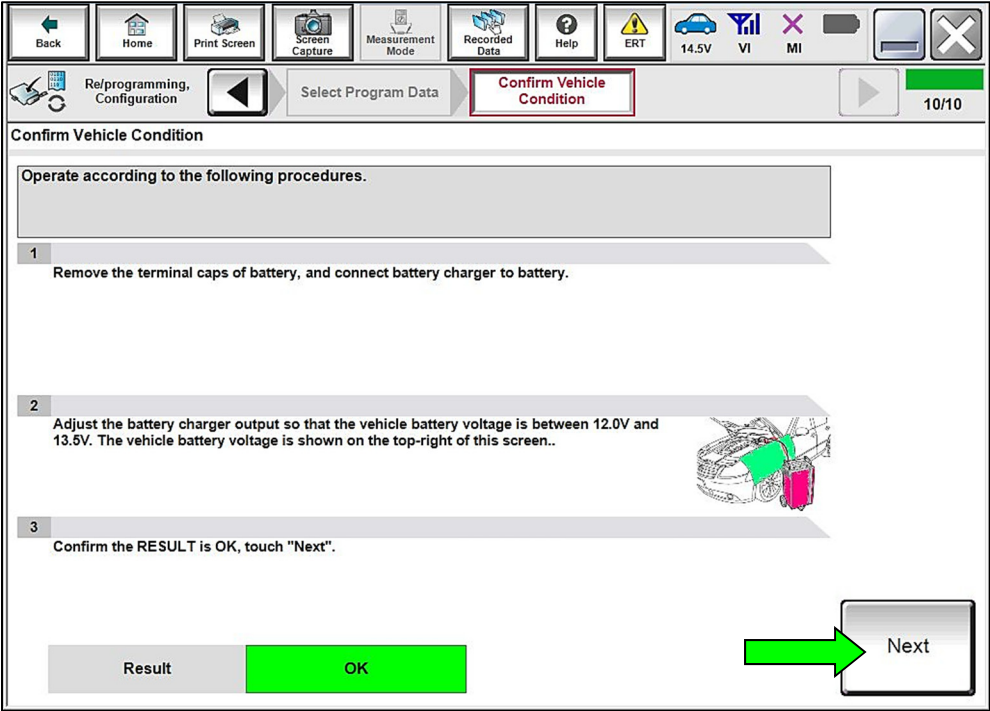
Figure 10

- 14. Confirm the battery charger is ON and the battery voltage is between 12V-15.5V, and then select **Next**.

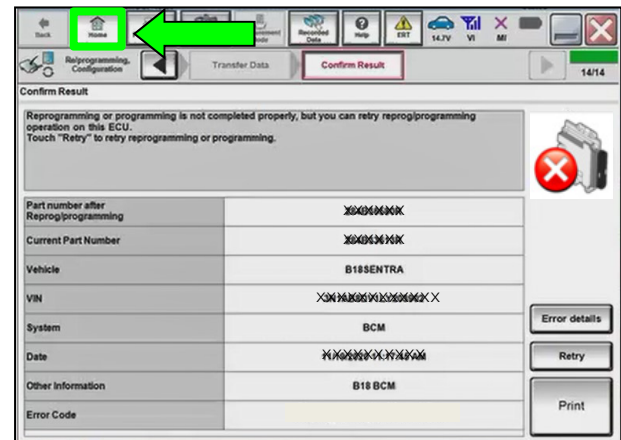
Figure 17

If reprogramming does not complete and the “X” symbol displays as shown in Figure 17:

- Do not disconnect the VI or shut down C-III plus if reprogramming does not complete.
- Check battery voltage (12.0 – 15.5V).
- CONSULT A/C adapter is plugged in.
- Ignition is ON, Engine is OFF.
- Transmission in Park.
- All C-III plus / VI cables are securely connected.
- All C-III plus updates are installed.
- Select **Home**, and then restart the reprogram procedure from the beginning.
