HYUNDAI Technical Service Bulletin	GROUP RECALL	NUMBER 22-01-017H
	DATE FEBRUARY 2022	MODEL(S) VARIOUS
SUBJECT:	FRONT SEAT BELT PRETENSIONER REPLACEMENT (RECALL 211)

Description: The front seat pretensioner may deploy abnormally in the vehicles described below, causing the MMG (Micro Gas Generator) to detach from the assembly. This bulletin describes the procedure to replace the front seatbelt pretensioner to resolve the condition.

FRONT SEAT BELT PRETENSIONER REPLACEMENT (RECALL 211)

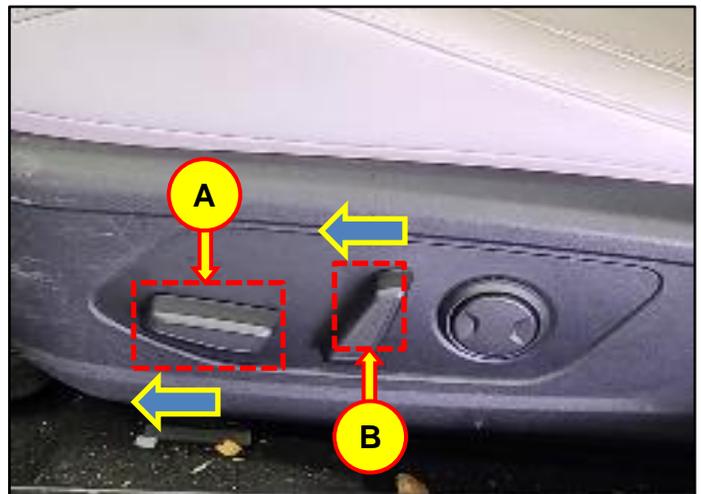
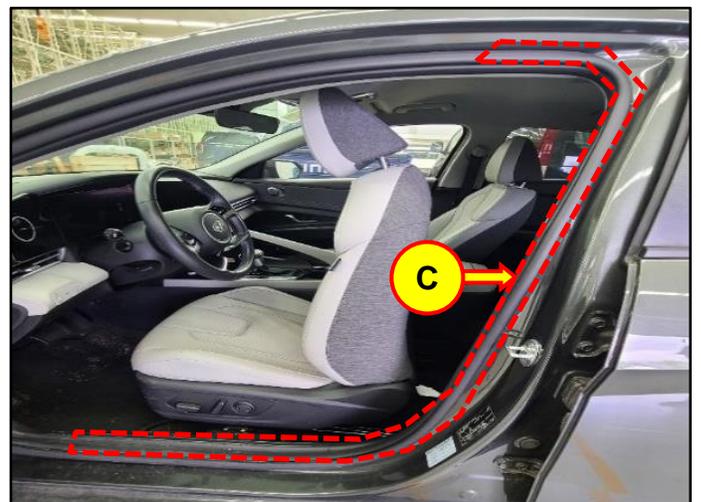
1. Move the seat as far forward as possible by using the front/rear switch (A) and seat back switch (B).
2. Record radio presets and disconnect the negative (-) battery terminal.
3. Turn off the vehicle's ignition key before continuing.
4. Partially remove the front door body side weather strip (C).

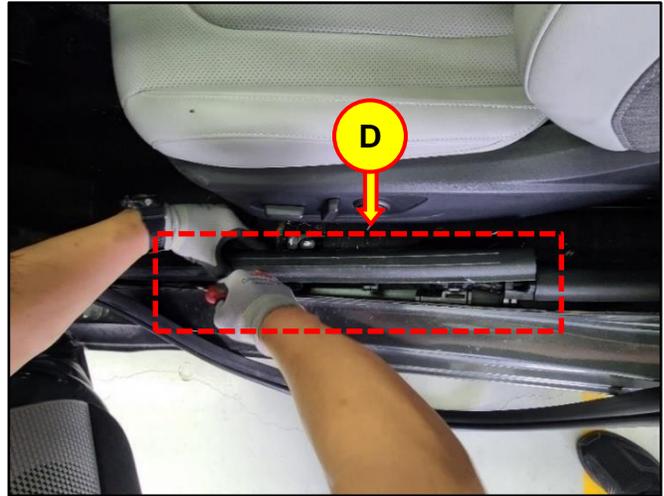
5. Remove the front door scuff trim (D) using a flat head screwdriver or plastic trim remover.

If using a screwdriver, be sure to wrap protective tape around the tip to prevent damage on the trim and panels.

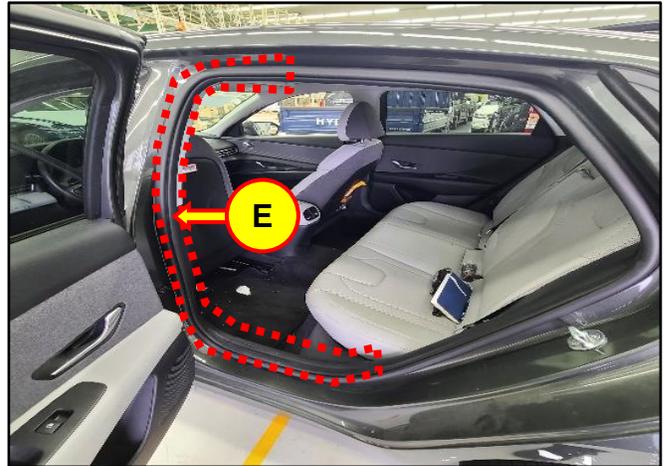
6. Partially remove the rear door body side weather strip (E).

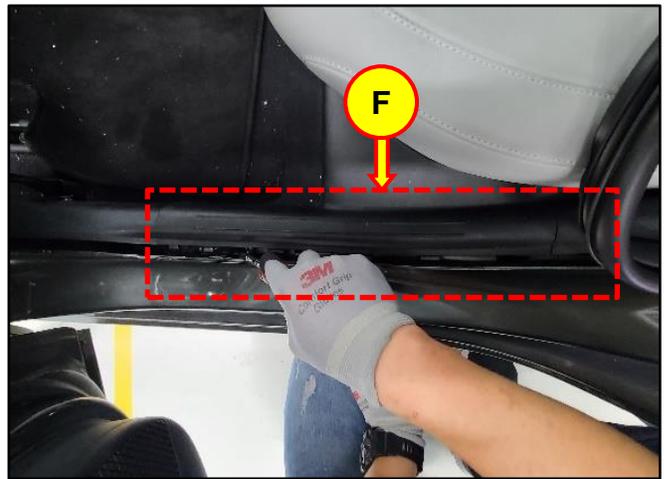
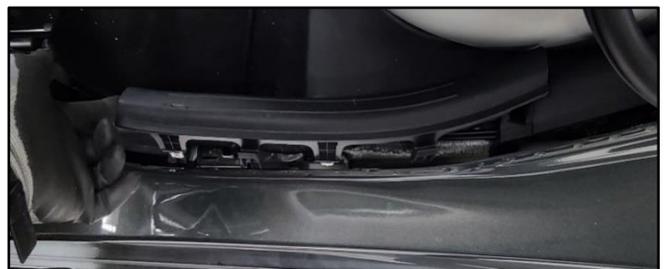
7. Partially remove the rear door scuff (F) using a screwdriver or plastic trim remover.

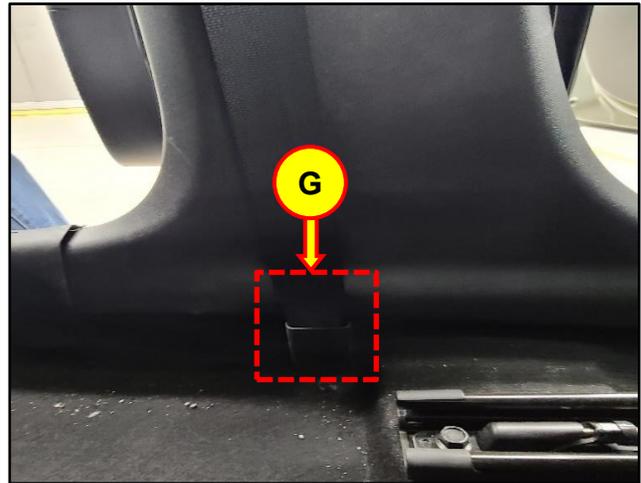
8. Move the front seat belt lower anchor cover (G) upward.

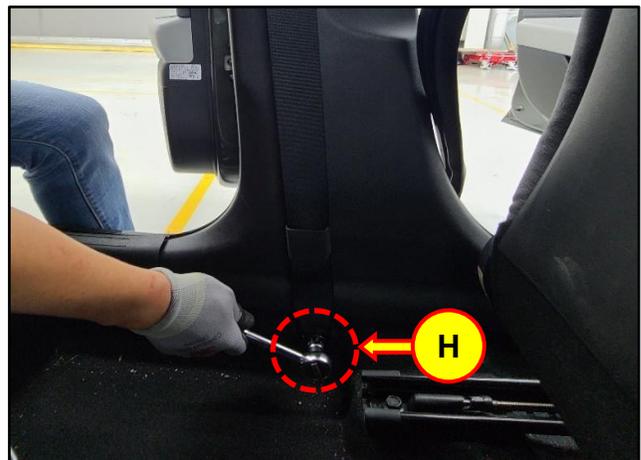
9. Loosen the mounting bolt (H) and remove the front seat belt lower anchor.

Tightening Torque:
28.9 – 39.8 lb-ft (39.2 – 53.9 Nm)

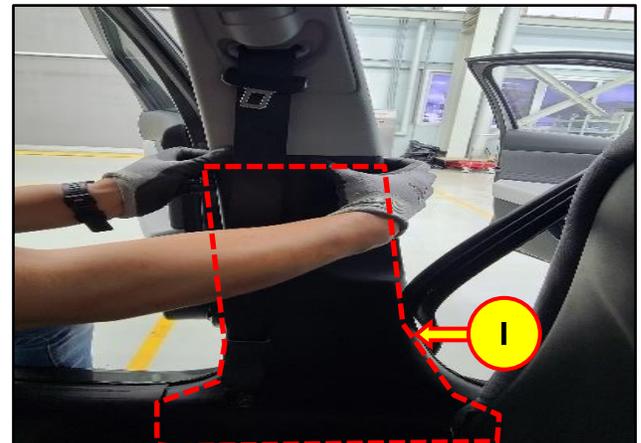
10. Pull and remove the center pillar lower trim (I).

Replace existing fasteners with new ones.

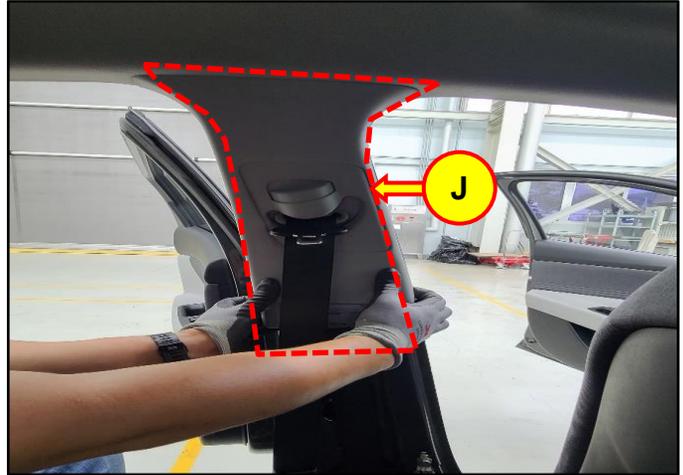
- Remove the center pillar upper trim (J).

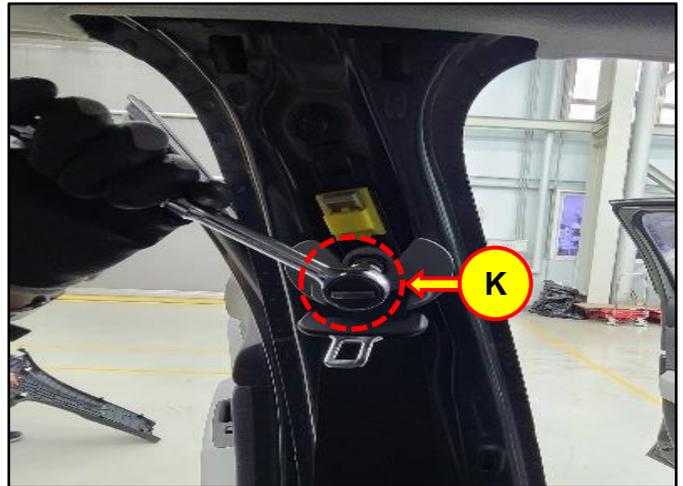
- Loosen the front seat belt upper anchor mounting bolt (K) and remove the front seat belt anchor.

Tightening Torque:
28.9 – 39.8 lb-ft (39.2 – 53.9 Nm)

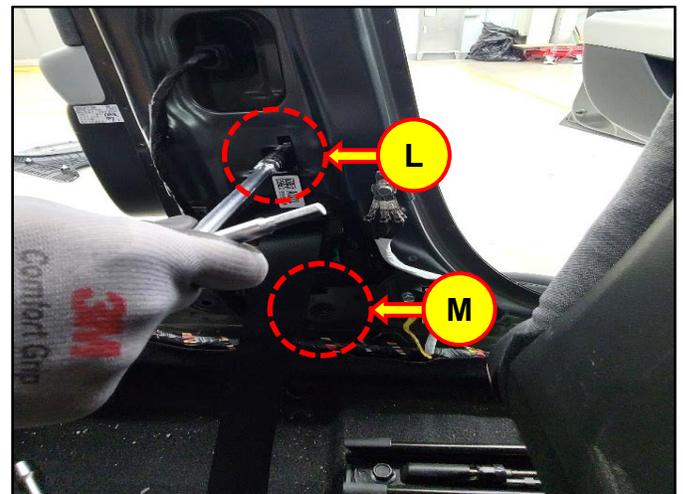
- Loosen the mounting bolts (L) and (M) and remove the front seat belt pretensioner.

Tightening Torque:
L: 5.8 – 8.7 lb-ft (7.7 – 11.8 Nm)
M: 28.9 – 39.8 lb-ft (39.2 – 53.9 Nm)

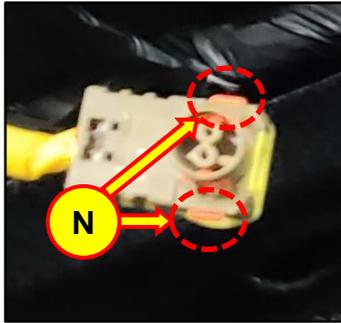
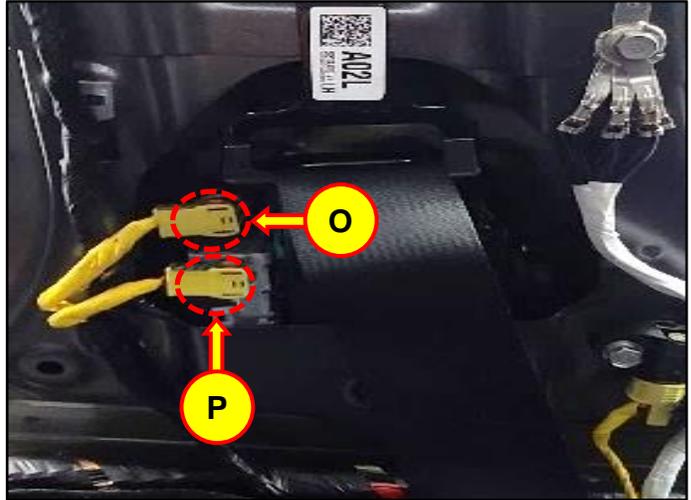
- Press in the tabs for the locking pin (N) to disconnect the front seatbelt pretensioner connector (O) and the free active seatbelt connector (P).

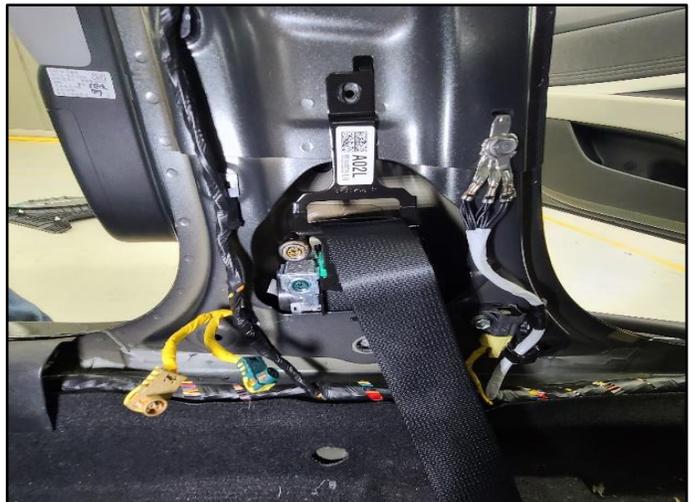
- Remove the front seat belt pretensioner.

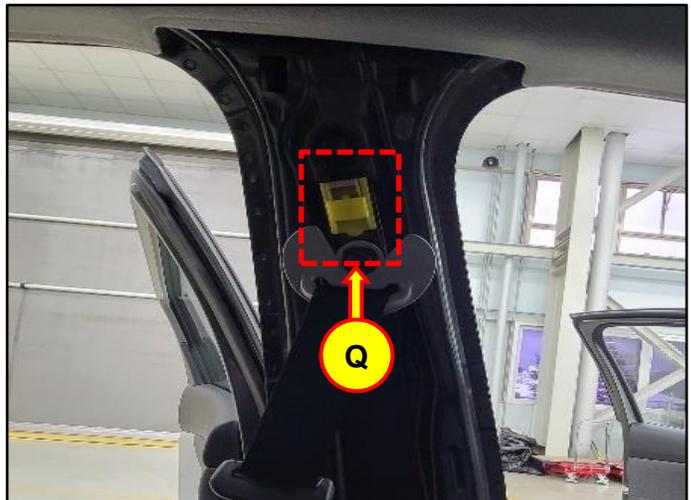
- Install the newly supplied front seat belt pretensioner.
- Reinstall parts in reverse order of removal. Make sure you replace existing fasteners with new ones.

Move the height adjuster lever (Q) to the highest point before reinstalling the upper center pillar trim.
