GROUP	MODEL
Safety Recall Campaign	2017-2018MY Optima (JF P/HEV) w/Nu 2.0L GDI HEV
NUMBER	DATE
SC218	November 2021

### ENGINE INSPECTION/REPLACEMENT AND KSDS S/W INSTALLATION (SC218)

This bulletin provides information to perform the Bearing Clearing Test (BCT) and, if necessary, replace the engine, and to update the Engine Control Unit (ECU) to install the Knock Sensor Detection System (KSDS) software on 2017-2018MY Optima (JF P/HEV) equipped with Nu 2.0L GDI ULEV/SULEV engine, produced from June 27, 2016 through April 27, 2018. Follow the flowchart on page 2 to perform the BCT and install the KSDS software. In some cases, engine long block replacement may be required if the BCT results in a “No Pass” or “Unable to Perform” (ex. seized engine).

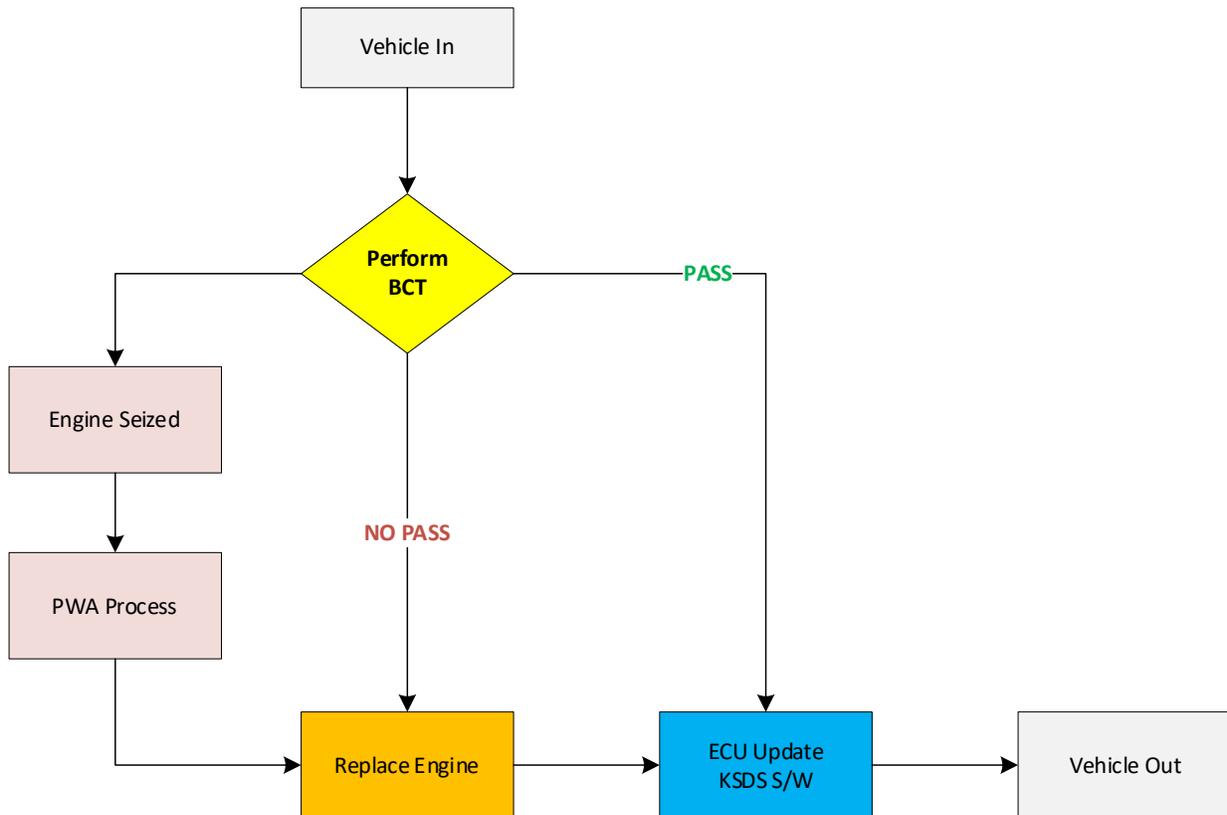
**Flowchart:**

Follow the flowchart below and refer to SST067 for BCT procedure. Be sure to apply the ECU Update (KSDS Software) after BCT or engine replacement.

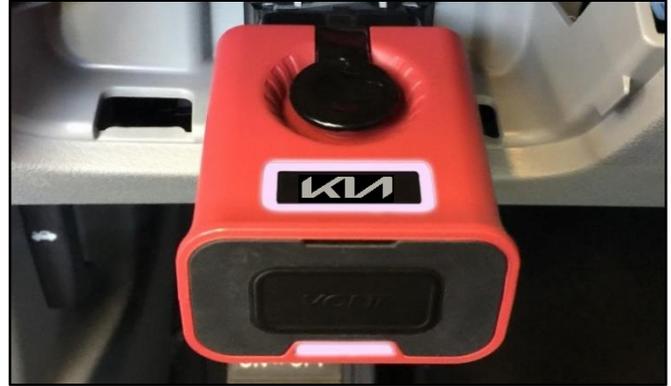
1. Connect the VCI-II to the OBD-II connector, located under the driver's side of the instrument panel.

The ECU upgrade function on KDS operates wirelessly. It is not necessary to perform the upgrade via USB cable.

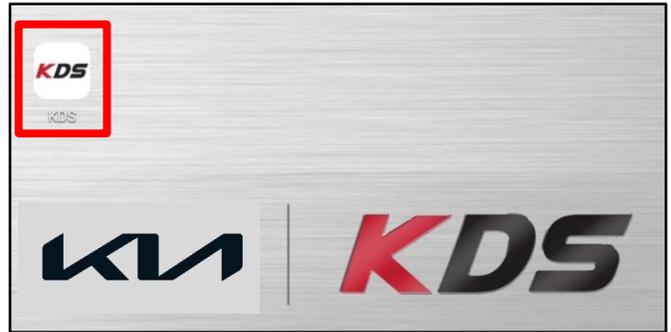
2. With the ignition ON, turn ON the KDS tablet. Select 'KDS' from the home screen.

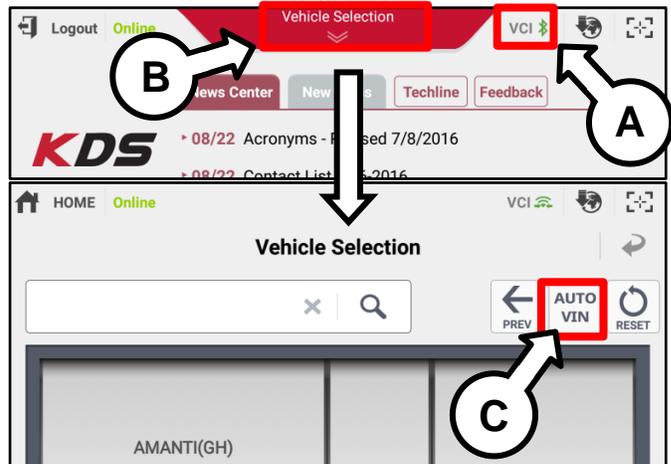
3. Confirm communication with VCI (A) and then configure the vehicle (B) using the 'AUTO VIN' (C) feature.

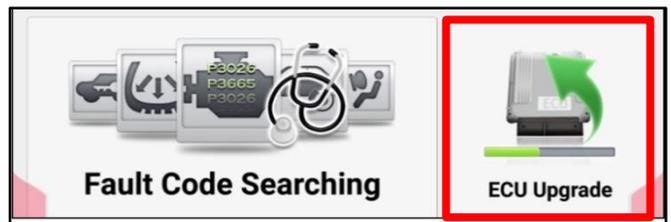
4. Select 'ECU Upgrade'.

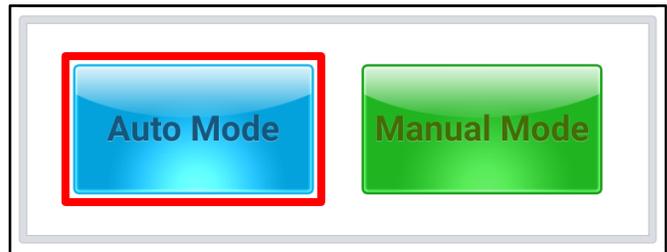
- Select Auto Mode.

Do NOT attempt to perform a Manual Mode upgrade UNLESS Auto Mode fails. Always follow the instructions given on the KDS in either Auto or Manual mode.

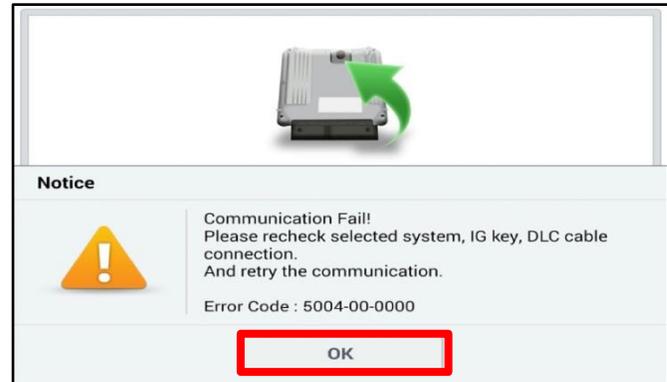
9. If a "Communication Fail" screen appears, verify that the VCI-II and KDS are communicating properly. Select 'OK' and restart the from step 4.

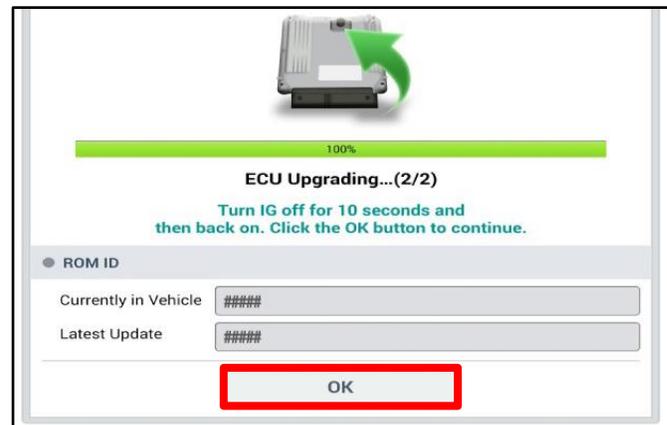
10. When instructed on the KDS, turn the ignition OFF for ten (10) seconds then back on. Select 'OK' to continue.

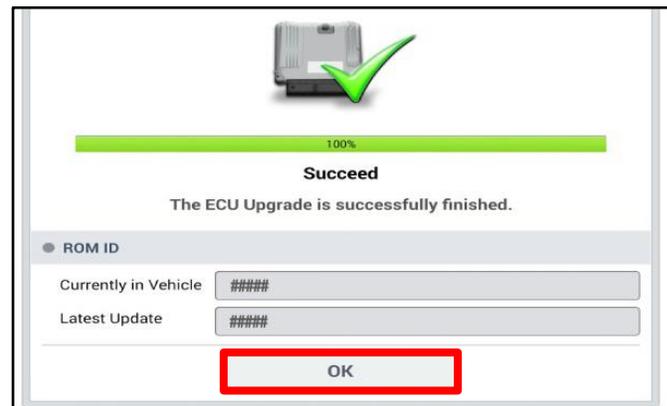
11. Once the upgrade is complete, select 'OK' to finalize the procedure.

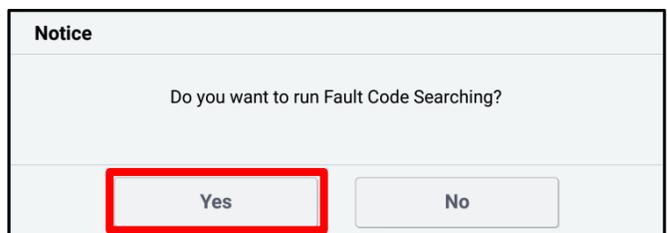
12. When prompted, select 'YES' to check for Diagnostic Trouble Codes (DTC) and erase any DTCs stored such as EPS, ESC, and TPMS that may have been set during the upgrade.

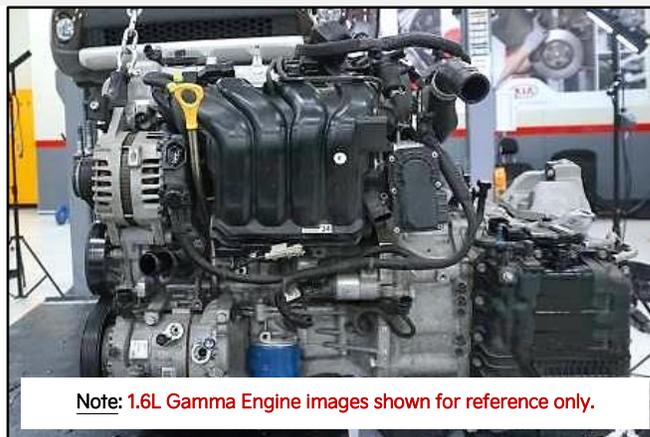
1. Replace the engine assembly by referring to the "Engine Mechanical System → Engine And Transmission (Transaxle) Assembly → Sub & Long Engine Assembly → Repair procedures" chapter in the applicable Shop Manual on KGIS.

**Note: 1.6L Gamma Engine images shown for reference only.**

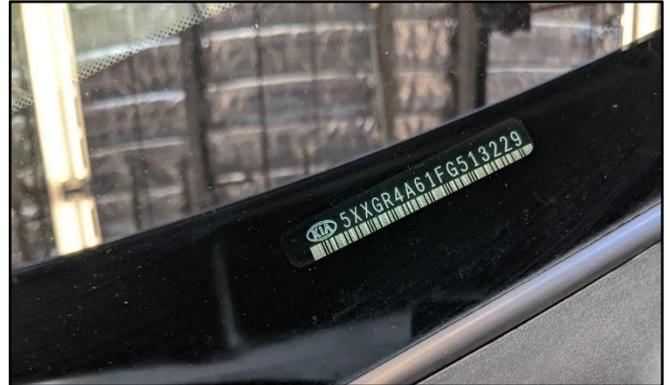
1. Start video showing vehicle and move in towards the dash VIN tag.

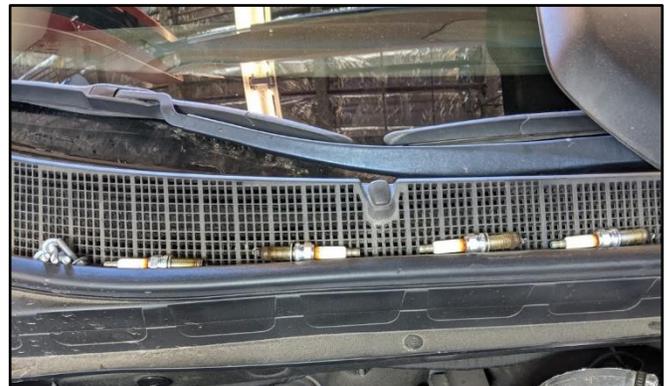
2. Show the removed spark plugs.

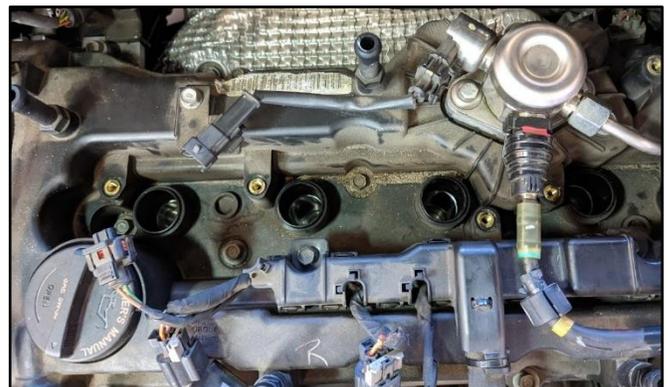
3. Show the empty spark plug holes from the engine.

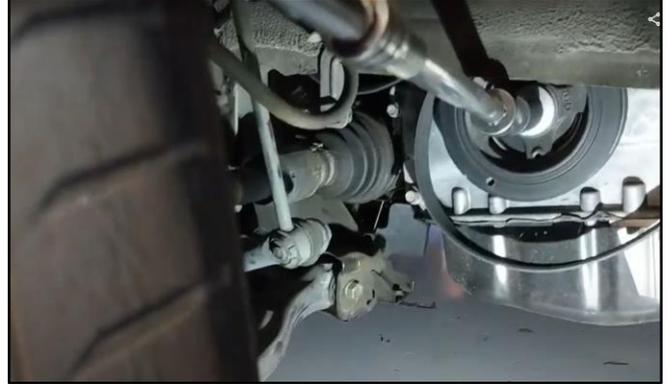
4. Show the removed drive belt and attached torque wrench to crank bolt.

**Prepare the vehicle prior to the video by removing the spark plugs and drive belt as well as setting the torque wrench to 94 lb.ft.**

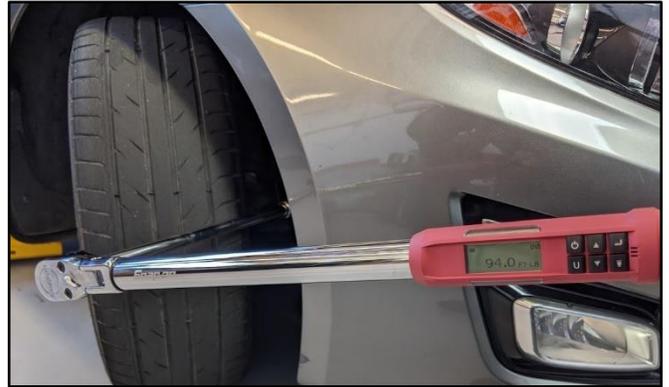
5. Show the engine being cranked and torque specification exceeding 94 lb.ft. torque.
