GROUP	MODEL
Safety Recall Campaign	2017-2018MY Optima (JF P/HEV) w/Nu 2.0L GDI
NUMBER	DATE
SC218A	January 2022

SUBJECT: **UPDATED KSDS SOFTWARE INSTALLATION (SC218A)**

This bulletin provides information to install the corrected and updated Knock Sensor Detection System (KSDS) software on certain 2017-2018MY Optima (JF P/HEV) equipped with Nu 2.0L GDI ULEV/SULEV engine, produced from June 27, 2016 through April 27, 2018, that already had the initial update performed under SC218. **Since Kia launched SC218 in November 2021, Kia has become aware that the original KSDS software version installed on the affected vehicles before January 25, 2022 has an error and requires the installation of a corrected and updated KSDS software. These vehicles are identified under SC218A in the WEBDCS.**

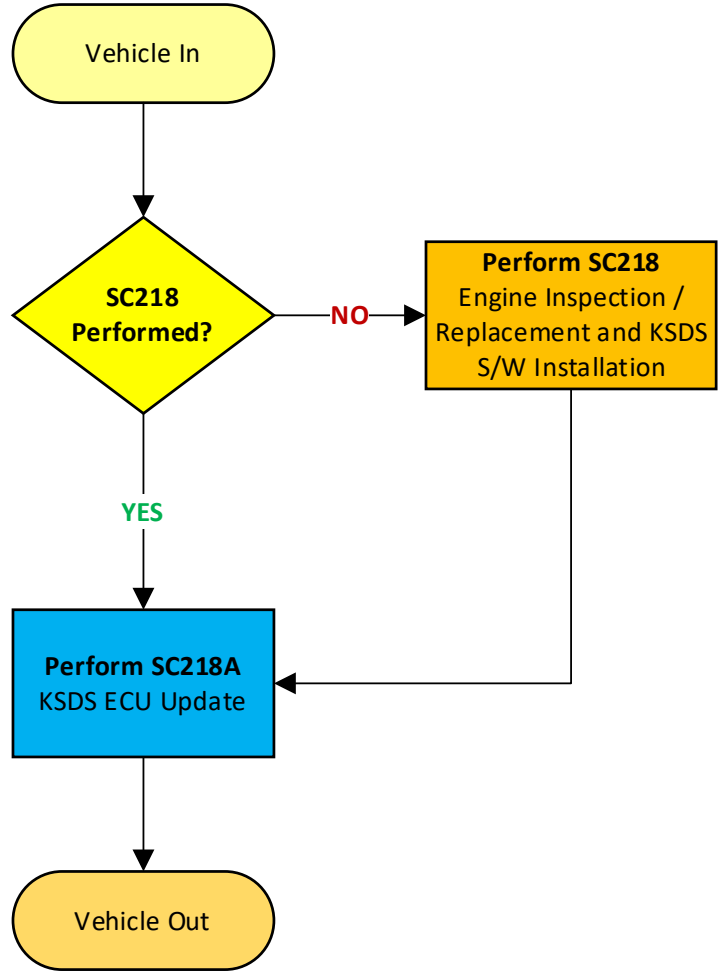
Flowchart:

Note: If any concerns arise during/after completing the flowchart, open a Techline case online.

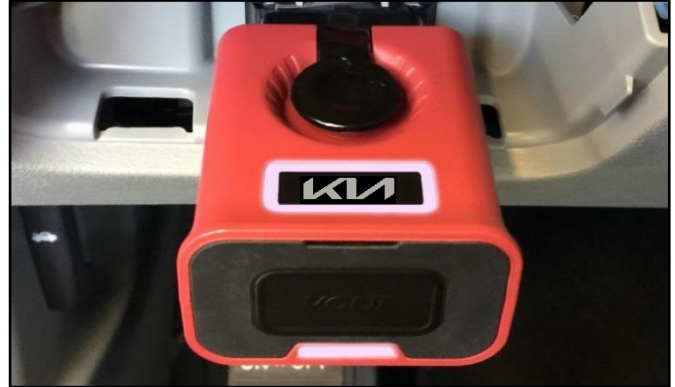
1. Connect the VCI-II to the OBD-II connector, located under the driver's side of the instrument panel.

The ECU upgrade function on KDS operates wirelessly. It is not necessary to perform the upgrade via USB cable.

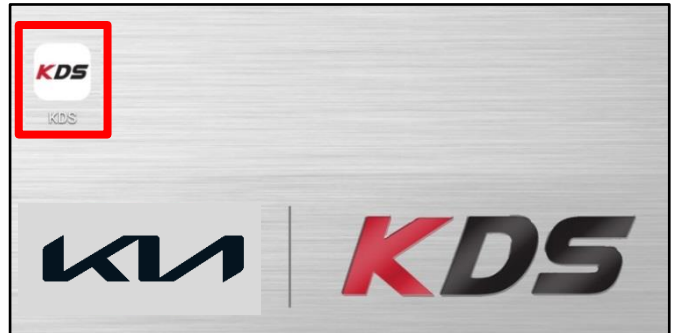
2. With the ignition ON, turn ON the KDS tablet. Select 'KDS' from the home screen.

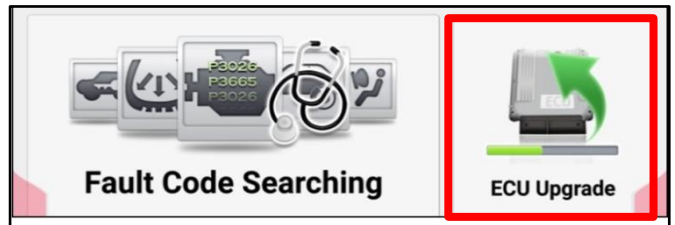
4. Select 'ECU Upgrade'.

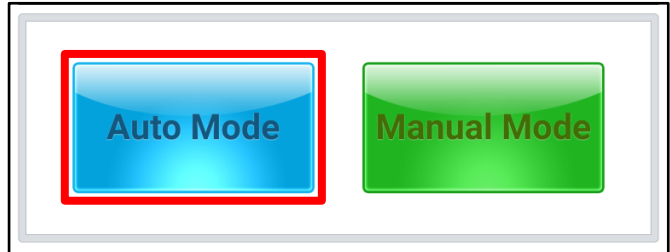
- Select Auto Mode.

Do NOT attempt to perform a Manual Mode upgrade UNLESS Auto Mode fails. Always follow the instructions given on the KDS in either Auto or Manual mode.

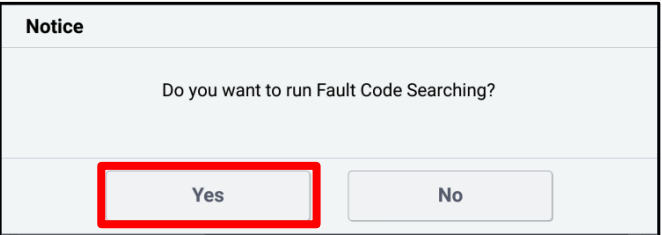
- When prompted, select 'YES' to check for Diagnostic Trouble Codes (DTC) and erase any DTCs stored such as EPS, ESC, and TPMS that may have been set during the upgrade.
