GROUP	MODEL
Safety Recall Campaign	2020-2021MY Stinger (CK)
NUMBER	DATE
SC219	December 2021

SUBJECT: **CLUSTER LOGIC IMPROVEMENT FOR ACCURATE FUEL GAUGE DISPLAY (SC219)**

This bulletin provides the procedure to update the instrument cluster (CLU) system software on certain 2020-2021MY Stinger (CK) vehicles produced from March 20, 2020 through December 28, 2020. The fuel gauge reading may not accurately display the amount of fuel remaining in the fuel tank due to a software logic/calibration error. If the fuel gauge wrongly displays more fuel than is present in the fuel tank, the vehicle can unexpectedly run out of fuel. If this occurs, the vehicle may stall, increasing the risk of a crash. Follow the procedure outlined in this publication to apply the improved logic to the 'CLU' system using the KDS ECU Upgrade function as described in this bulletin. For confirmation that the latest reflash has been applied to a vehicle you are working on, verify the ROM ID using the table on page 3 of this bulletin. Before conducting the procedure, verify that the vehicle is included in the list of affected VINs.

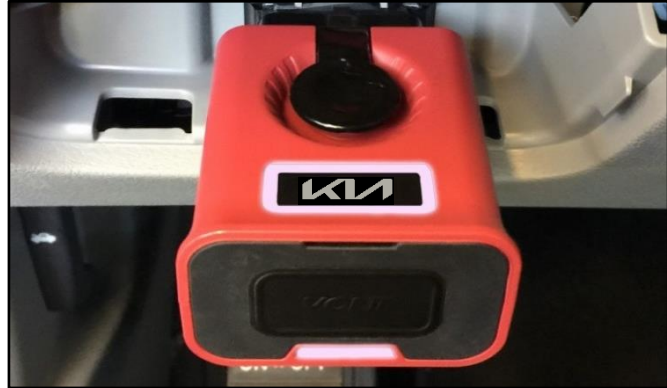
1. Connect the VCI-II to the OBD-II connector, located under the driver's side of the instrument panel.

NOTICE
The ECU upgrade function on KDS operates wirelessly. It is not necessary to perform the upgrade via USB cable.

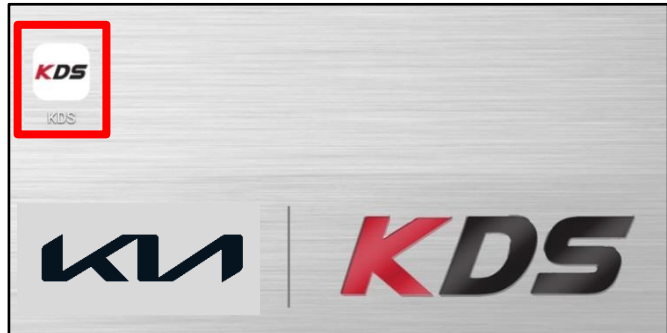
2. With the ignition ON, turn ON the KDS tablet. Select 'KDS' from the home screen.

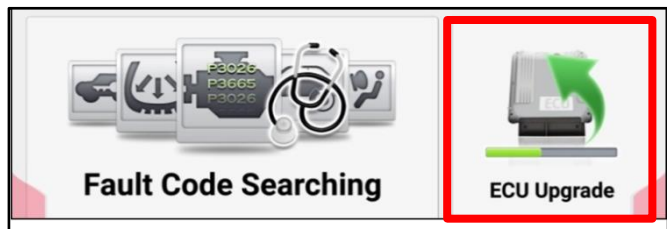
4. Select 'ECU Upgrade'.

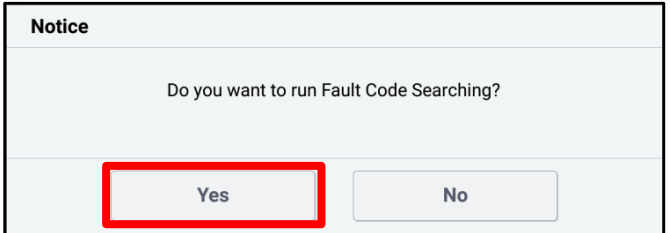
- 12. When prompted, select 'YES' to check for Diagnostic Trouble Codes (DTC) and erase any DTCs stored such as EPS, ESC, and TPMS that may have been set during the upgrade.
