Product Safety Recall

N212328800 Front Passenger Airbag Takata Inflator

Correction	Dealers will replace the passenger-side frontal airbag inflator.

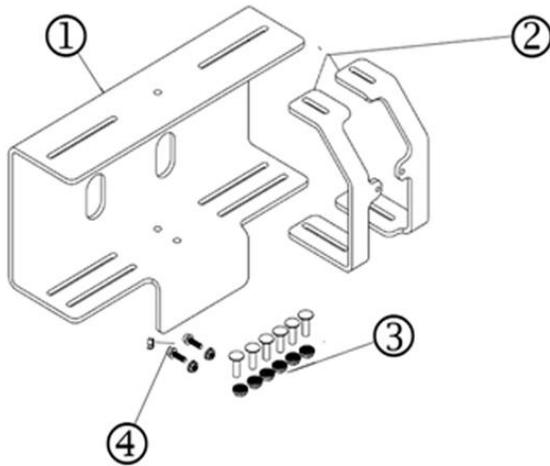
4006668

(1) Mounting Bracket (2) Support Bars (3) Support Bar Hardware (4) Airbag Mounting Hardware.

Dealers must use the airbag mounting bracket, shown below, to replace the front passenger airbag inflator. As of December 31, 2015, all U.S. dealers have been shipped the airbag mounting bracket at no charge through Bosch Automotive Service Solutions. The Bosch tool number is EL-51377. If your dealership does not have the airbag mounting bracket, do not attempt to perform this service procedure and immediately contact **1-800-GM-TOOLS** for assistance. Attempting to replace the front passenger airbag inflator without using the bracket may pose a safety risk for the technician and anyone else in the area.

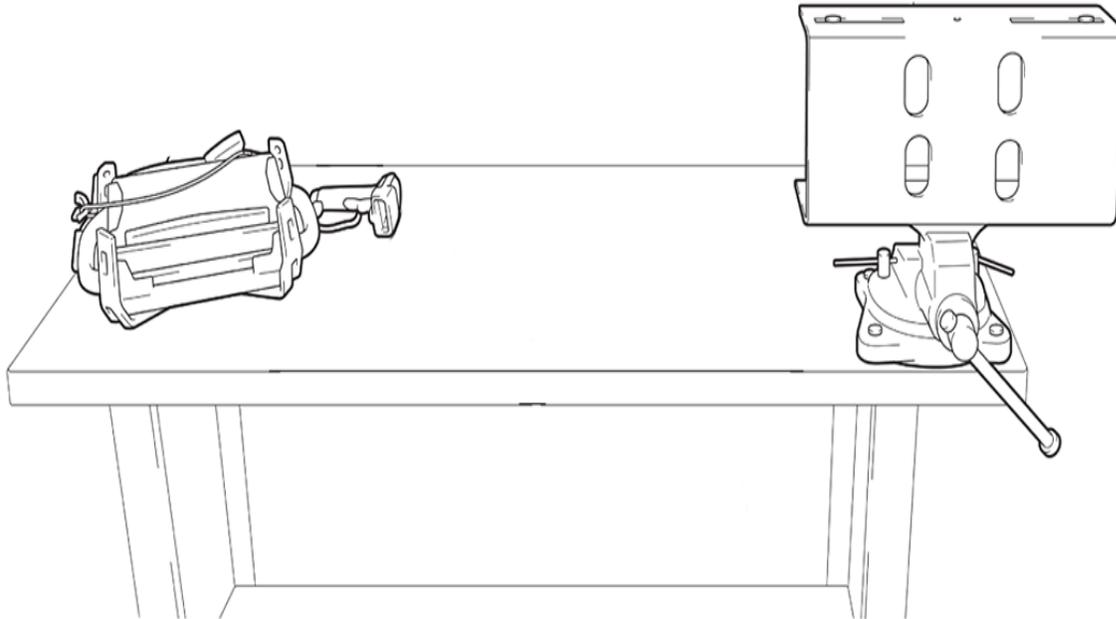
3607819

Danger: To avoid personal injury or death, it is critical to use an airbag module bracket when replacing an inflator module. Carefully read and follow the instructions below:

1. Confirm the bracket assembly is installed securely in the vise.
2. Confirm there are no loose objects or people exposed to the back side of the bracket for safety in the unlikely event of airbag deployment due to improper work procedures. The airbag is NOT being replaced due to an inadvertent deployment concern.
3. Confirm that no objects, tools or people are within 3 feet (1 meter) of the back side of the bracket.
4. Confirm that no objects, tools or people are within 2 feet (0.6 meters) of the sides of the bracket.
5. BEFORE starting work and periodically while working on the airbag module, touch a metallic part of the work bench to discharge static electricity in the body.

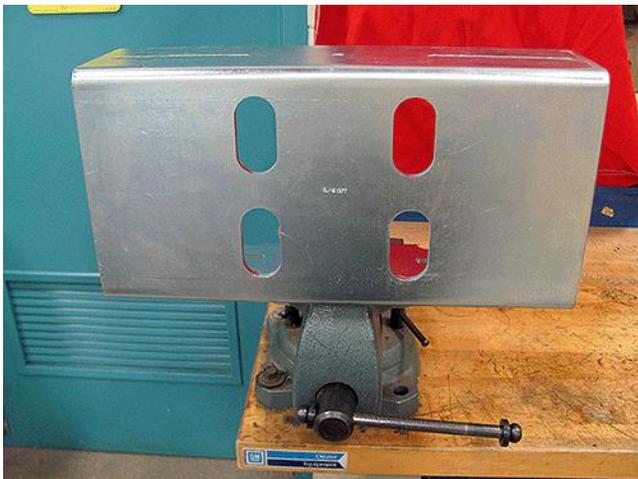
4664047

1. Mount the airbag module bracket securely in a vise.

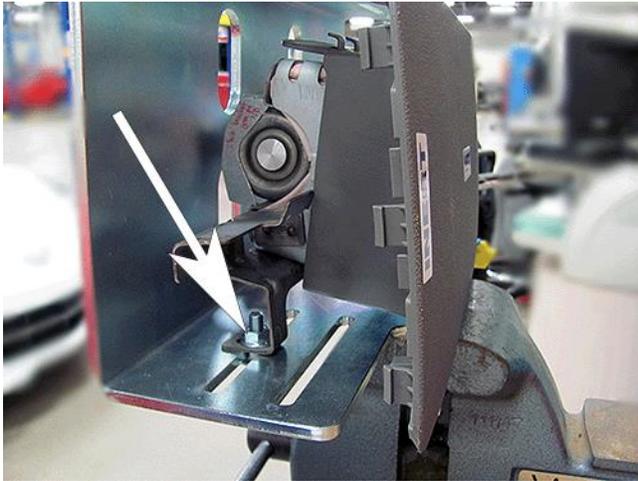
4664048

- Using the hardware kit supplied with the module bracket, loosely mount the airbag assembly to the bracket using two nuts and bolts.

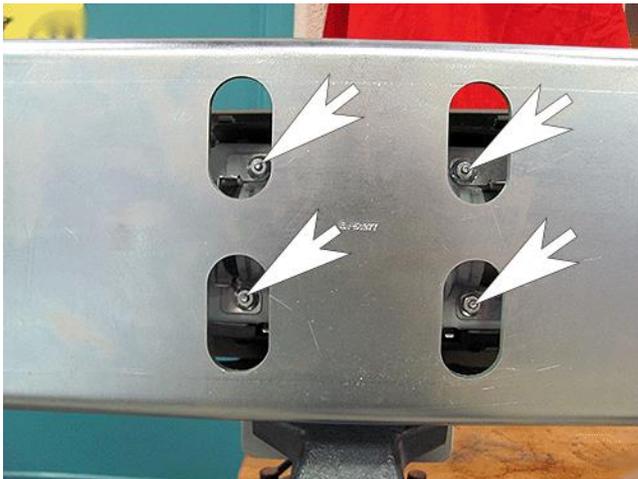
4664049

- Position the airbag assembly so that all four stopper plate nuts can be removed through the access holes.

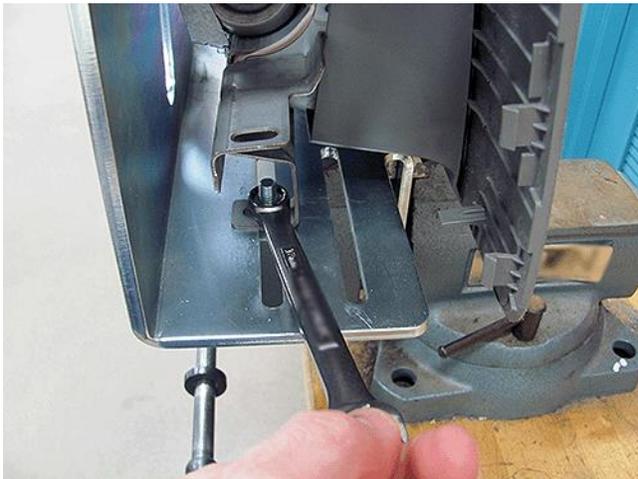
4664050

- Tighten the two fasteners that attach the airbag assembly to the module bracket.
- Confirm the following steps have been completed BEFORE proceeding to the next step:
 - The mounting bracket is secure in the vise.

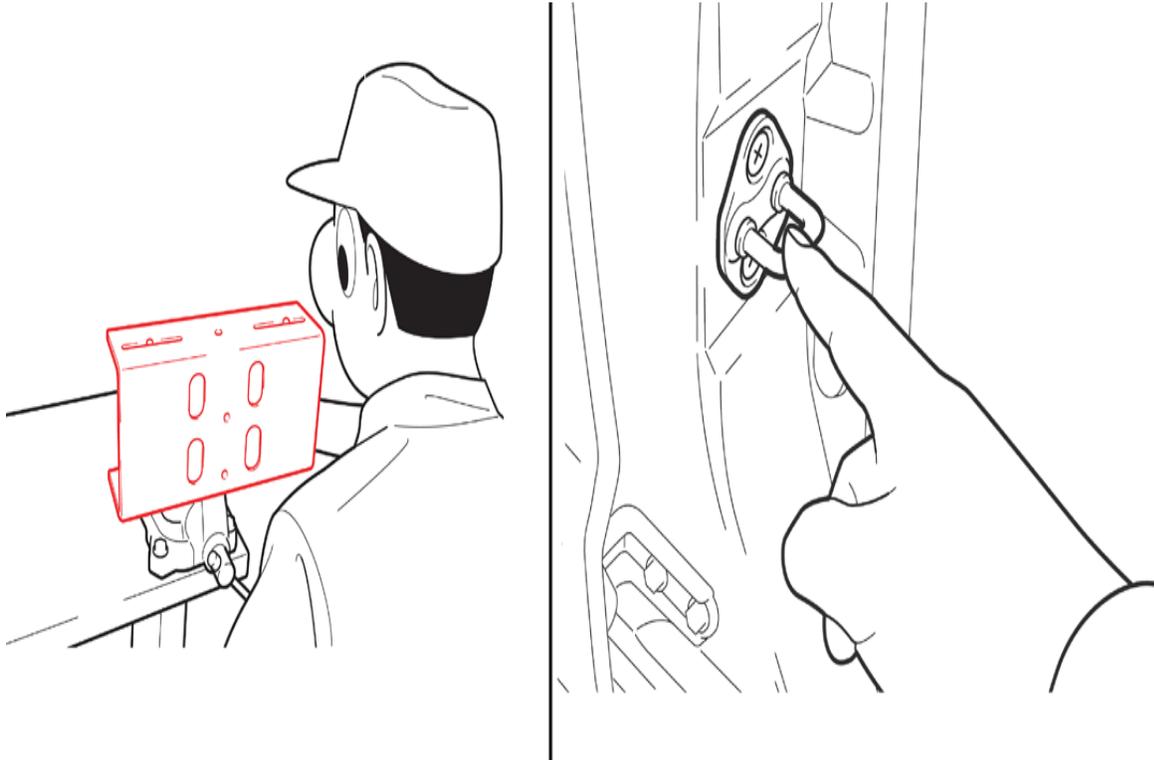
3607909

Danger: To avoid personal injury, *ALWAYS* keep as much of your body as possible in front of the bracket when working on the airbag assembly. Remember to periodically touch a metallic part of the vehicle or work bench to discharge static electricity in the body. **DO NOT** use power tools when performing the inflator removal/reinstallation steps.

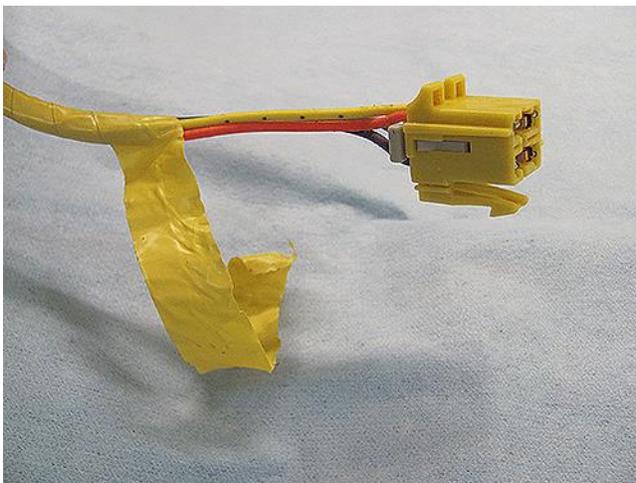
5680363

Create a short circuit before disconnecting the inflator wires.

1. Peel the yellow tape off of the wire harness near the connector. **DO NOT** use a knife or sharp tool to remove the yellow tape.

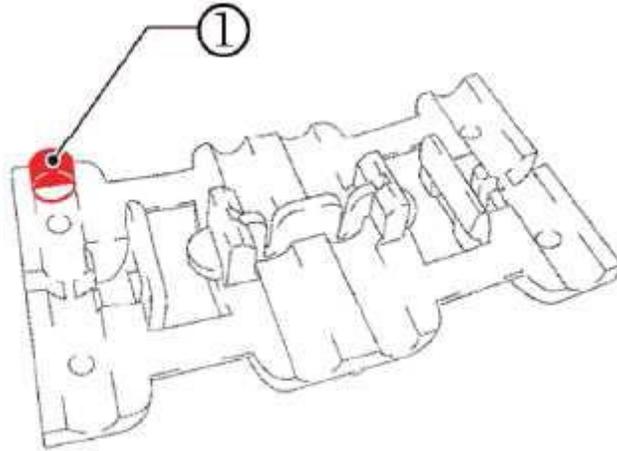
5680722

2. Locate the red plastic "Electro Tap" from the service kit. If required, remove the small tab from the electro tap as shown (1).

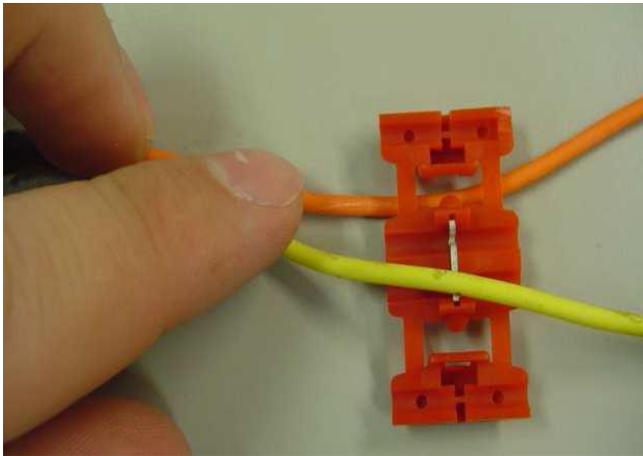
5680660

3. Locate the yellow wire and place it in the electro tap.

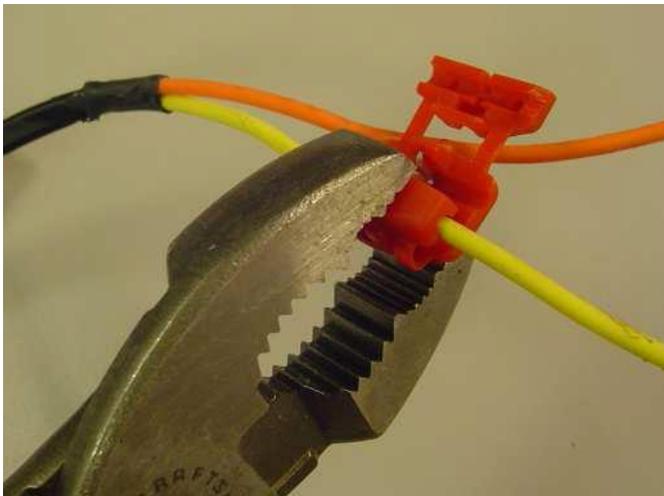
5680663

4. Use pliers to firmly close the electro tap on the **yellow wire** until an audible "click" is heard confirming the installation.

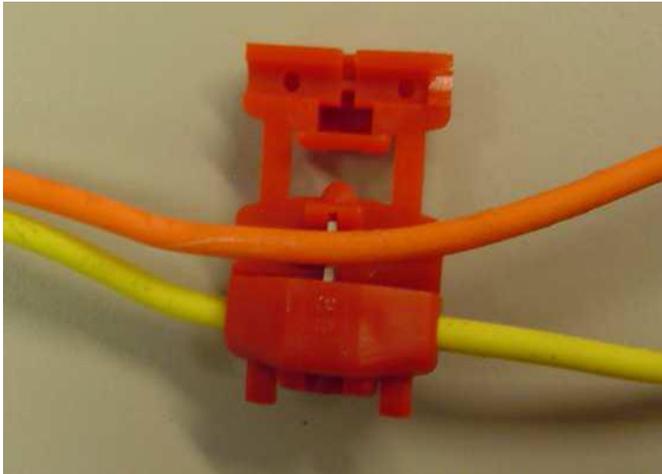
5680664

5. Locate the orange wire and place it in the electro tap.
6. Use pliers to firmly close the electro tap on the **orange wire** until an audible “click” is heard confirming the installation.

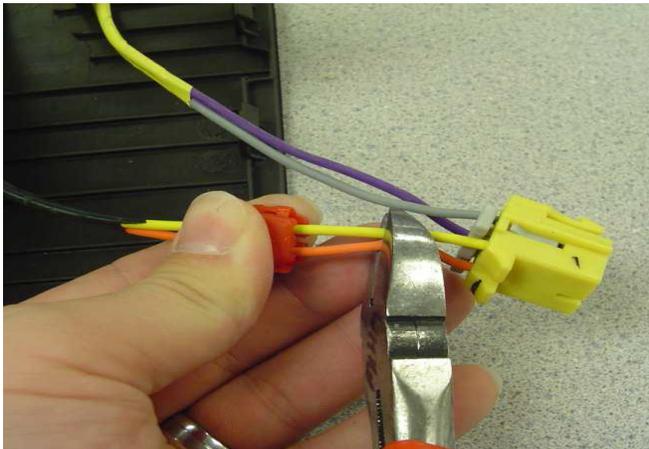
5680666

7. Place wire cutters on the connector side of the electro tap and cut the wires as shown.

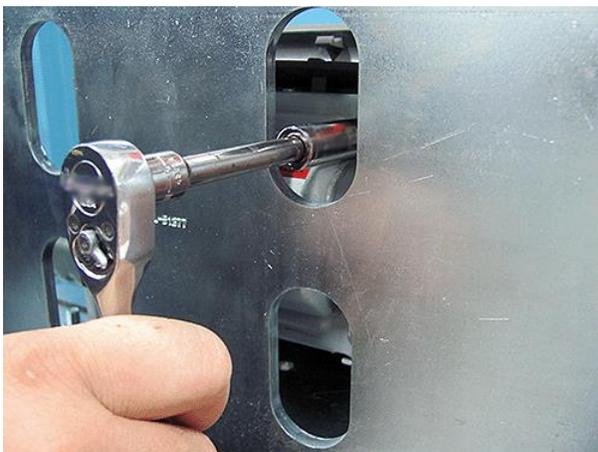
4664052

8. Use the access holes in the bracket to loosen and remove the four self-locking nuts, **do not use power tools to remove the nuts**. Discard the nuts, they will not be reused.

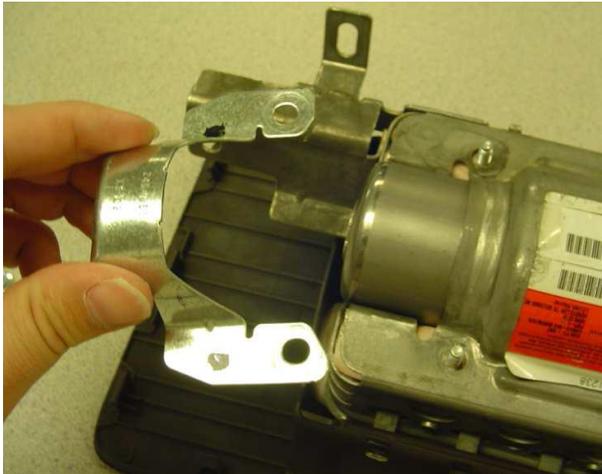
5680667

9. Remove the stopper plate (bracket).

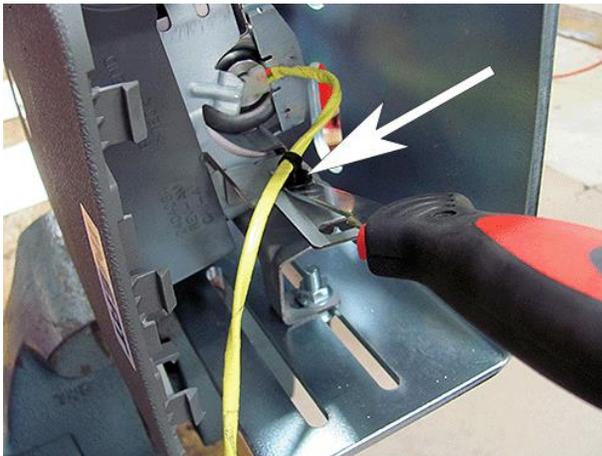
4664053

10. Disengage the wire harness locator from the housing.

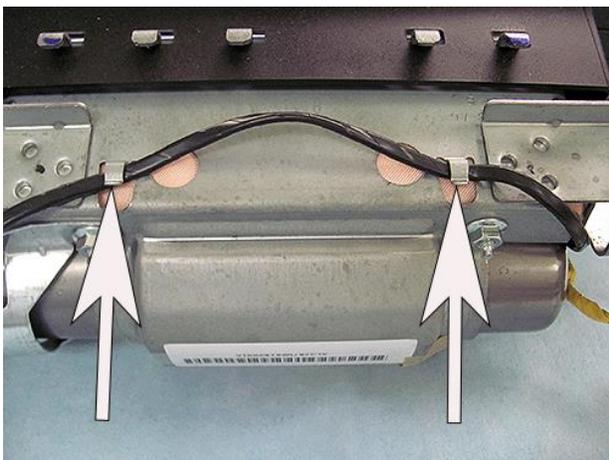
5680364

11. Remove the black taped wire from the housing tabs. The wire harness is now fully disconnected from the housing.

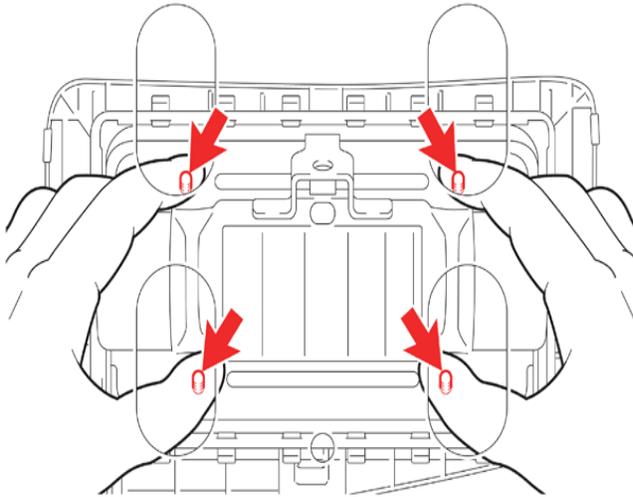
3607857

12. Gently push in the 4 studs to loosen the inflator for removal.

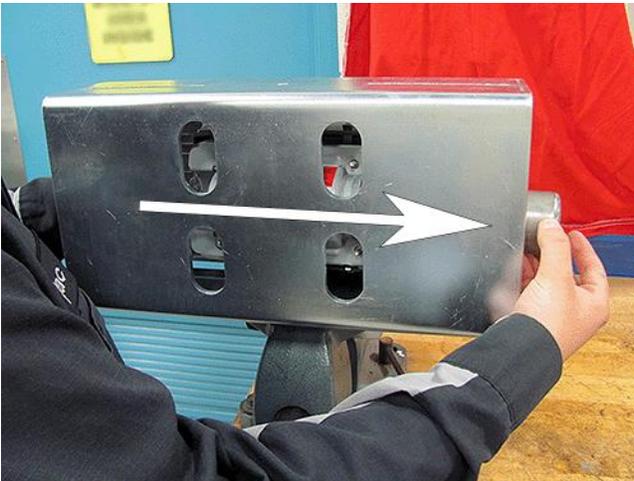
4664060

13. Remove the inflator from the housing, slide the inflator to the right.

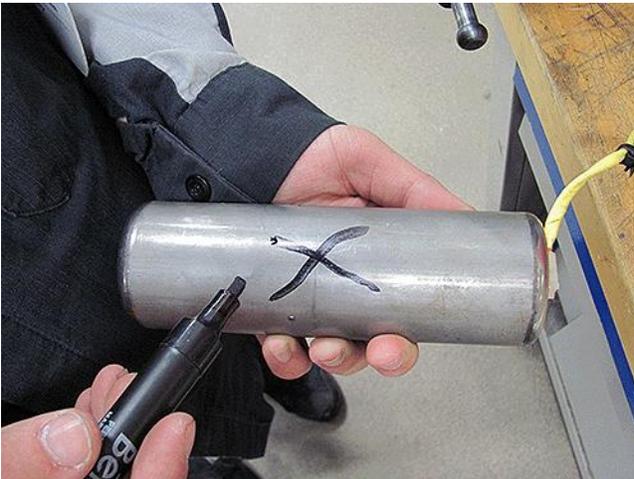
4664063

14. Put a mark on the removed inflator and store it in the provided replacement part box. Refer to the instructions that were included with the new inflator module kit.

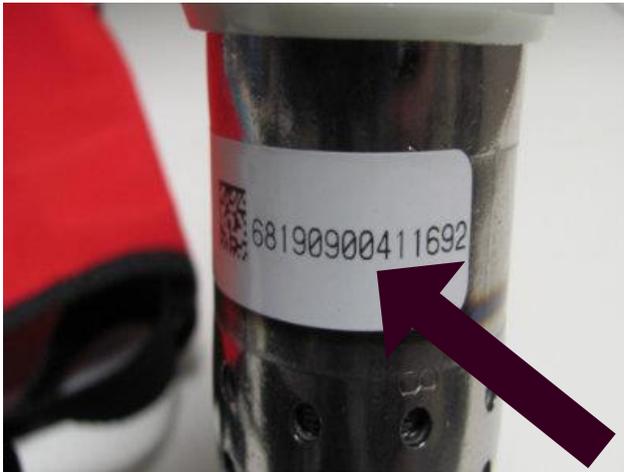
5845761

15. Record the serial number of the new (replacement) inflator from the service kit on the job card.

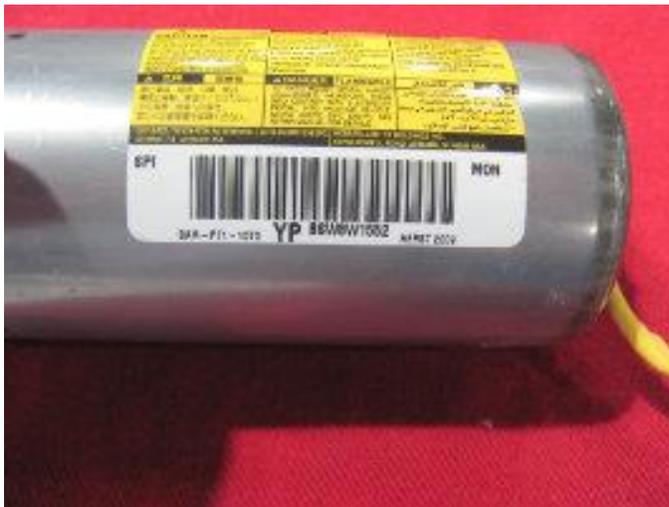
5844318

16. Record the serial number of the used inflator that is being returned on the job card.
17. Inspect the new inflator for the following two conditions:

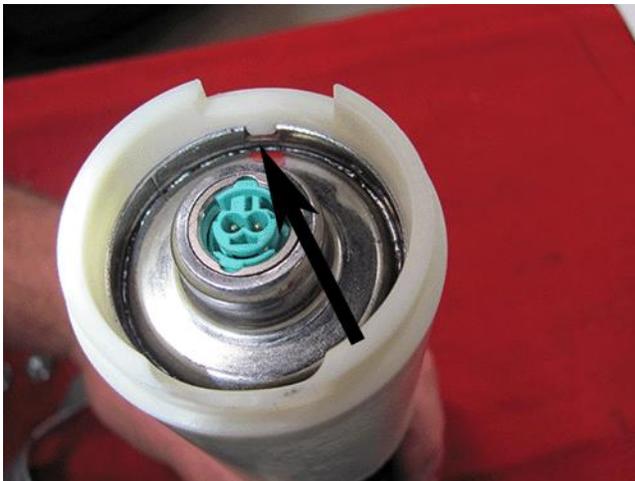
5680402

- Ensure the tab on the white end cap is aligned with the notch in the inflator.

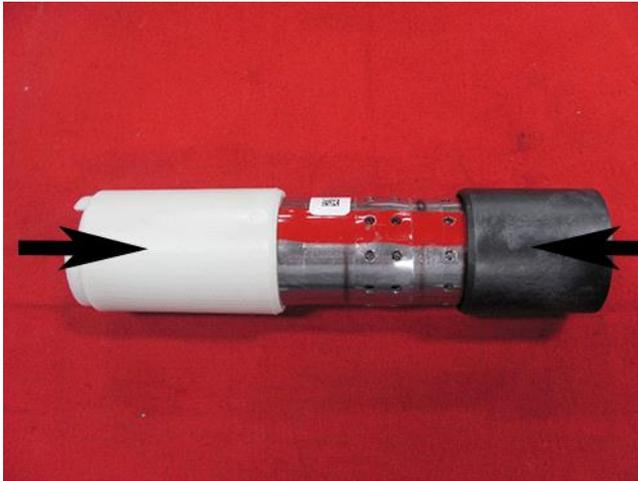
5680403

- Ensure both end caps are fully seated onto the inflator.

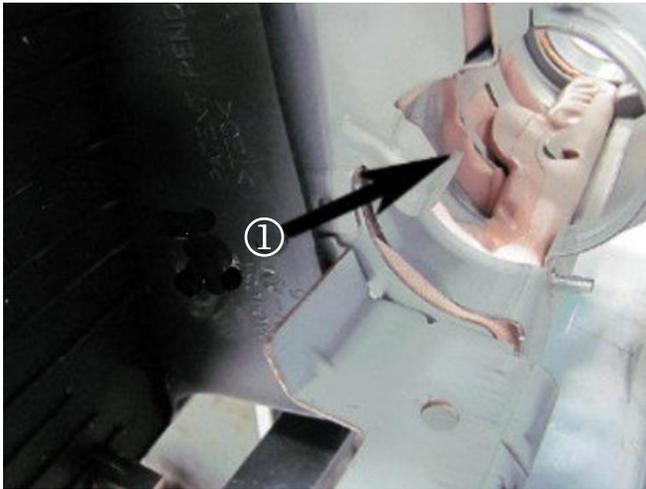
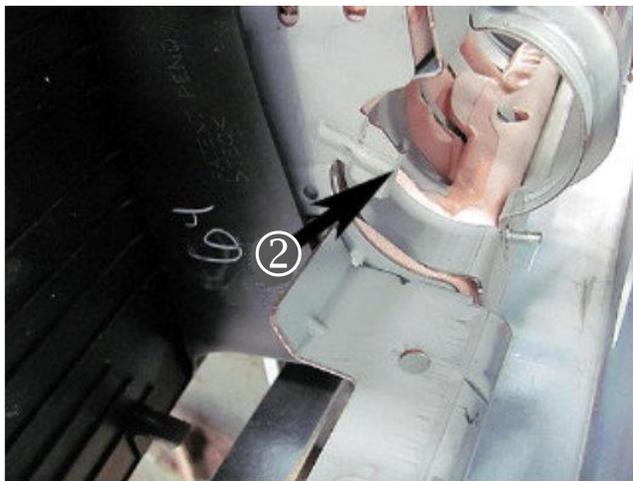
18. Using a small pair of slip joint pliers, bend the alignment tab on the airbag inward from a 90 Deg. angle (1) to a 45 Deg. angle (2).

Note: Only the small return tab should be bent. Take care to not bend any other portion of the orientation tab.

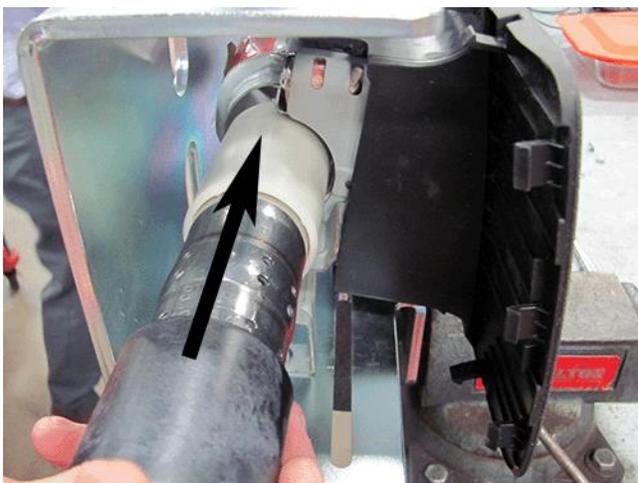
5680409

19. Slide the new inflator into the housing with the white end cap first.

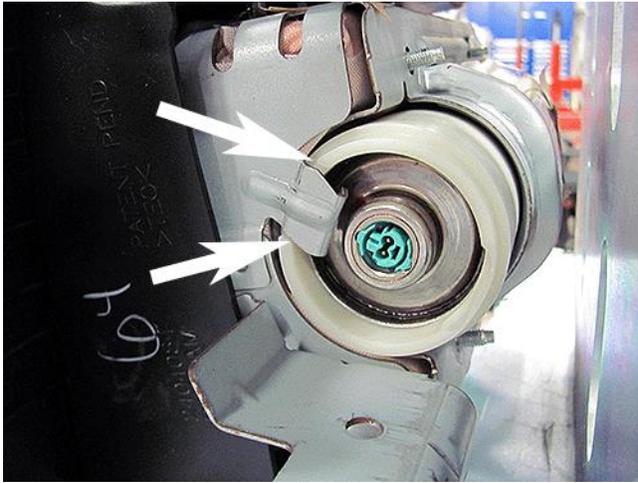
5680411

20. Rotate the inflator until the notch in the white end cap aligns with the alignment tab.

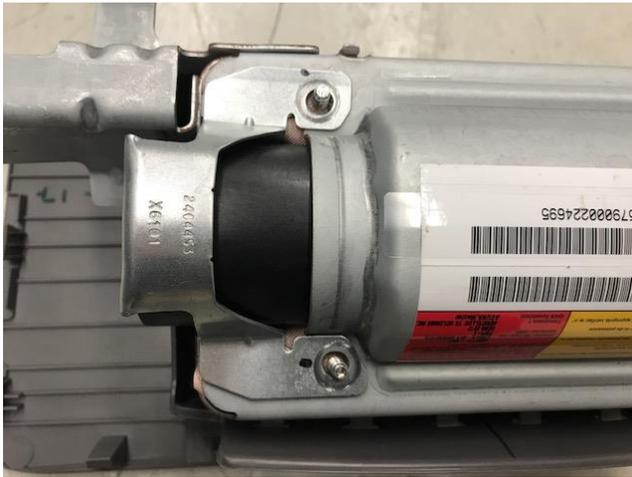
5680668

21. Place the stopper plate onto the studs as shown.

22. Loosely hand start the 4 new nuts on the studs.

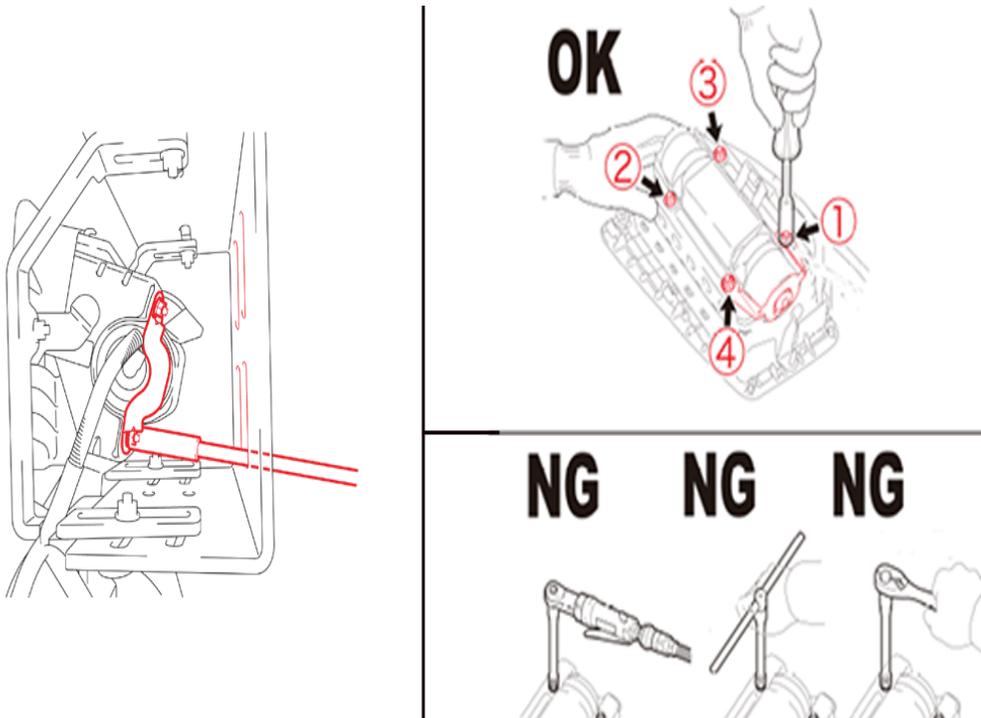
3610416

23. Tighten four (4) **NEW** plate nuts evenly in several increments in the order shown in the illustration using a 10-mm socket driver while pushing on the inflator against the alignment tab.

Note: The inflator should be netted out against the alignment tab prior to tightening the nuts. You will encounter some resistance during tightening because these nuts are self-locking nuts. **Torque Specification: 6.5 Nm (57 in-lb).**

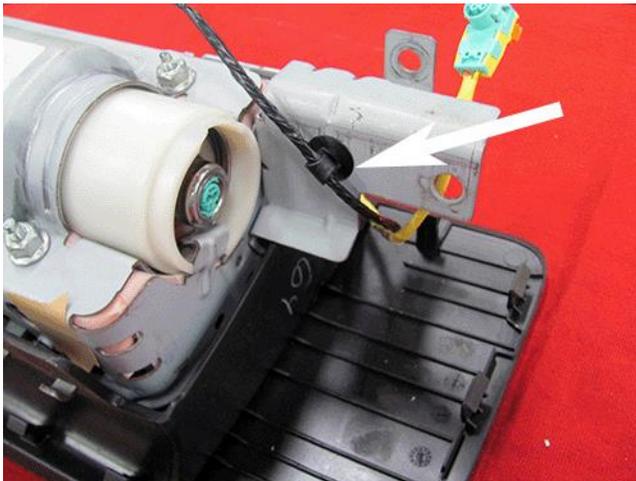
5680514

24. Install the wire harness locator to the housing.

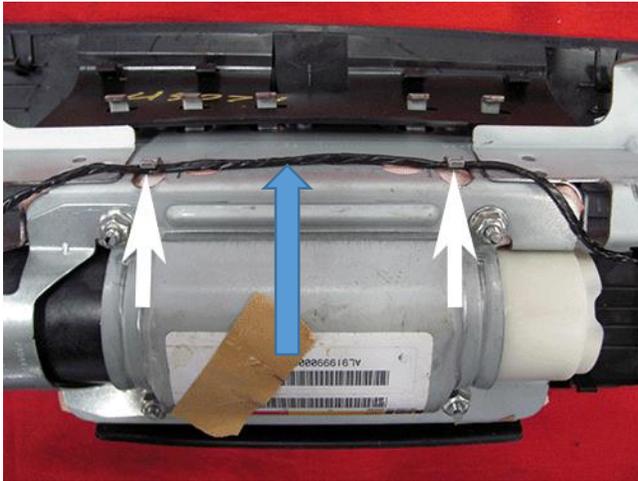
5845760

25. Press the black taped wire into the housing tabs as shown. Tape the wire harness to the metal housing in between the tabs (in the area of the blue arrow).

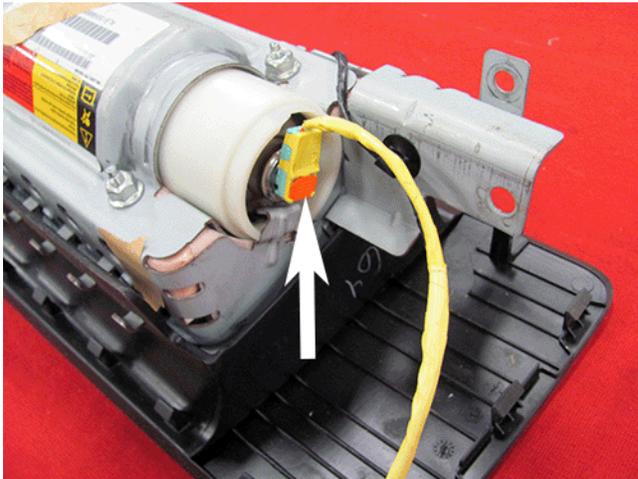
5680520

26. Install the yellow taped wire into the inflator (white cap end). Ensure the CPA is engaged.

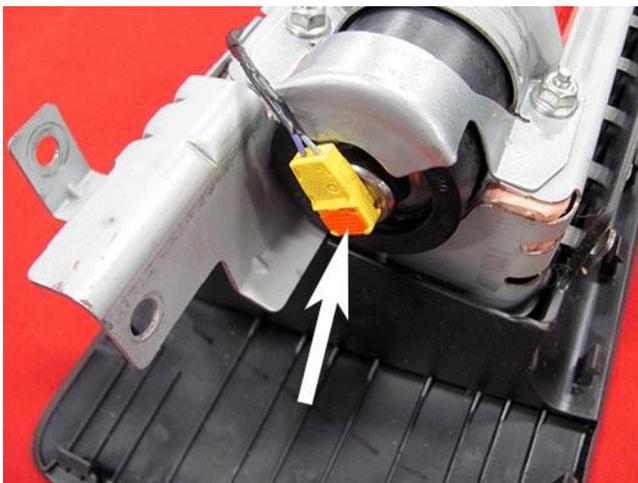
5680522

27. Install the black taped wire into the inflator (black cap end). Ensure the CPA is engaged.

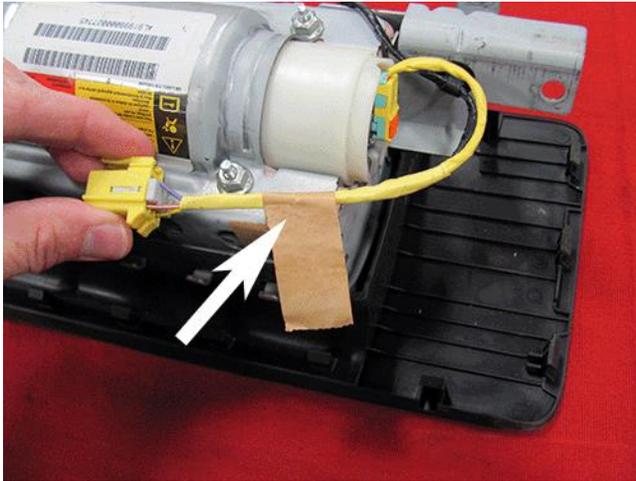
5680523

28. Apply a masking tape strip to the wire harness in the location shown below.

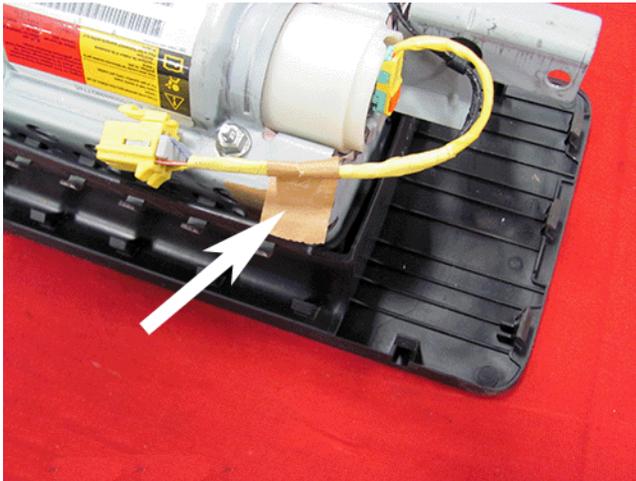
5680525

29. Adhere the tape strip and wire harness to the metal housing as shown.
30. Confirm the wire harness is in the correct orientation after taping.
31. Remove the airbag assembly from the bracket by removing the two bolts and the airbag assembly.
32. Reinstall the instrument panel passenger airbag assembly. Refer to *Airbag Instrument Panel Module Replacement* in SI.

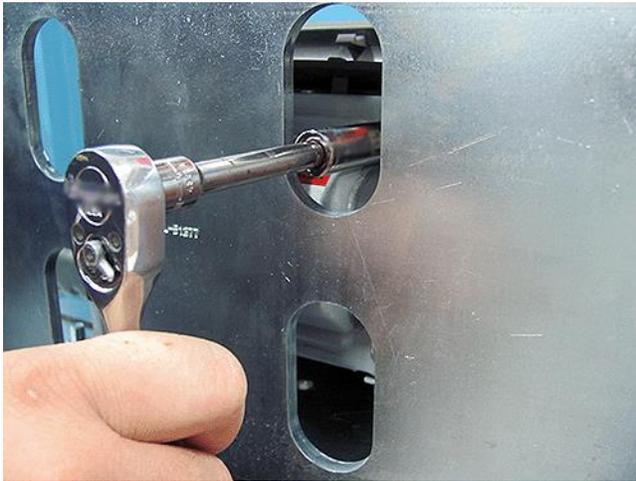
4664052

1. Use the access holes in the bracket to loosen and remove the four self-locking nuts, **do not use power tools to remove the nuts**. Discard the nuts, they will not be reused.

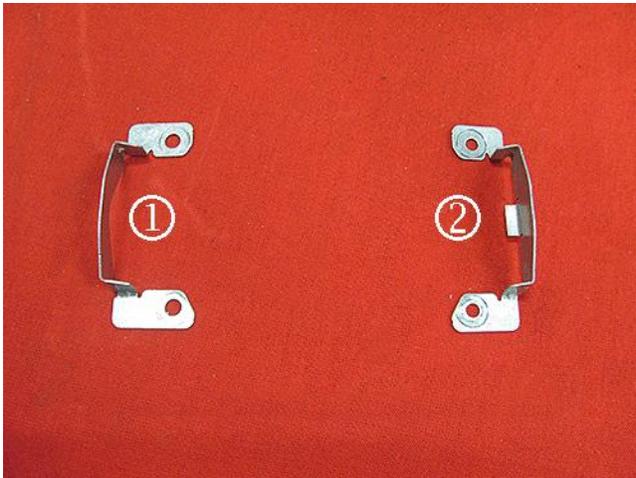
4664065

2. Remove the two stopper plates (1 and 2). Discard the stopper plates, they will not be reused.

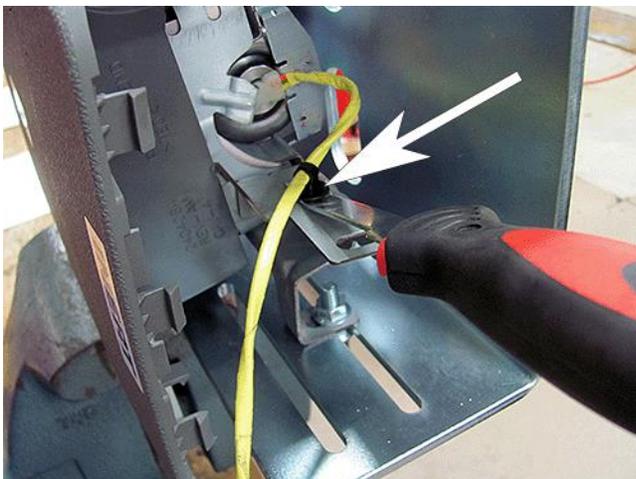
4664053

3. Disengage the wire harness locator from the housing.

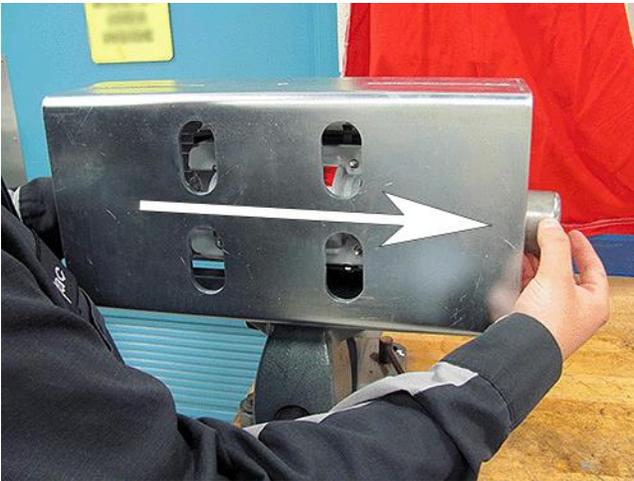
4664060

5. Remove the inflator from the housing, slide the inflator away from the harness side.

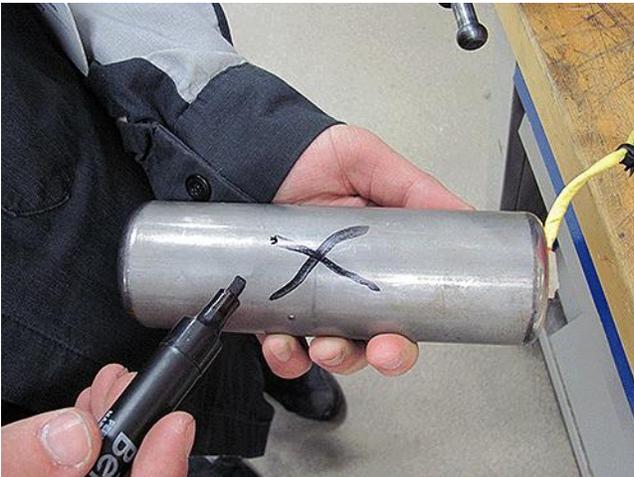
4664063

6. Put a mark on the removed inflator and store it in the replacement part box.

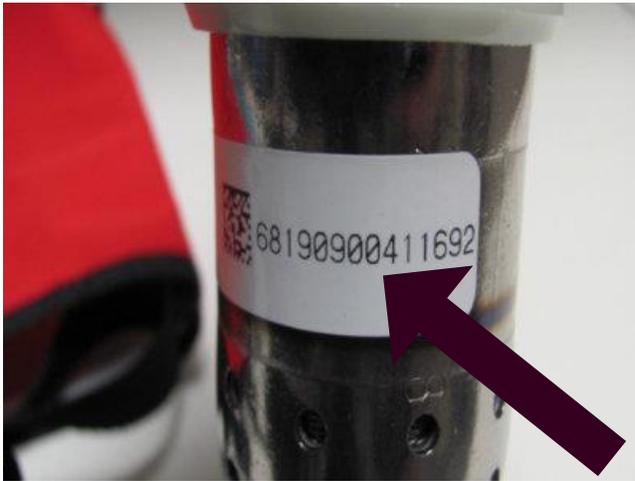
5845761

- Record the serial number of the new (replacement) inflator from the service kit on the job card.

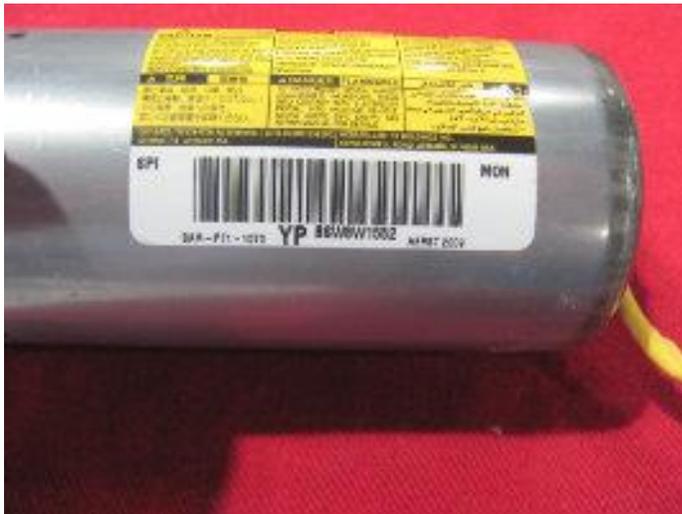
5844318

- Record the serial number of the used inflator that is being returned on the job card.
- Inspect the new inflator for the following two conditions:

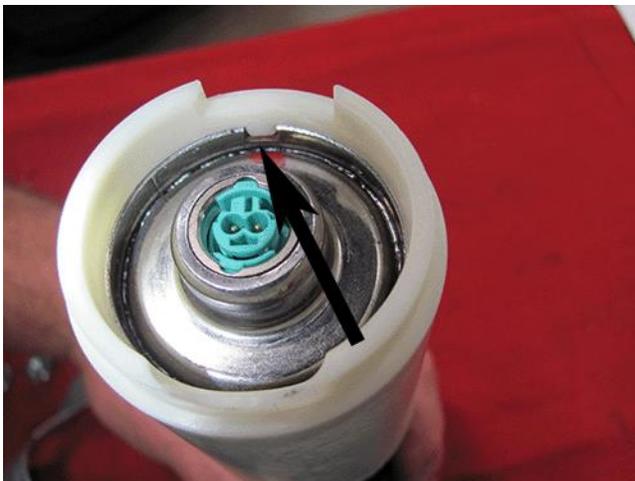
5680402

- Ensure the tab on the white end cap is aligned with the notch in the inflator.

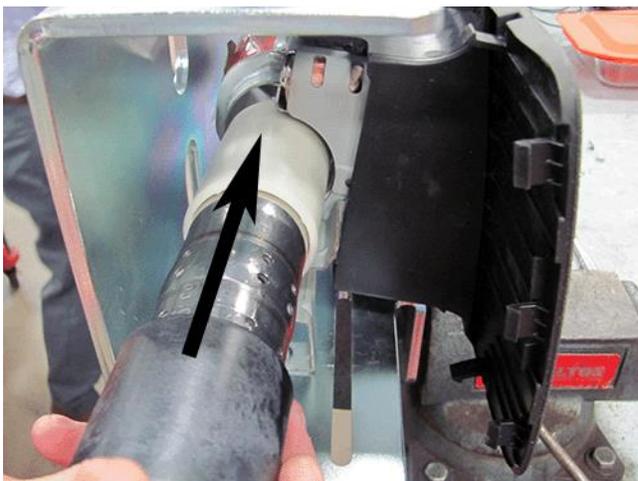
5680409

11. Carefully slide the new inflator into the airbag assembly. Ensure the inflator is installed with the harness (white end cap) end first.

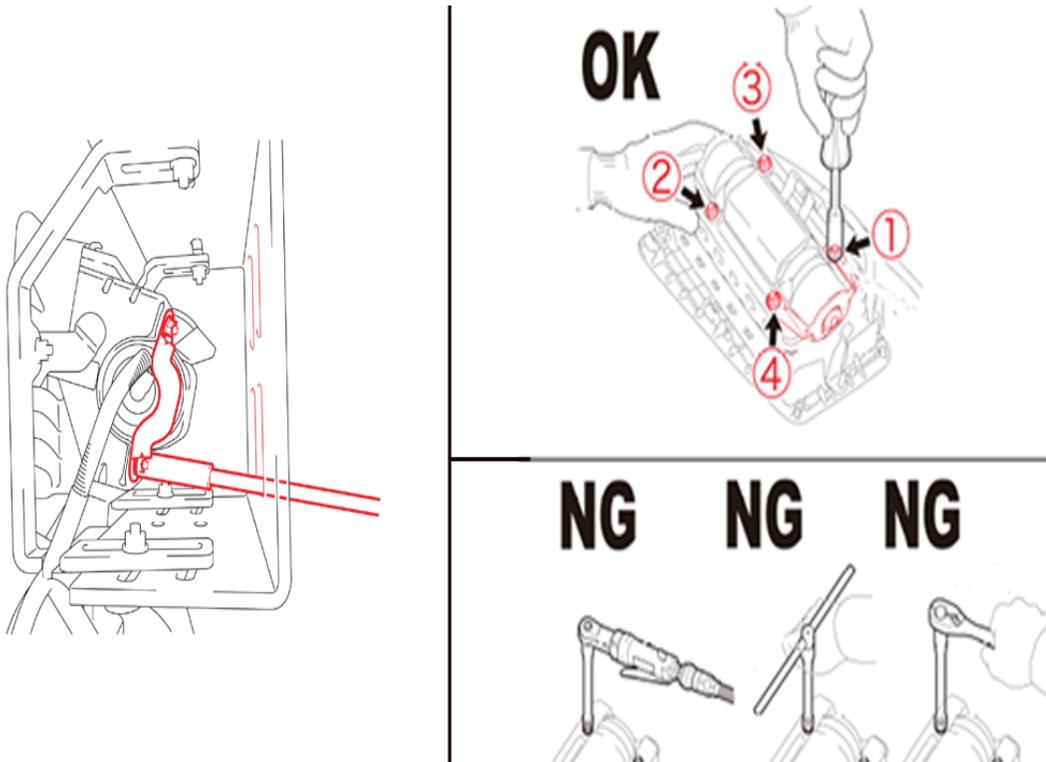
3610416

15. Tighten four (4) **NEW** plate nuts evenly in several increments in the order shown in the illustration using a 10-mm socket driver while pushing the inflator. You will encounter some resistance during tightening because these nuts are self-locking nuts. **Torque Specification: 6.5 Nm (57 in-lb).**

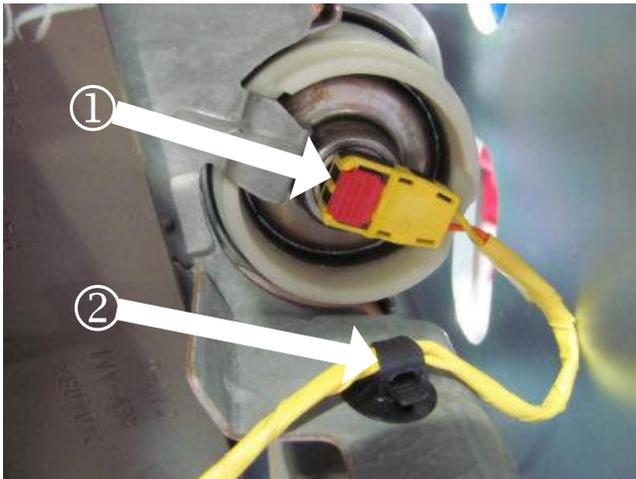
5845807

16. Connect the new yellow wiring harness to the airbag inflator, fully engage the CPA (1).
17. Install the wire harness locator to the housing (2).
18. Remove the airbag assembly from the bracket by removing the two bolts and the airbag assembly.
19. Reinstall the instrument panel passenger airbag assembly. Refer to *Airbag Instrument Panel Module Replacement* in SI.
