IMPORTANT SAFETY RECALL
NHTSA Recall No. 22T-021

Bridgestone Americas Tire Operations, LLC (“**BATO**”) has determined that certain Firestone Destination LE2, Bridgestone Alenza Sport A/S, and Bridgestone Turanza EL440 tires may have sustained bead cuts from a warehouse de-palletizer during the shipping process, and that this condition could pose a safety risk. BATO has initiated a voluntary safety recall of these tires.

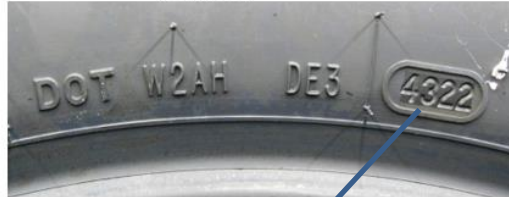
FULL DOT

NOTE: Potentially impacted tires would have "2522" or "2622" here.

The tire's DOT TIN can be found on the sidewall just above the rim (see images on pages 7 and 8).

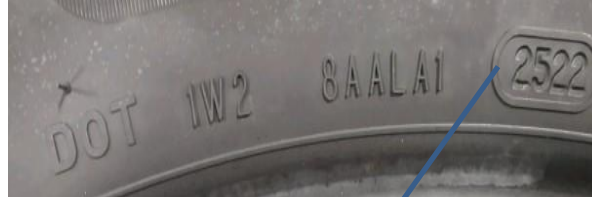
FULL DOT

NOTE: Potentially impacted tires would have "2522," as indicated here, or "2422," "2622," or "2722."

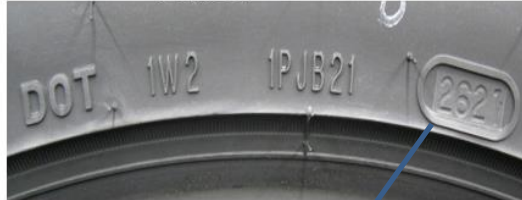
FULL DOT

NOTE: Potentially impacted tires would have "2621" as indicated here, or "2521."
