Service Engineering Operations
Ford Customer Service Division

SUBJECT: **NEW VEHICLE DEMONSTRATION / DELIVERY HOLD**
Safety Recall 22S27 - Supplement # 10
Certain 2020-2022 Model Year Explorer Vehicles
Rear Axle Bolt Fractures

CERTAIN 2020 - 2022 MODEL YEAR EXPLORER VEHICLES — EQUIPPED WITH A 3 BOLT DIFFERENTIAL HOUSING BUSHING REPLACEMENT (POLICE UNITS ONLY)

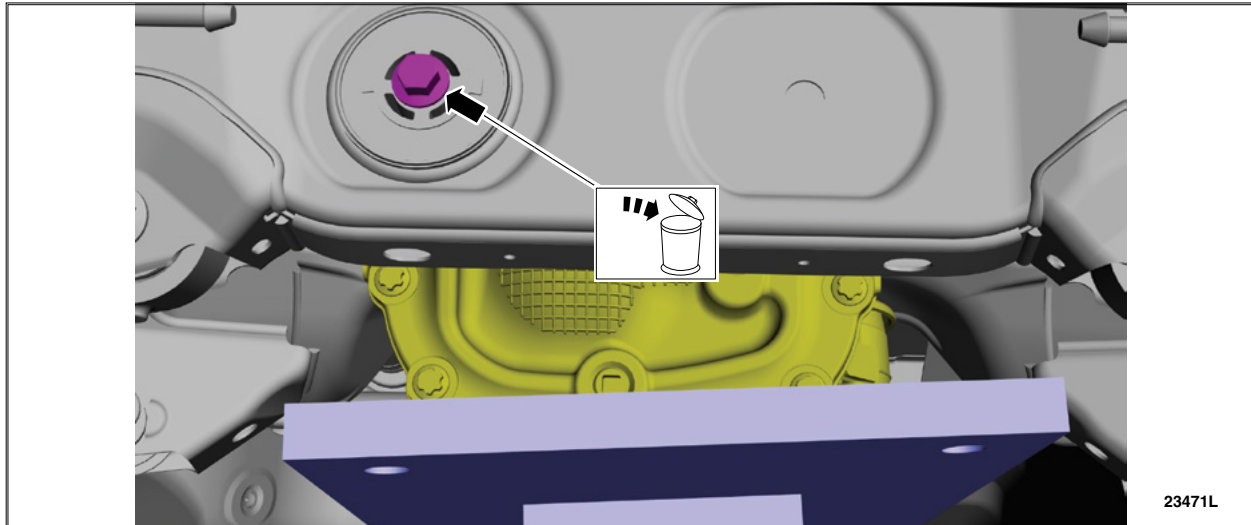
FIGURE 12

18. Remove and discard the rear axle housing support rear bolt. See Figure 12.

Stage 1: Torque to: 74 lb.ft (100 Nm).

Stage 2: Tighten an additional: 100° (*degrees*).

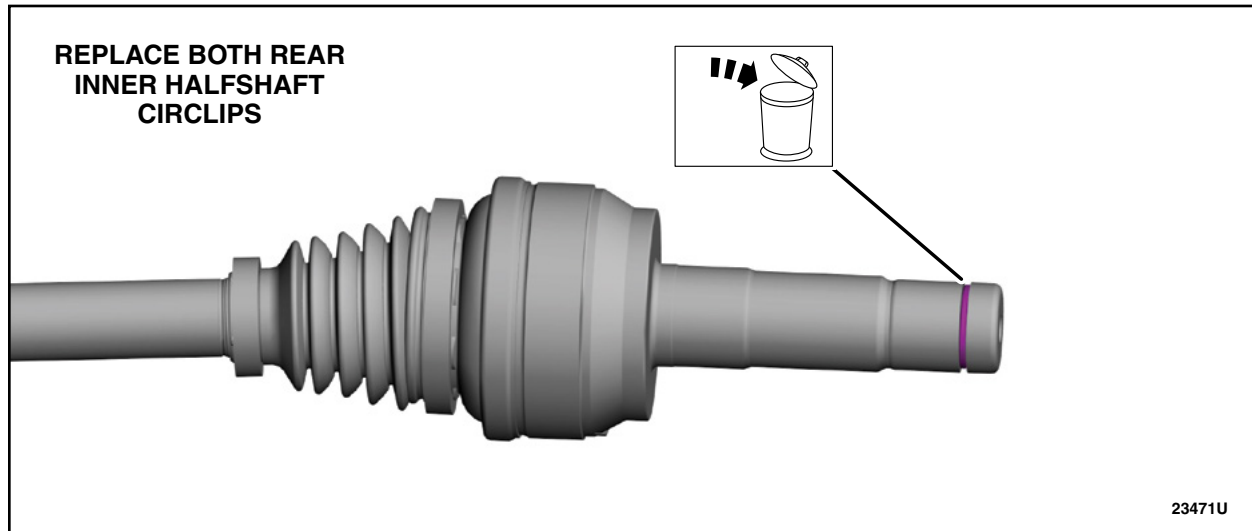
FIGURE 18

NOTE: In the next Step, make sure both rear halfshaft circlip openings are located at the bottom or 6 o'clock position to allow for easy installation when directed to install them.

25. Remove and discard both rear inner halfshaft circlips. Then, install *new* circlips onto both rear inner halfshafts. See Figure 18. Then, proceed to the next Step.
