TO: Mercedes-Benz Dealer Principals, General Managers, Sales Managers, Service Managers, Parts Managers	FROM: Anthony Washington, Senior Manager, Regulations and Certifications
Re: Launch Recall Campaign Notification Model: Sprinter (907) Model Years: 2019-2021 Replace eCall Communication Module	DATE: April, 2024

Campaign No. :	Campaign Desc. :	Replace eCall Communication Module
2024030013	VS3SIMKOW	
<p>This is to notify you of a Recall Campaign launch to replace eCall communication module on approximately 1,686 MY 2019-2021 Sprinter Vans. The recall campaign will be visible on the www.safercar.gov website and may generate questions from customers. All affected VINs will be flagged as "OPEN" in VMI and cannot be sold until remedied.</p>		
Background		
Issue	<p>Mercedes-Benz AG ("MBAG"), the manufacturer of Mercedes-Benz Sprinter vans, has determined that due to an interaction between a SIM card security mechanism and the affected SIM profile, the SIM card might inadvertently become disabled. Should this occur, the communication module would not be able to establish a connection with a mobile phone network. In this case, the eCall function would not be available. Therefore, the con

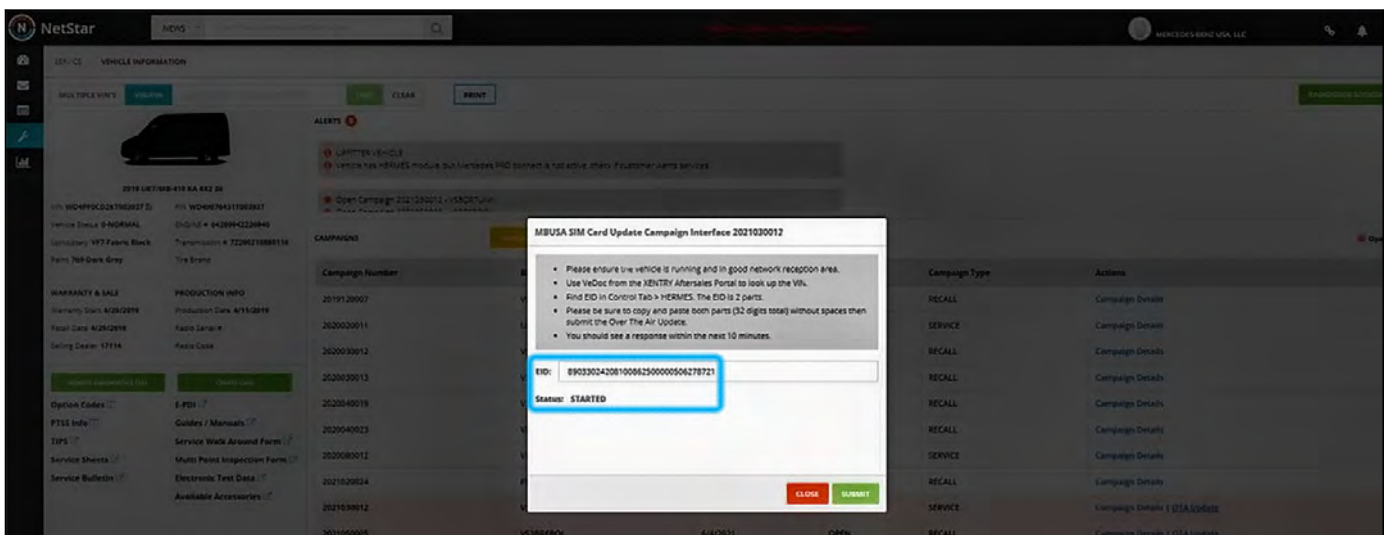
D82.95-A024-78

Update (over-the-air update (OTA update)) started on "NetStar" system (shown in English)

Screen on "NetStar" system if "OTA Update" is clicked again during the update process (over-the-air update (OTA update)).
