TO: Freightliner Dealer Principals, General Managers, Sales Managers, Service Managers, Parts Managers	FROM: Anthony Washington, Senior Manager, Regulations and Certifications
<b>Re: Launch Recall Campaign Notification</b> <b>Model: Sprinter (907)</b> <b>Model Years: 2019-2021</b> <b>Replace eCall Communication Module</b>	DATE: April, 2024

<b>Campaign No. :</b>	<b>Campaign Desc. :</b>	<b>Replace eCall Communication Module</b>
<b>2024030013</b>	<b>VS3SIMKOW</b>	
<p>This is to notify you of a Recall Campaign launch to replace eCall communication module on approximately <b>137</b> MY 2019-2021 Freightliner Sprinter Vans. The recall campaign will be visible on the <a href="http://www.safercar.gov">www.safercar.gov</a> website and may generate questions from customers. All affected VINs will be flagged as "<b>OPEN</b>" in VMI and cannot be sold until remedied.</p>		
<b>Background</b>		
<b>Issue</b>	<p>Mercedes-Benz AG ("MBAG"), the manufacturer of Freightliner Sprinter vans, has determined that due to an interaction between a SIM card security mechanism and the affected SIM profile, the SIM card might inadvertently become disabled. Should this occur, the communication module would not

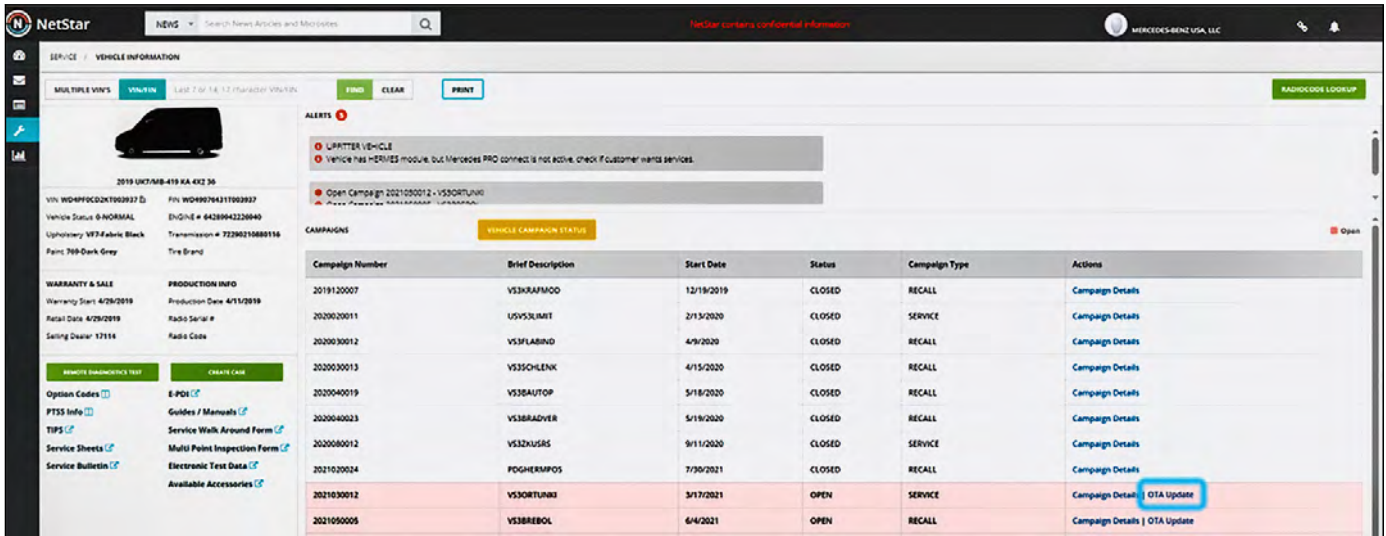
D82.95-A020-78

**Search for vehicle identification number (VIN/FIN) on "NetStar" system (shown in English)**

You can see the update link (over-the-air update (OTA update)) in the campaign table on the VMI mask when the update campaign (over-the-air update (OTA update)) for the vehicle identification number (FIN) is open.
