Recall Campaign Launch Notification			May 3, 2024
Campaign No. :	NHTSA ID	Campaign Desc. :	<b>Update Communication Module SIM Card Software - Wave 1</b>
2023110006	22V365	23P5497319	
<p>This is to notify you of the <b>Recall Campaign Launch</b> to update the communication module SIM card software in <b>2,000</b> Model Year (“MY”) 2019-2022 A-class, C-Class, CLA, CLS, E-Class, G-Class, GLA, GLB, GLC, GLE/GLS, AMG GT 4-door, and S-Class vehicles (177, 205, 118, 257, 213, 238, 463, 247, 253, 167, 290, 217, 222 platform). The recall campaign will be visible on the www.NHTSA.gov website and may generate questions from customers. Affected VINs will be flagged in VMI as “OPEN” on <b>May 3, 2024</b>.</p>			
Background			
<b>Issue</b>	Mercedes-Benz AG (“MBAG”), the manufacturer of Mercedes-Benz vehicles, has determined that on certain MY 2019-2022 models mentioned above, the communication module's SIM card software might inadvertently become disabled. Should this occur, the communication module would not be able to establish a connection with a mobile phone network. In this case, both the manual and automatic eCall functions would not be available, which could preclude or delay the arrival

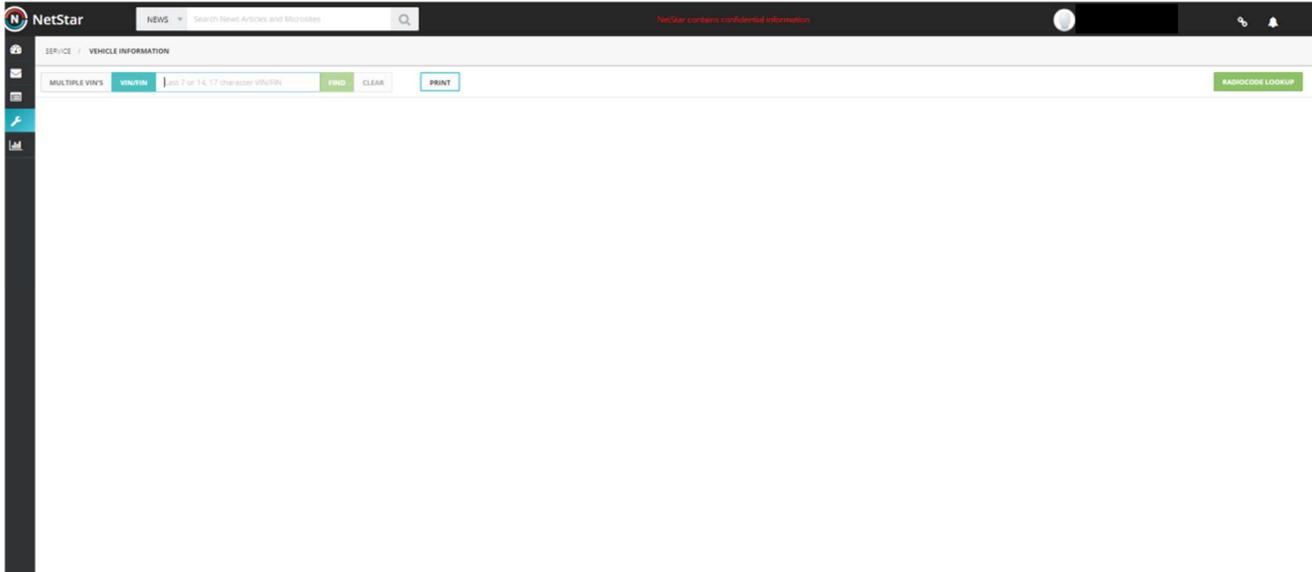
Figure 3

1. Log in to "NetStar" and call up the Vehicle Master Inquiry (VMI) screen (Figure 3).

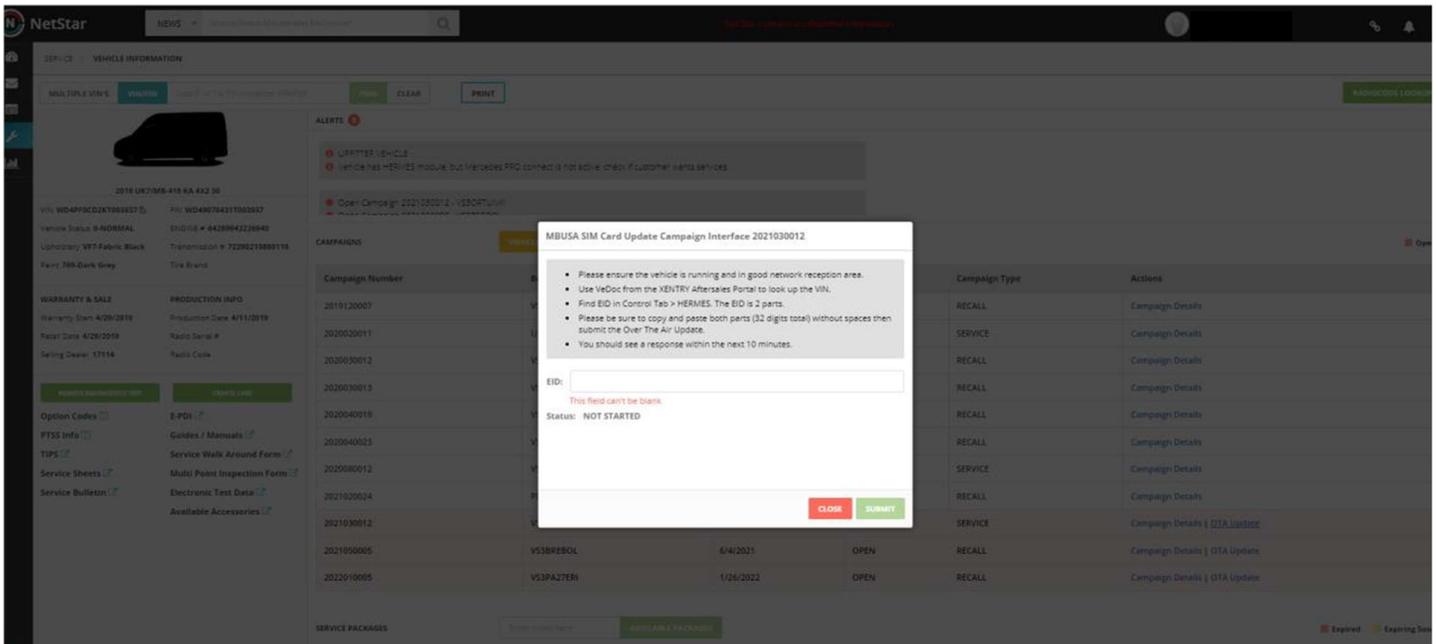
Figure 5

**i** A pop-up window requesting an EID number for the OTA update will appear (Figure 5).

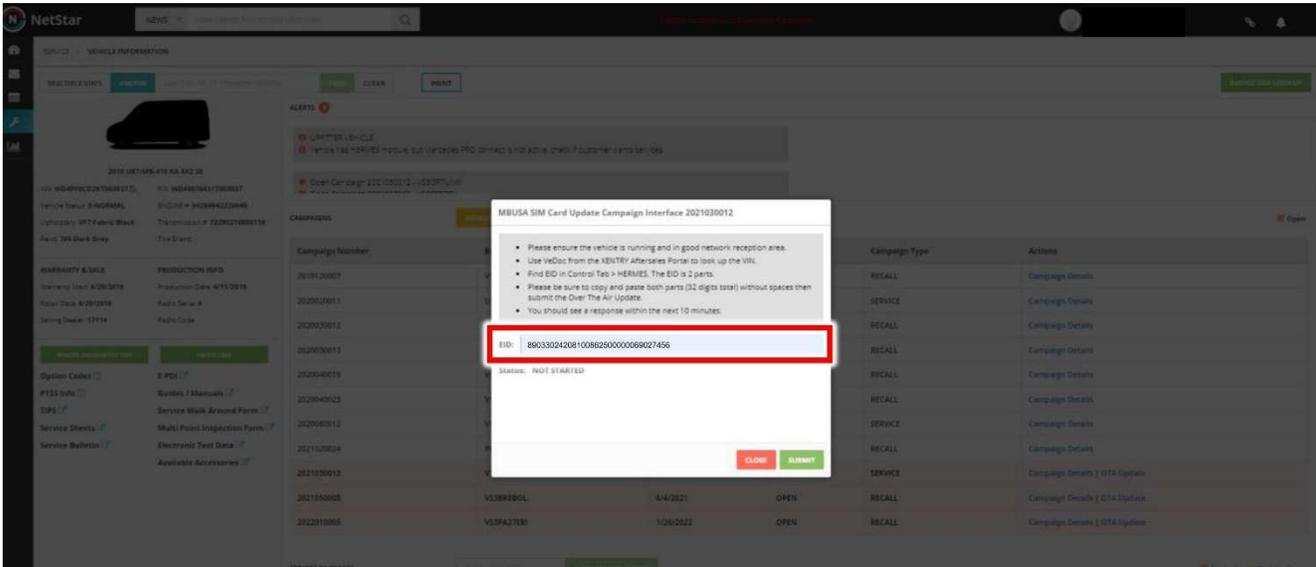
5. Enter the valid EID number and click on "Submit" (Figure 7).

To do this, enter the **EID1 + EID2** numbers from VeDoc **without spaces or special characters** as shown. (e.g.: 89033024208100862500000069027456 – **EXAMPLE ONLY**).

Figure 7 – EID1 + EID2 input

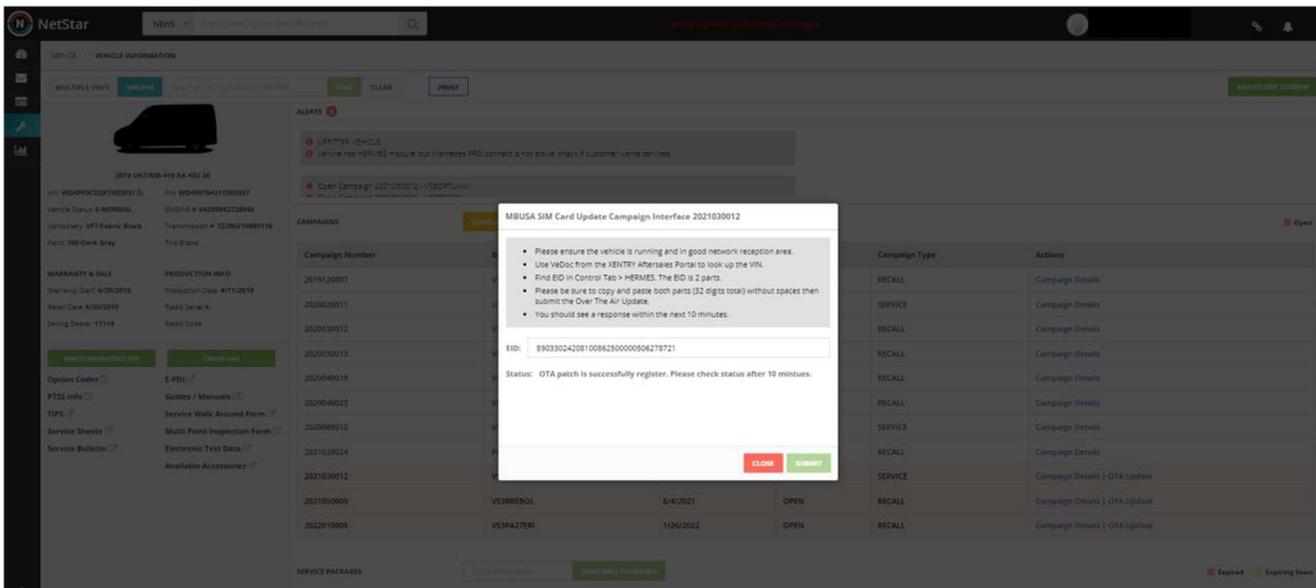
Figure 8 (screen on "NetStar" after the OTA update has been registered successfully)  
 Status: OTA patch is successfully registered. Please check status after 10 minutes

**i** After you click "Submit", the following screens can be displayed depending on the results of the OTA Update: (Figures 8, 9, 10 11, and 12).

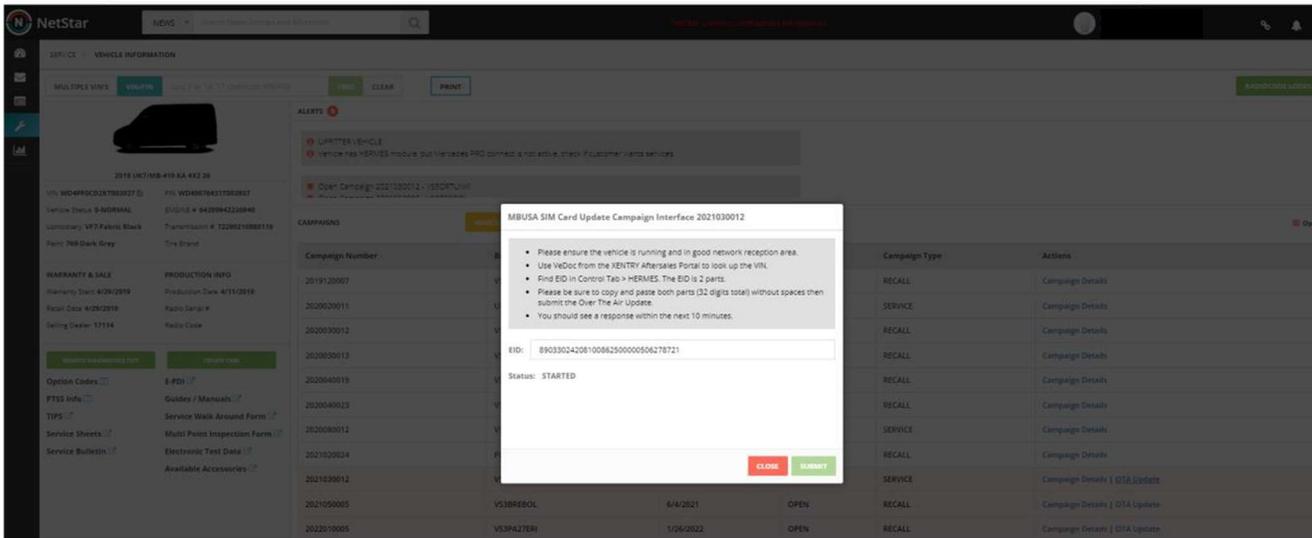
Figure 9 (screen on "NetStar" if "OTA update" is clicked again during the OTA update process)  
 Status: Started

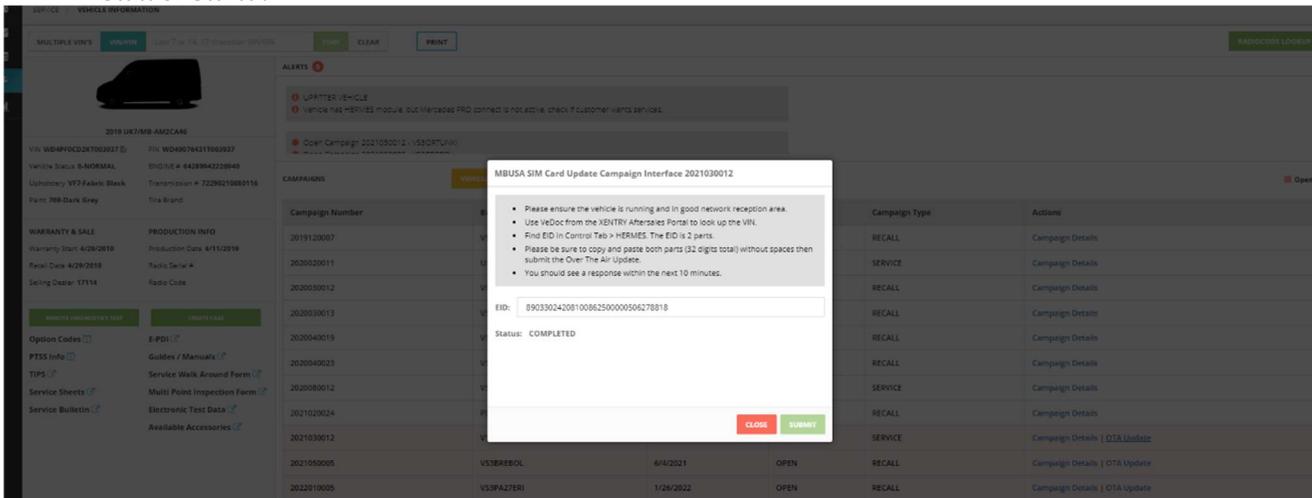
Figure 10 (screen on "NetStar" if the OTA update was successful)  
 Status: Completed

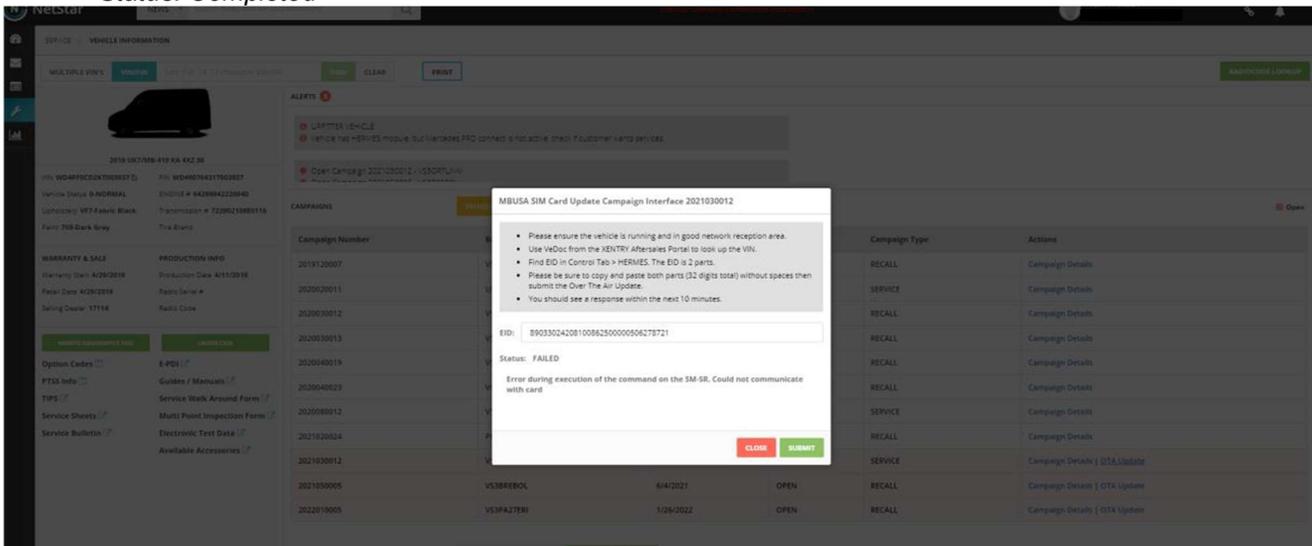
Figure 11 (screen on "NetStar" if the OTA update was not successful)  
 Status: Failed – Error during execution of the command on the SM-SR. Could not communicate with card.
