**REF. NO. C24100080**

**REPLACEMENT OF BRAKE FLUID  
RESERVOIR CAP**

Ferrari \_\_\_\_\_  
**F8TRIBUTO**

Ferrari \_\_\_\_\_  
**F8SPIDER**

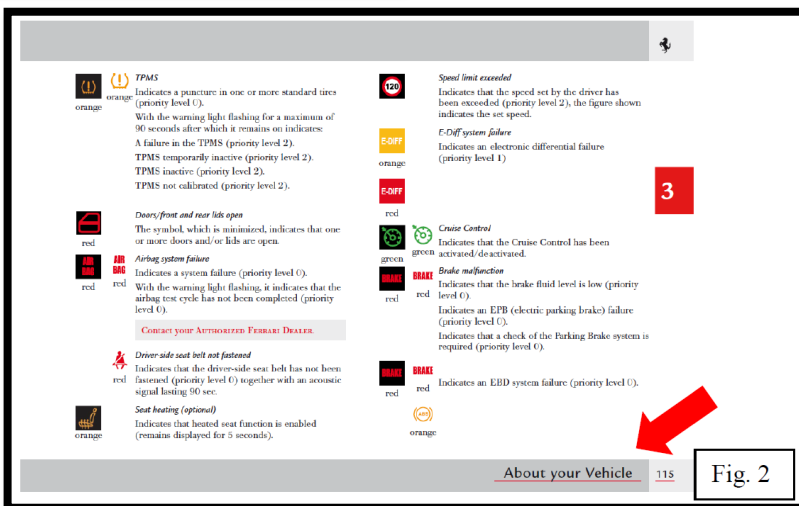
Page Location to Apply  
New Adhesive Sticker

The sticker must be placed on the page shown above in the Owner's Manual. This page is located in the **"About Your Vehicle"** section where the warning lights on the instrument panel are described. Please be sure to attach it to the page with the **"Low Brake Fluid"** description as shown above in Fig. 2.

Once you locate the proper page, remove the adhesive protector off of the back of the sticker. Ensure there is no residue or other particles on the page that may inhibit the longevity of adhesion to the page. Place the sticker to allow the bottom of the sticker to lay directly above the gray margin at the bottom of the page that contains the text **"About your Vehicle"**.
