**RECALL CAMPAIGN
INSTRUCTIONS**

REF. NO. C24100080

**REPLACEMENT OF BRAKE FLUID
RESERVOIR CAP**

FERRARI
California **T**

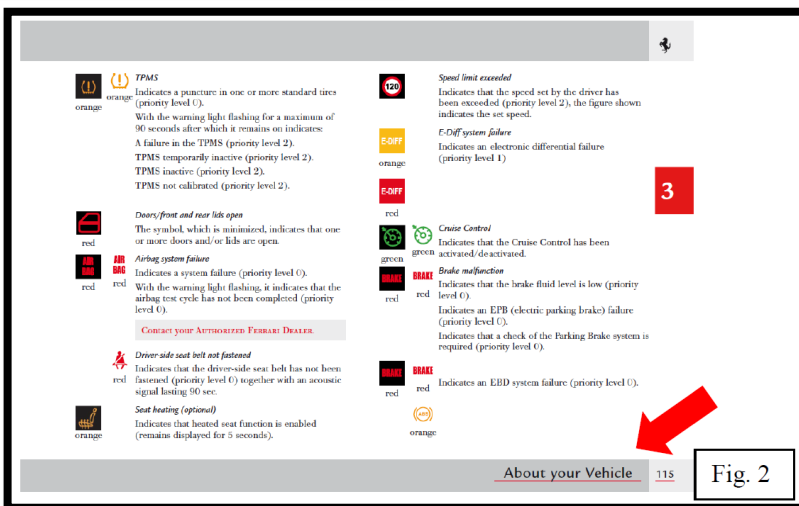
Page Location to Apply
New Adhesive Sticker

The sticker must be placed on the page shown above in the Owner's Manual. This page is located in the **"About Your Vehicle"** section where the warning lights on the instrument panel are described. Please be sure to attach it to the page with the **"Low Brake Fluid"** description as shown above in Fig. 2.

Once you locate the proper page, remove the adhesive protector off of the back of the sticker. Ensure there is no residue or other particles on the page that may inhibit the longevity of adhesion to the page. Place the sticker to allow the bottom of the sticker to lay directly above the gray margin at the bottom of the page that contains the text **"About your Vehicle"**.
