Stacy L. Balzer  
 Director  
 Service Engineering Operations  
 Ford Customer Service Division

**SUBJECT:** **NEW VEHICLE DEMONSTRATION / DELIVERY HOLD**  
**Compliance Recall 22C27- Supplement #4**  
 Certain 2021-2022 Model Year Bronco Vehicles  
 Accessory Protocol Interface Module Software Update

Some of the affected vehicles may not conform to the requirements specified by Federal Motor Vehicle Safety Standard (FMVSS) 111 S5.5 Rear Visibility. The rearview camera image may reappear on the SYNC screen after a backing event has been completed while in 4WD Low mode. The reappearance of the rearview camera image may distract the driver, increasing the risk of a crash.

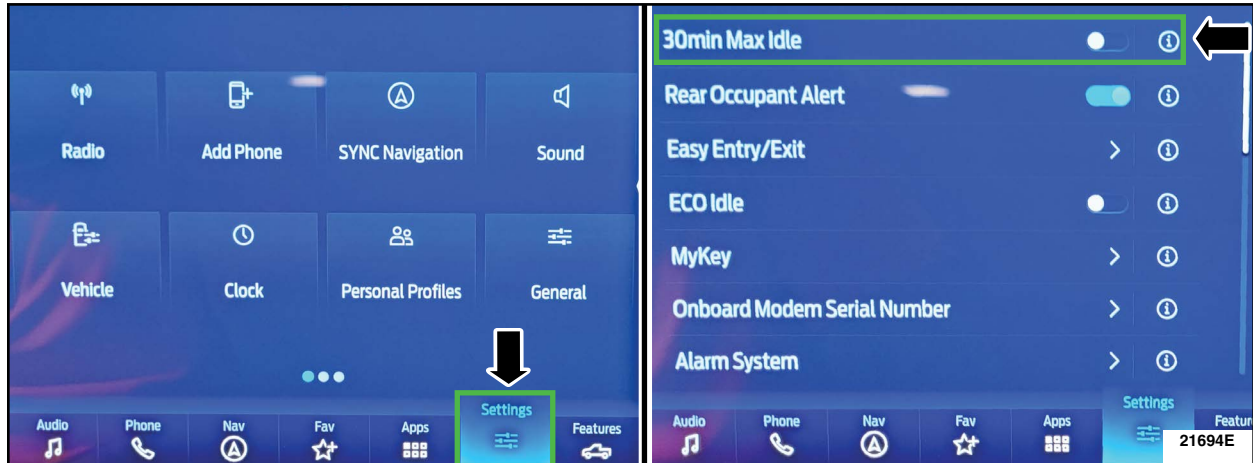
**FIGURE 1**

1. From the vehicle settings menu disable the 30 minute max idle option. From the center display press the vehicle settings button and turn off the 30 minute max idle setting. See Figure 1.

**NOTE:** F-150 shown, Bronco similar.

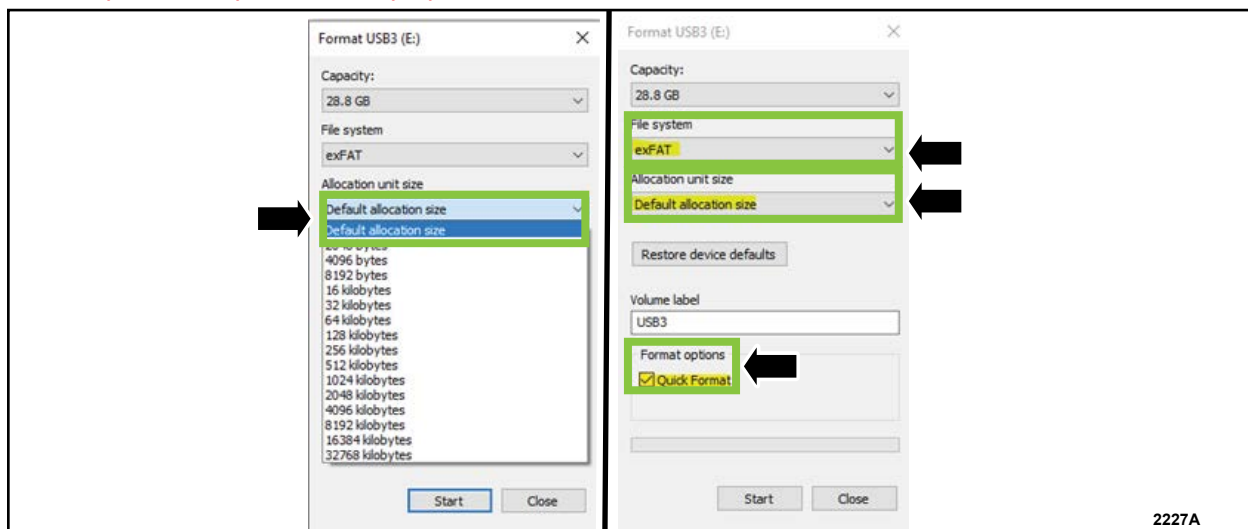
**FIGURE 2**

- a. *Right click on the USB flash drive.*
- b. *Select Format, select exFAT for the File System.*
- c. *Select Default Allocation Size for the Allocation Unit Size.*
- d. *De-selecting Quick Format is not necessary and will result in a lengthier operation. See Figure 2.*

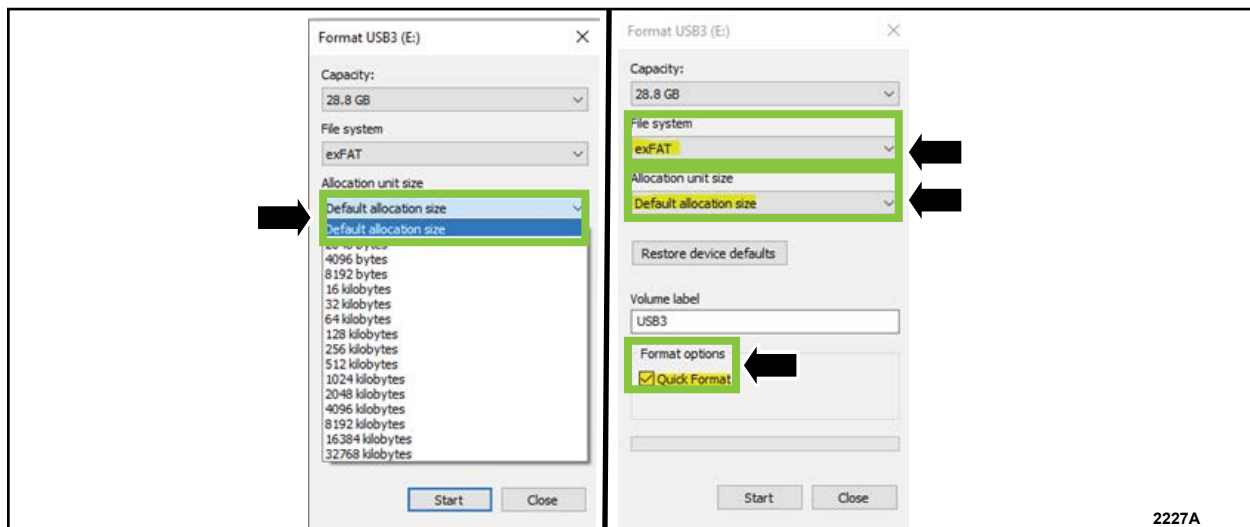
FIGURE 4

- a. Right click on the USB flash drive.
- b. Select Format, select exFAT for the File System.
- c. Select Default Allocation Size for the Allocation Unit Size.
- d. De-selecting Quick Format is not necessary and will result in a lengthier operation. See Figure 4.

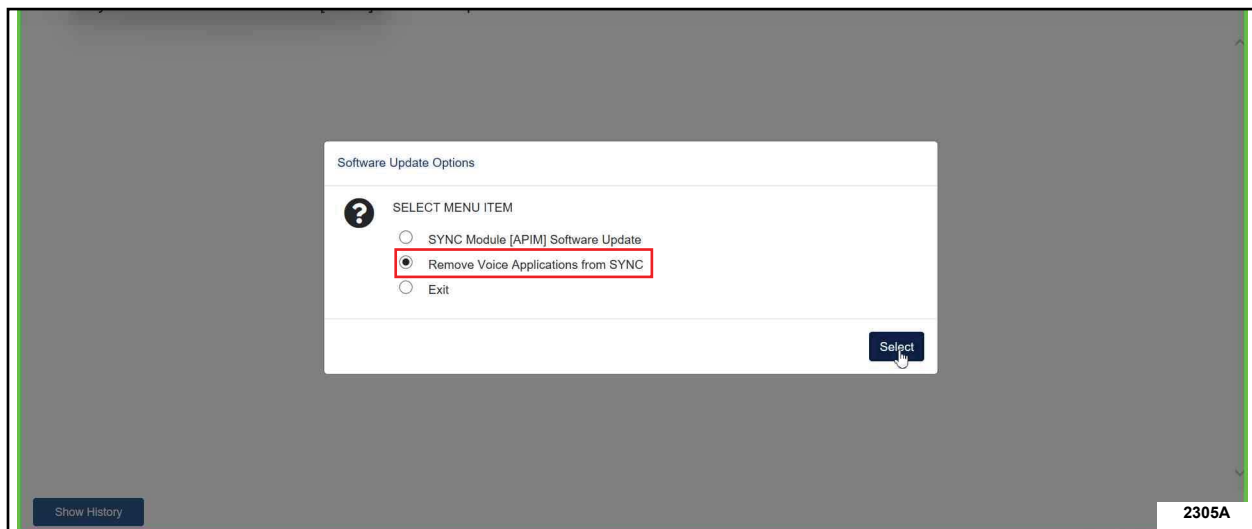
FIGURE 5

32. When prompted for Software Update Option, click "*Remove* Voice application from module", then click *Select*. See Figure 5.

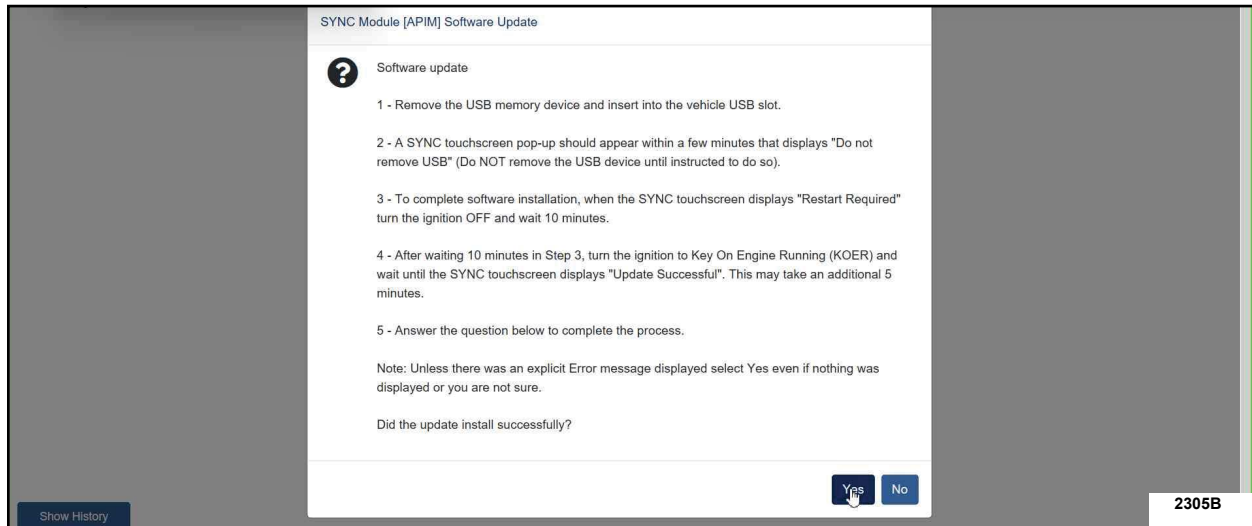
FIGURE 6

33. Continue to follow all on-screen instructions carefully until the following screen is reached. See Figure 6.

35. After 10 minutes continue with the remaining steps shown in Figure 6.

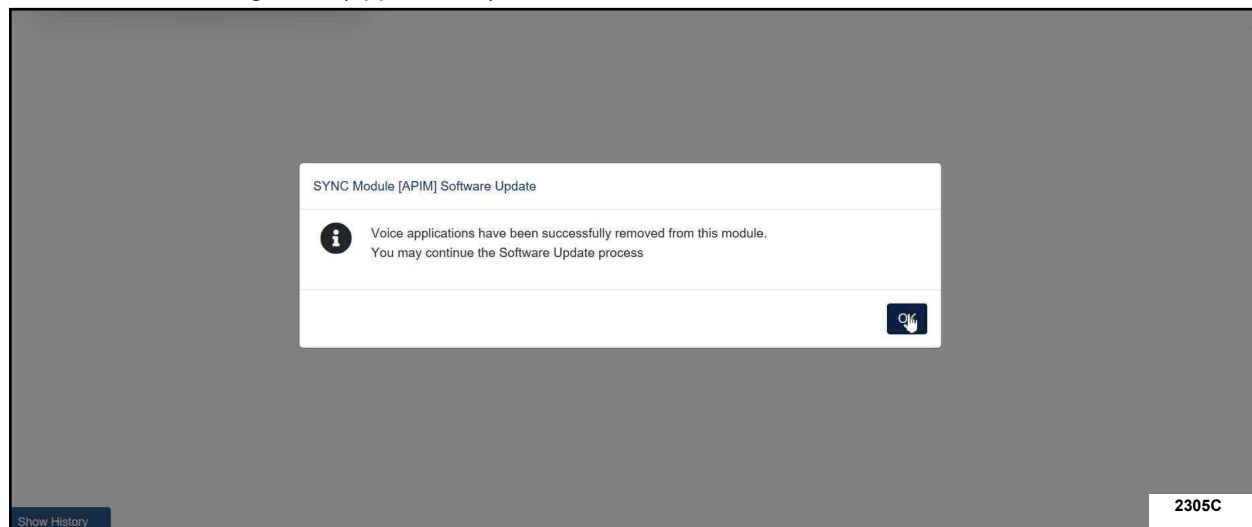
FIGURE 7

36. Continue to follow all on-screen instructions carefully until the voice application has been successfully removed. See Figure 7. (app deleted)

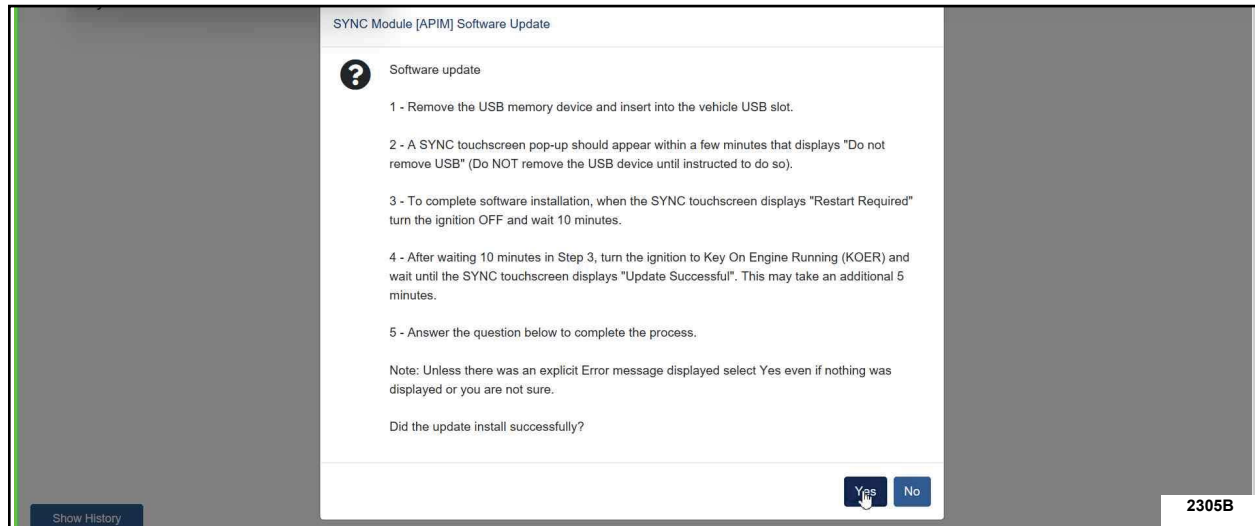
FIGURE 8

37. Return the USB thumb drive to the FDRS and follow the on-screen prompts carefully until the following screen is reached. See Figure 8.
