Stacy L. Balzer Operating Director Service Engineering Operations Ford Customer Service Division Ford Motor Company P. O. Box 1904 Dearborn, Michigan 48121

May 9, 2023

#### SUBJECT: NEW VEHICLE DEMONSTRATION / DELIVERY HOLD -Compliance Recall 22C27 - Supplement #2 Certain 2021-2022 Model Year Bronco Vehicles Accessory Protocol Interface Module Software Update

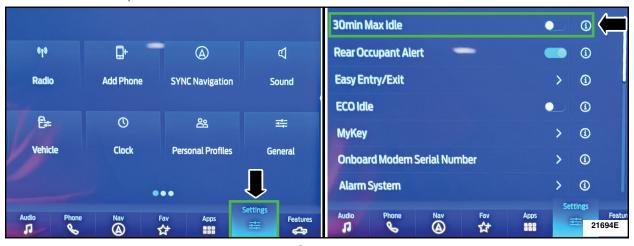
1. From the vehicle settings menu disable the 30 minute max idle option. From the center display press the vehicle settings button and turn off the 30 minute max idle setting. See Figure 1.

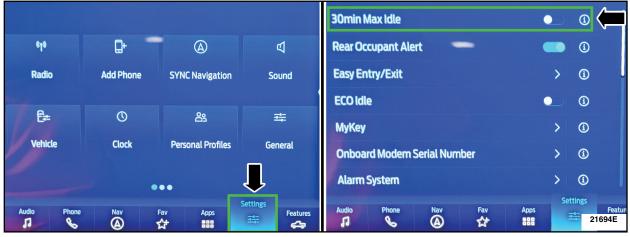
**FIGURE 2**

- **NOTE:** Before beginning programing ensure the vehicle has enough fuel to idle for 2 hours.
- **NOTE:** Program appropriate vehicle modules before performing diagnostics and clear all DTCs after programming. For DTCs generated after programming, follow normal diagnostic service procedures.
- 1. From the vehicle settings menu disable the 30 minute max idle option. From the center display press the vehicle settings button and turn off the 30 minute max idle setting. See Figure 2.

NOTE: F-150 shown, Bronco similar.
