Stacy L. Balzer  
 Director  
 Service Engineering Operations  
 Ford Customer Service Division

**SUBJECT:** **NEW VEHICLE DEMONSTRATION / DELIVERY HOLD**  
**Compliance Recall 22C27- Supplement #3**  
 Certain 2021-2022 Model Year Bronco Vehicles  
 Accessory Protocol Interface Module Software Update

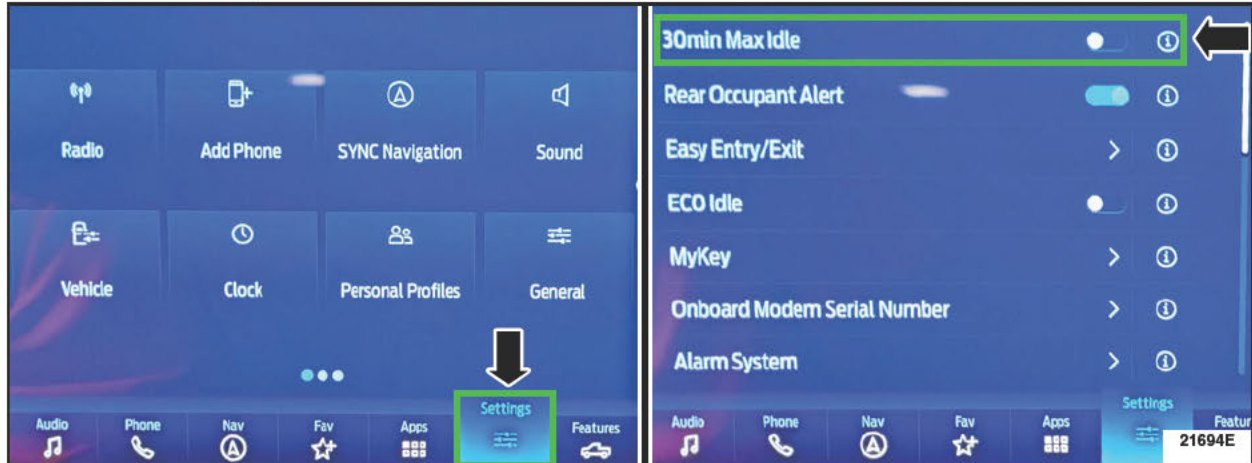
**FIGURE 1**

1. From the vehicle settings menu disable the 30 minute max idle option. From the center display press the vehicle settings button and turn off the 30 minute max idle setting. See Figure 1.

**NOTE:** F-150 shown, Bronco similar.

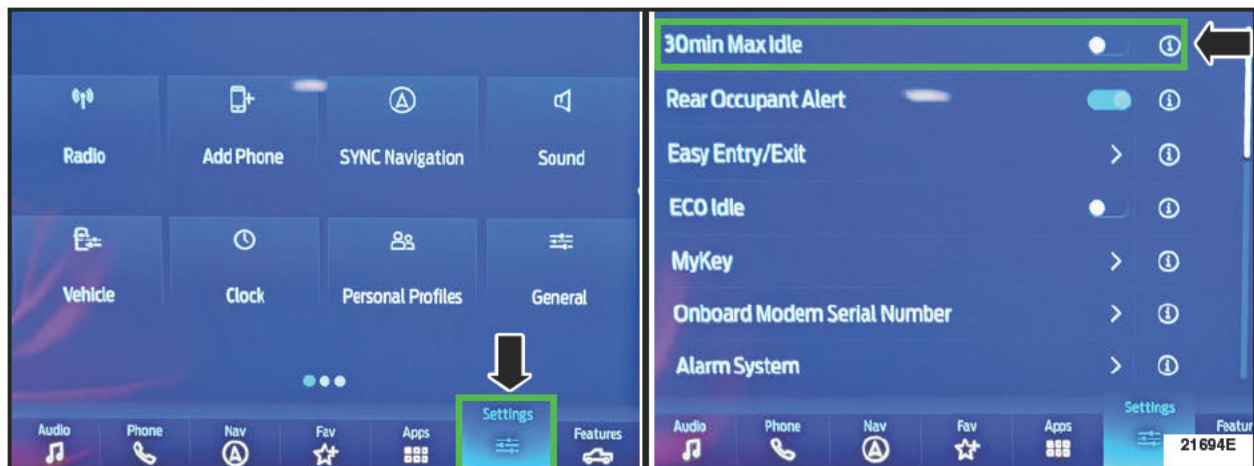
FIGURE 2

1. From the vehicle settings menu disable the 30 minute max idle option. From the center display press the vehicle settings button and turn off the 30 minute max idle setting. See Figure 2.

**NOTE:** F-150 shown, Bronco similar.

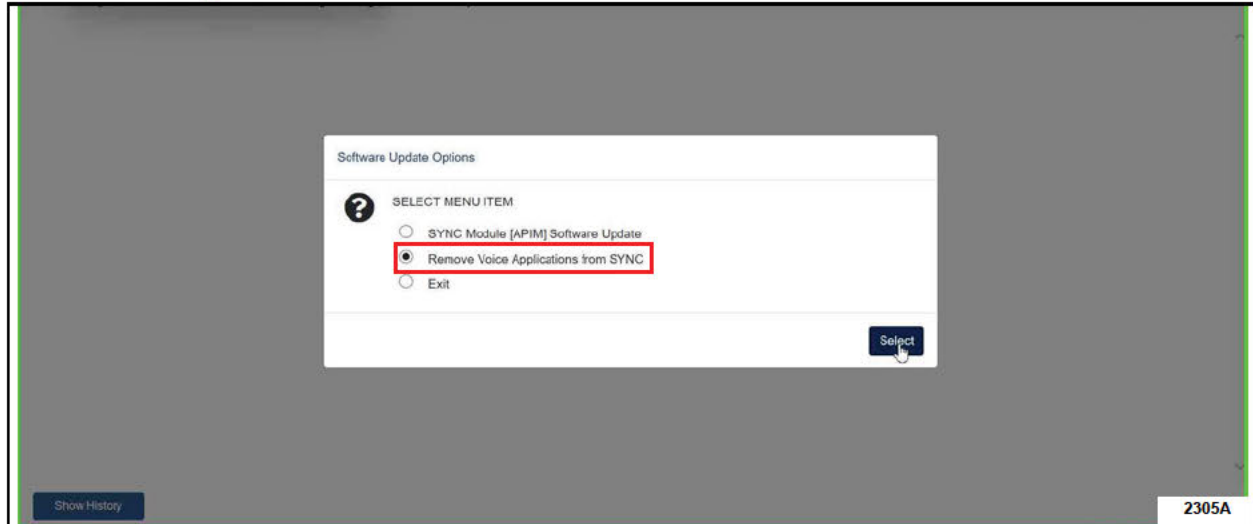
FIGURE 1

8. When prompted for Software Update Option, click "Delete Voice application from module", then click **Select**. See Figure 1.

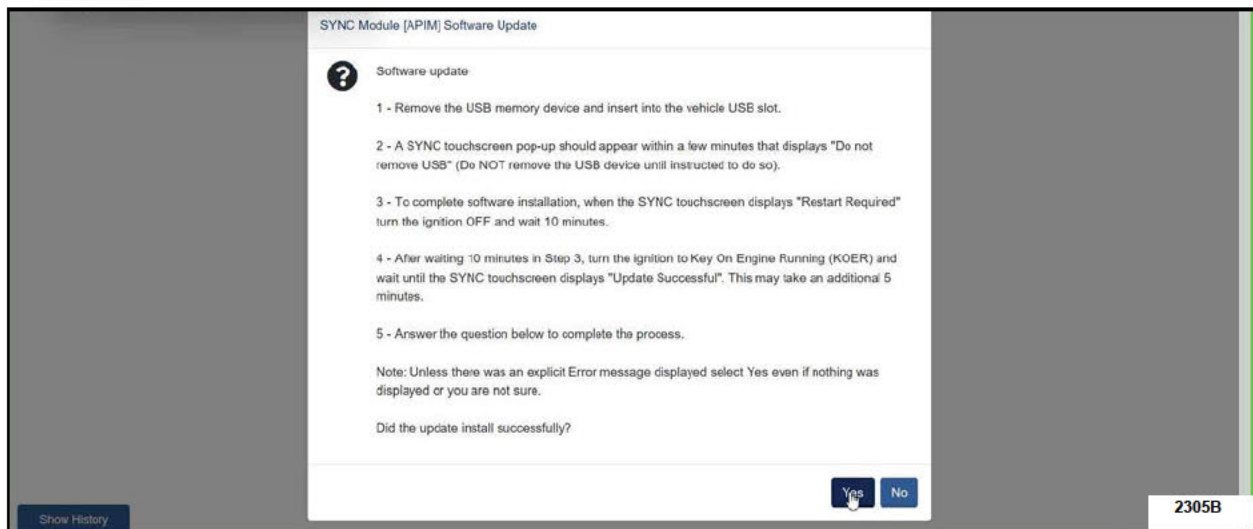
FIGURE 2

9. Continue to follow all on-screen instructions carefully until the following screen is reached. See Figure 2.

10. Complete Steps 1 and 2 as shown on the screen in Figure 2. **For Step 3**, to complete software installation, when the SYNC touchscreen displays "Restart Required" turn the ignition OFF, **open and close the driver's door**, and wait 10 minutes.
11. After 10 minutes continue with the remaining steps shown in Figure 2.
12. Continue to follow all on-screen instructions carefully until the voice application has been successfully removed. See Figure 3. (app deleted)

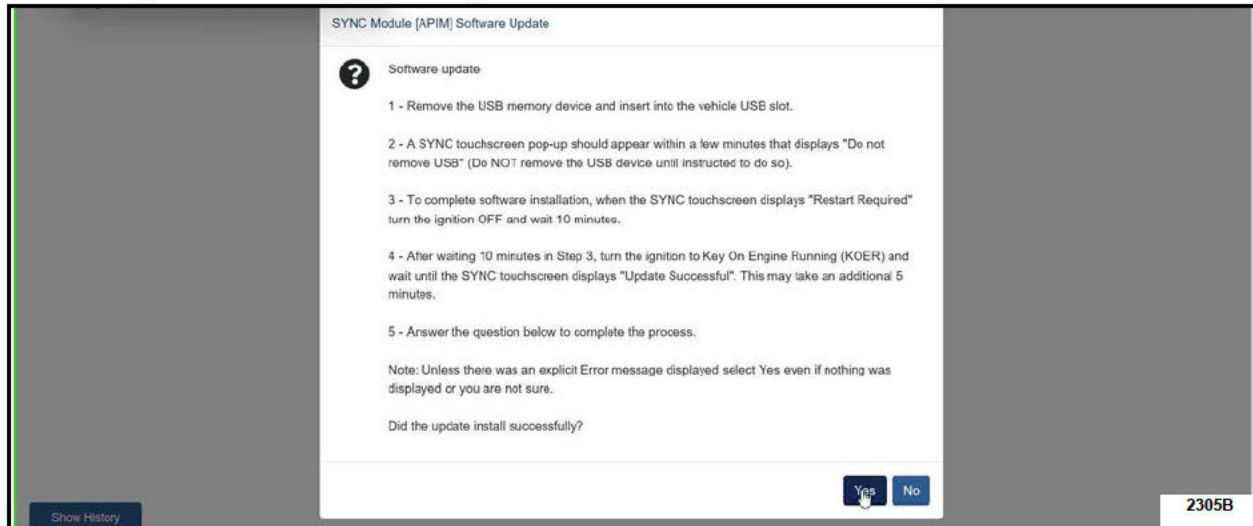
FIGURE 4

13. Return the USB thumb drive to the FDRS and follow the on-screen prompts carefully until the following screen is reached. See Figure 4.

14. Complete Steps 1 and 2 as shown on the screen in Figure 4. **For Step 3**, to complete the software installation, when the SYNC touchscreen displays "Restart Required" turn the ignition OFF, **open and close the driver's door**, and wait 10 minutes.
