| SC226 | March 2022 |

SAFETY RECALL CAMPAIGN

SUBJECT: **AIRBAG CONTROL UNIT (ACU) REPLACEMENT FOR
DTC B1620 OR ACU SOFTWARE UPDATE (SC226)**

This bulletin provides information to replace the Airbag Control Unit (ACU) or to update the ACU software logic on certain Kia vehicles listed below.

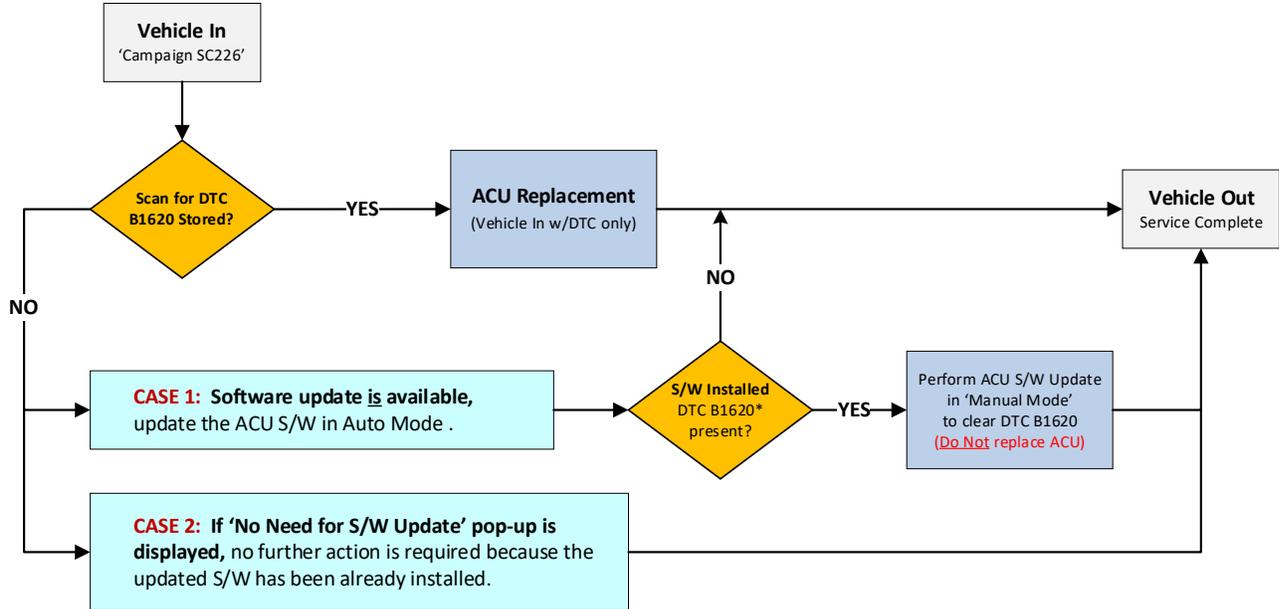
Flowchart:

***NOTE:** In very rare cases, DTC B1620 may be present due to a software installation error/glitch after 'Auto Mode' software installation is completed even though there was no Airbag Warning Light (ABWL) w/DTC B1620 prior to upgrade. If this occurs, perform the 'Manual Mode' upgrade in order to clear DTC B1620.

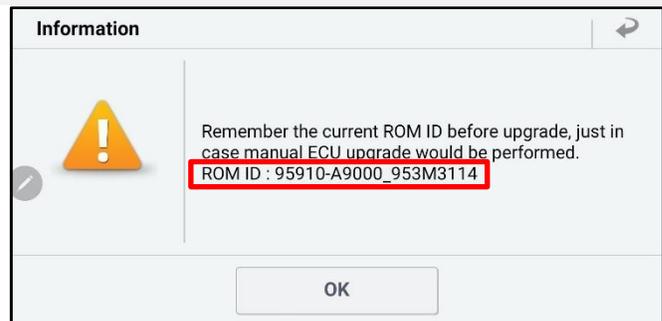
Software Check:

Confirm and note the existing ROM ID of the Airbag Control Unit (ACU).

Perform the 'Manual Upgrade Procedure' only if one of the following conditions occur:

- 1) Auto Mode S/W update fails
- 2) DTC B1620 present after S/W update

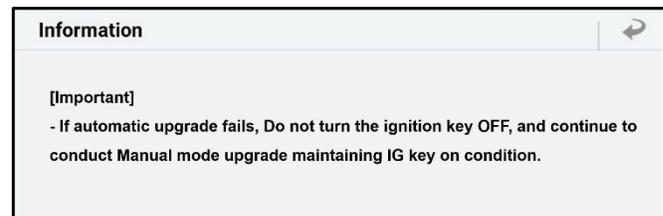
If a "No need for S/W update" pop-up is displayed on KDS in 'Auto Mode', then the software upgrade is not required because the updated S/W has been already installed.. (The ACU part does not need this upgrade event)

If automatic upgrade fails, **Do Not** turn the ignition key OFF, and continue to conduct Manual mode upgrade maintaining IG key on condition.

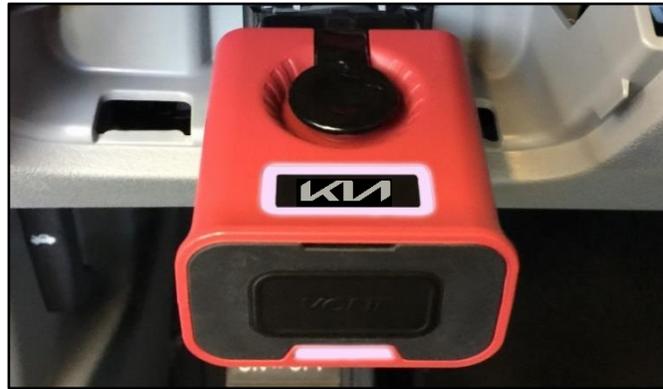
1. Connect the VCI-II to the OBD-II connector, located under the driver's side of the instrument panel.

NOTICE
The ECU upgrade function on KDS operates wirelessly. It is not necessary to perform the upgrade via USB cable.

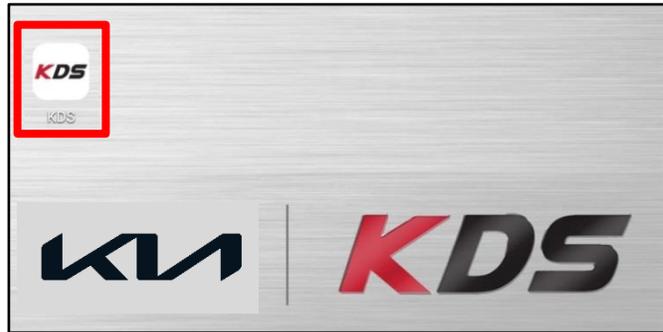
2. With the ignition ON, turn ON the KDS tablet. Select 'KDS' from the home screen.

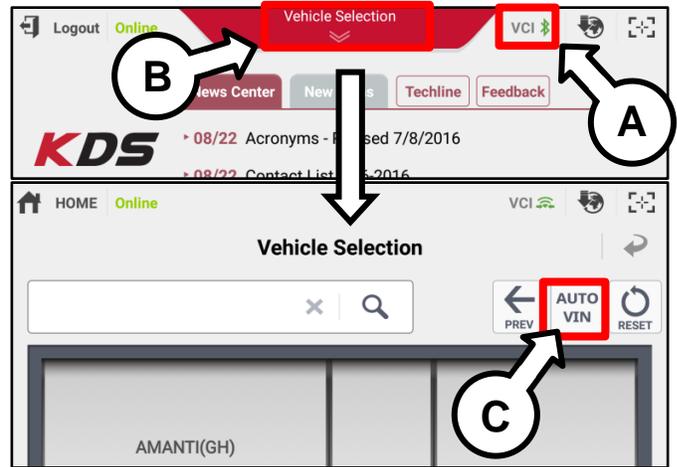
3. Confirm communication with VCI (A) and then configure the vehicle (B) using the 'AUTO VIN' (C) feature.

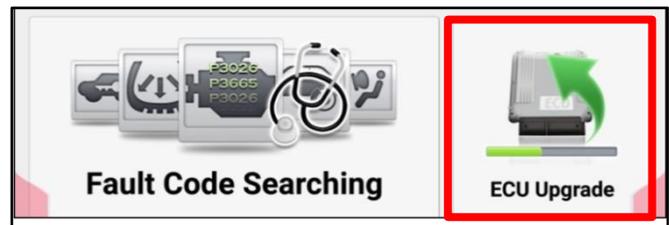
4. Select 'ECU Upgrade'.

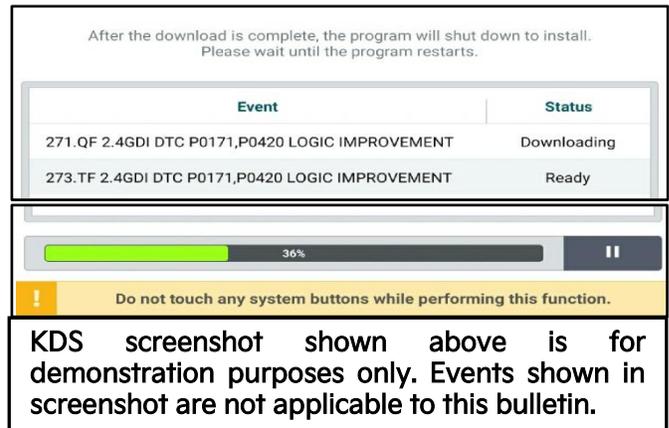
5. The KDS will check the server for recently uploaded Events and then automatically download Upgrade Event(s) #586-589, 597 (as applicable).

The vehicle must be identified in Vehicle Selection to download an Event for that vehicle.

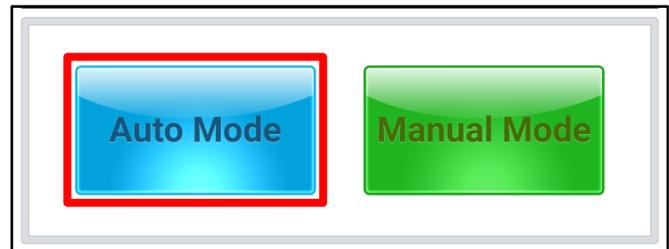
6. Select Auto Mode.

Do NOT attempt to perform a Manual Mode upgrade UNLESS Auto Mode fails. Always follow the instructions given on the KDS in either Auto or Manual mode.

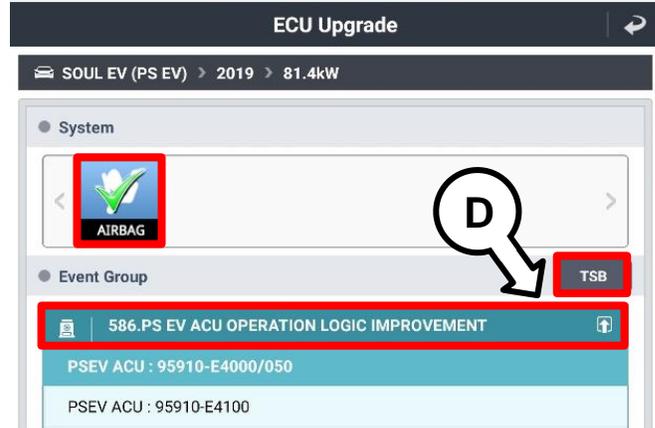
7. Select **AIRBAG** system and the corresponding software event for the vehicle.

- 586. PS EV ACU OPERATION LOGIC IMPROVEMENT
- 587. PS PE ACU OPERATION LOGIC IMPROVEMENT
- 588. YP PE ACU OPERATION LOGIC IMPROVEMENT
- 589. YDm ACU OPERATION LOGIC IMPROVEMENT
- 597. YD PE ACU OPERATION LOGIC IMPROVEMENT

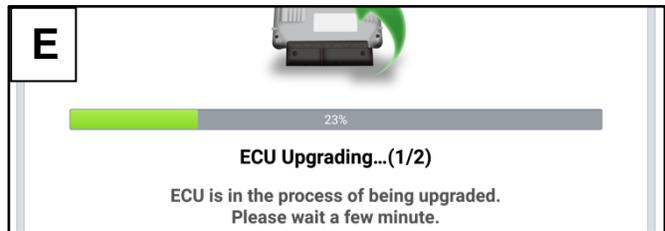
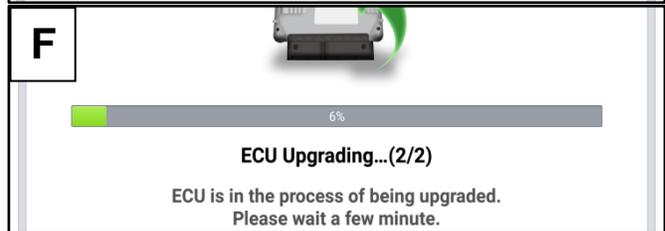
8. The ECU upgrade will begin and the progress of the upgrade will appear on the bar graph. Upgrade part (1/2) (E) will download the upgrade event to the VCI-II. Upgrade part (2/2) (F) will upgrade the ECU.

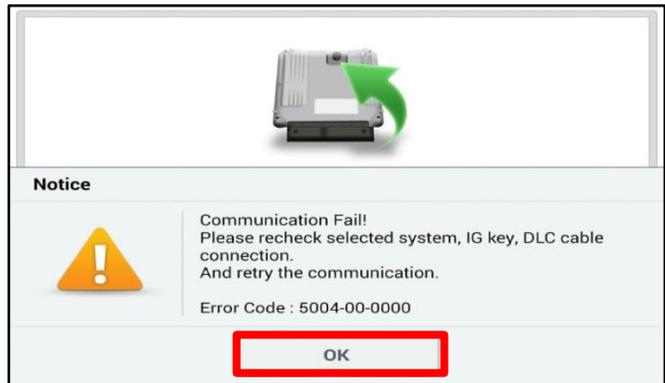
9. If a "Communication Fail" screen appears, verify that the VCI-II and KDS are communicating properly. Select 'OK' and restart the from step 4.

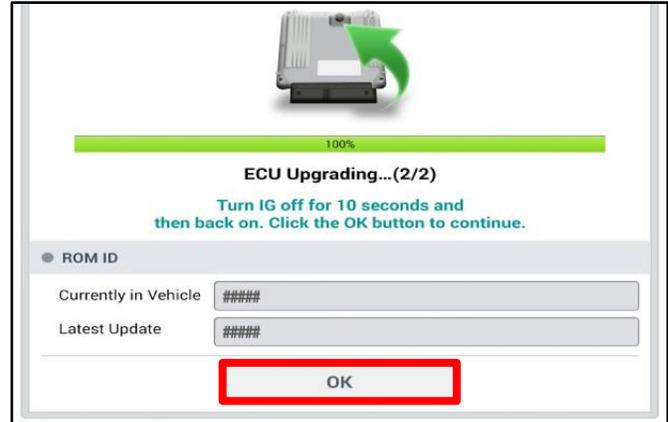
10. When instructed on the KDS, turn the ignition **OFF** for ten (10) seconds then back on. Select **'OK'** to continue.

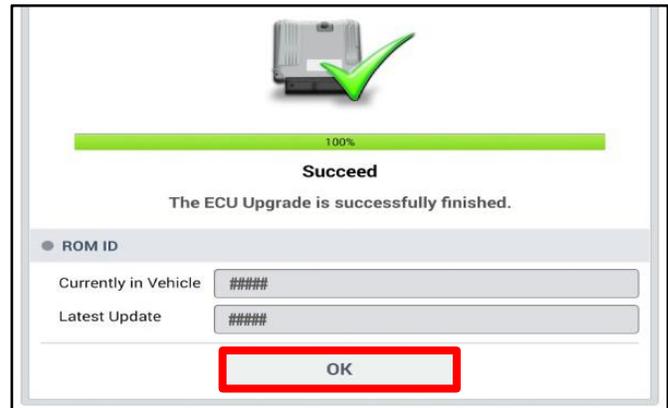
11. Once the upgrade is complete, select **'OK'** to finalize the procedure.

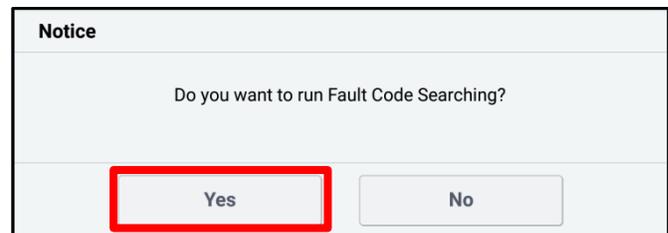
12. When prompted, select **'YES'** to check for Diagnostic Trouble Codes (DTC) and erase any DTCs stored such as EPS, ESC, and TPMS that may have been set during the upgrade.

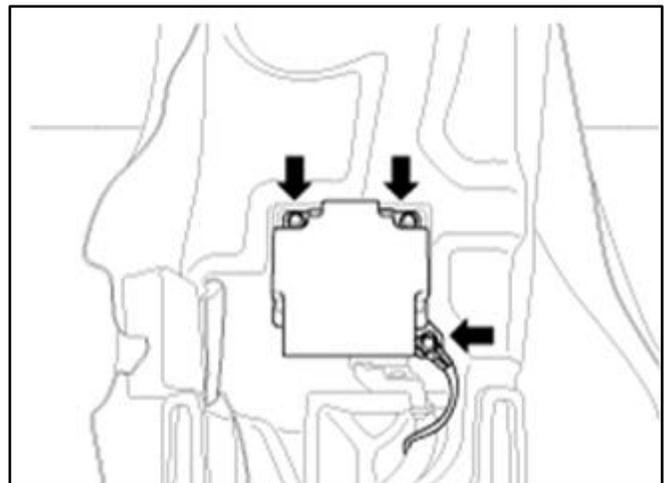
1. Replace the Airbag Control Unit (ACU) by referring to the Restraint → SRSCM → SRS Control Module (SRSCM) → Repair Procedures” chapter in the applicable Shop Manual on KGIS.

Use a non-marring trim removal tool (such as Snap-on® Part Number PBN5 or equivalent) to avoid damaging trim pieces.
