Safety Recall

Code: 97GF

Subject Front Door Wiring Harness

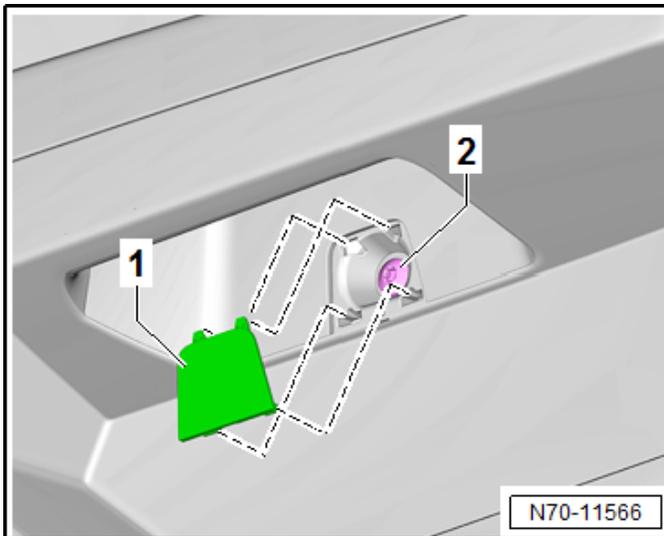
- Pry off the cap <1> with the Trim Removal Wedge -3409-.
- Remove the bolt <2>.

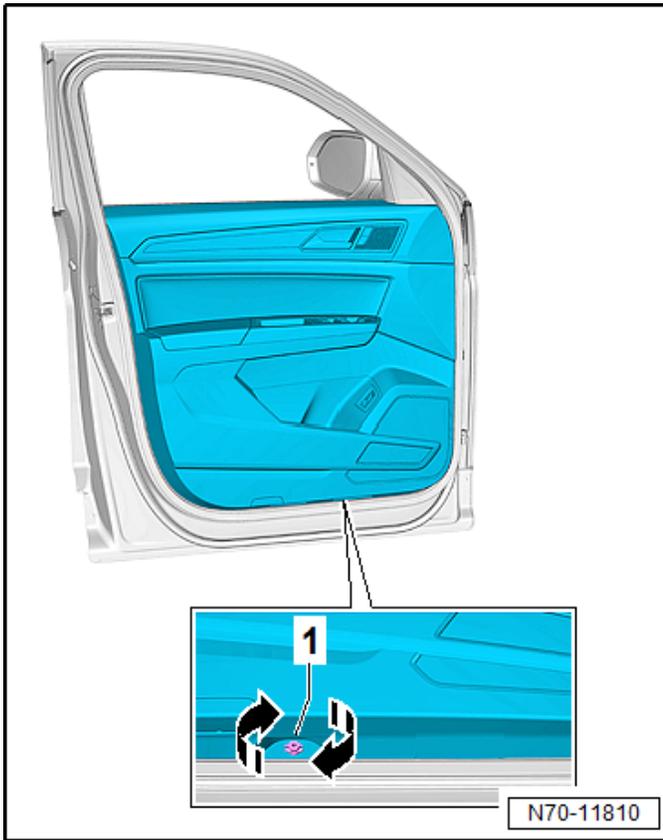
- Turn/release the rotor clip <1> 90° in the <direction of the arrow> (1/4 of a turn) using the open end wrench (10 mm) or Torx T30.

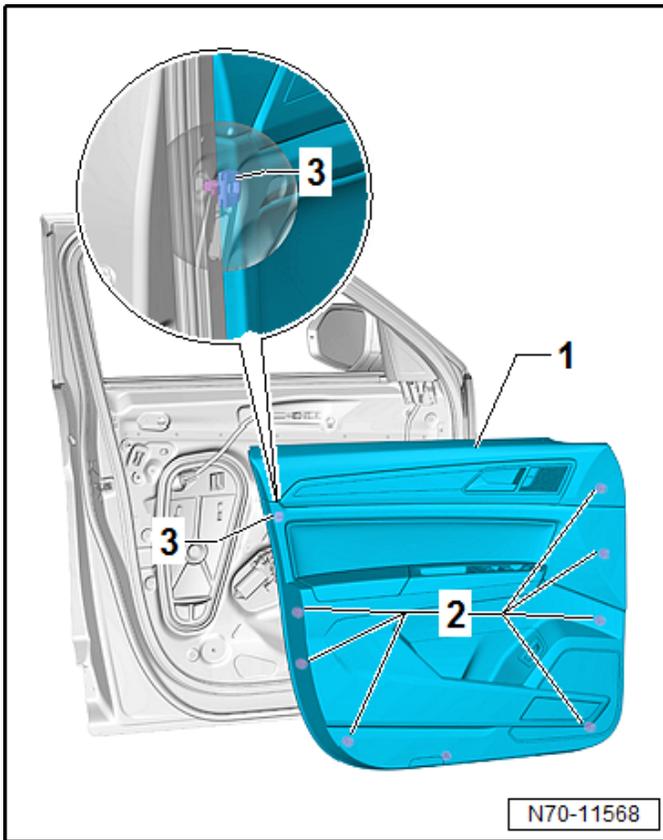
- Loosen the clips <2> for the door trim panel <1> out of the mounts using the Wedge Set <T10383>.
- Remove the door trim panel vertically upward from the window shaft strip. At the same time the crash clip <3> is automatically released.
- **Roll the window all the way up after disengaging door panel and before disconnecting the connectors.**
- Depending on the vehicle equipment level, disconnect the connectors from the door trim panel.

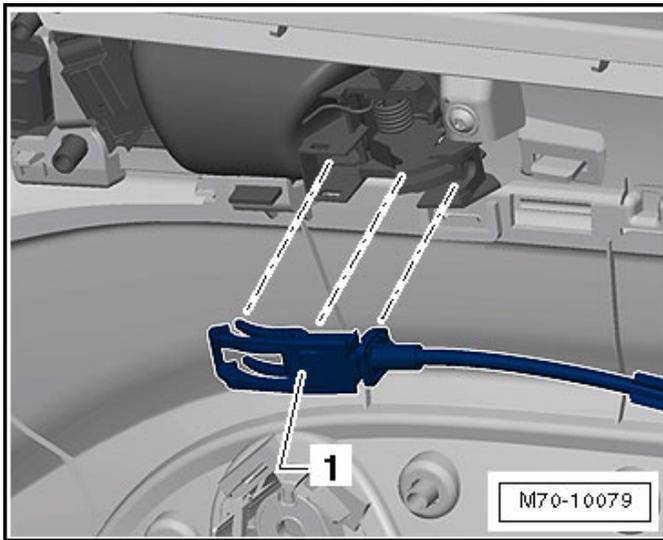
- Disconnect the cable <1> from the interior door mechanism.

Risk of damaging the operating cable by deforming it.

Never sharply bend or kink the operating cable.

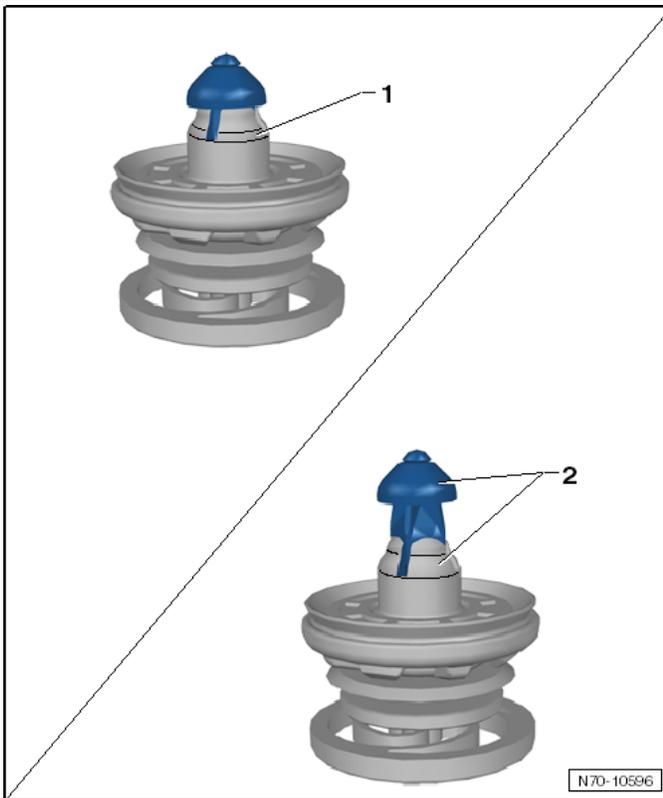
Risk of damaging the locking mechanism.

Always turn the clip from the position <2> into the position <1>.

The door trim panel can only be installed when the clip is in the position <1>.

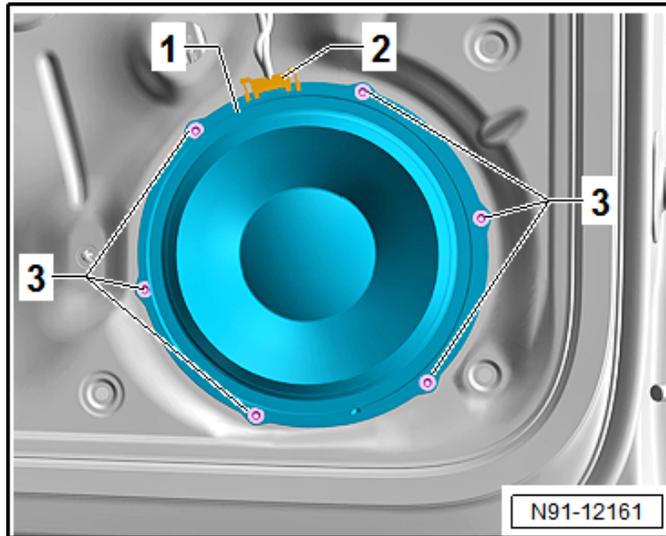
Remove door speaker:

- Release and disconnect the connector <2>.
- Remove the pop rivets <3> with a suitable drill and a suitable drill bit.
- Remove the speaker <1> from the door.
- Use care so the seal on the speaker is not damaged.

Always remove any shavings resulting from the drilling from the door, otherwise they may cause corrosion damage later.

If the paint on the door frame gets damaged during drilling, touch-up immediately.

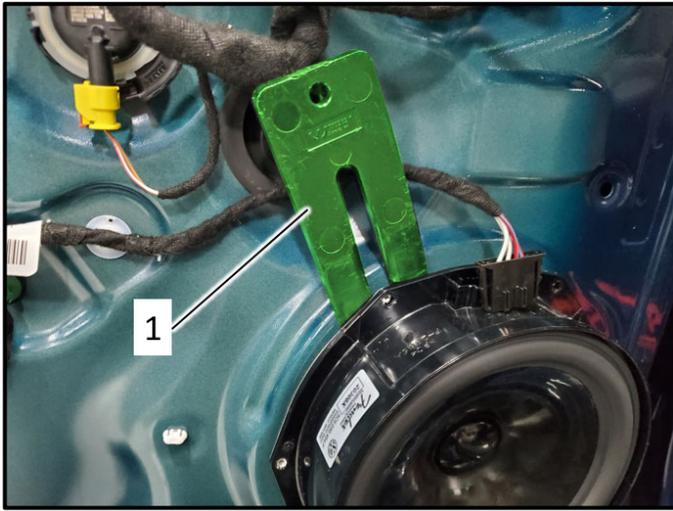
Use a wedge <1> from Wedge Set -T10383- to aid in removing the speaker.

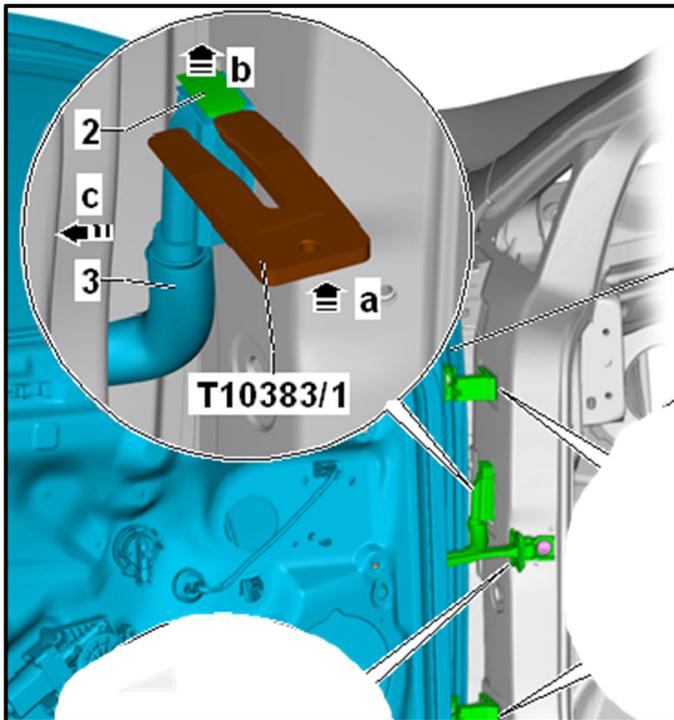
Replace door harness:

The removal and installation for the driver side front door harness is described. The removal and installation for the front passenger side is similar.

- Refer to ETKA for the correct door harness part number.
 - Pull connector lock <2> upward in direction of <arrow b>.
 - Using Wedge -T10383- may assist in releasing the connector lock.
 - Pull the harness <3> out from the A-pillar in direction of <arrow c>.
-
- Work through the speaker opening to disengage the door harness from the door.
 - Release the three locking tabs in the <direction of arrows>.

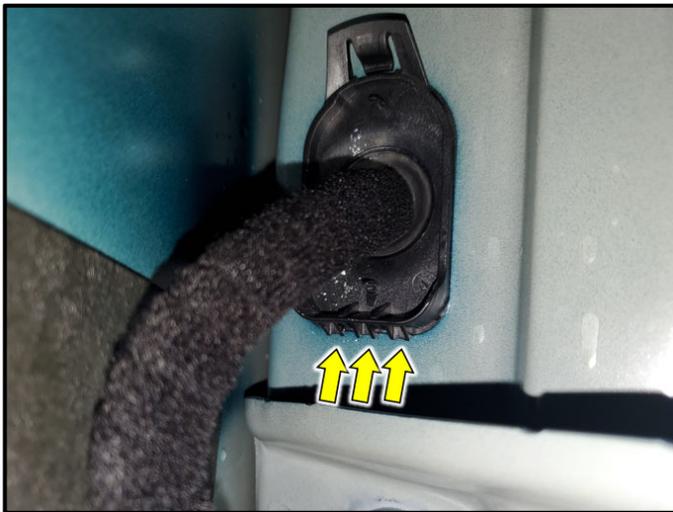
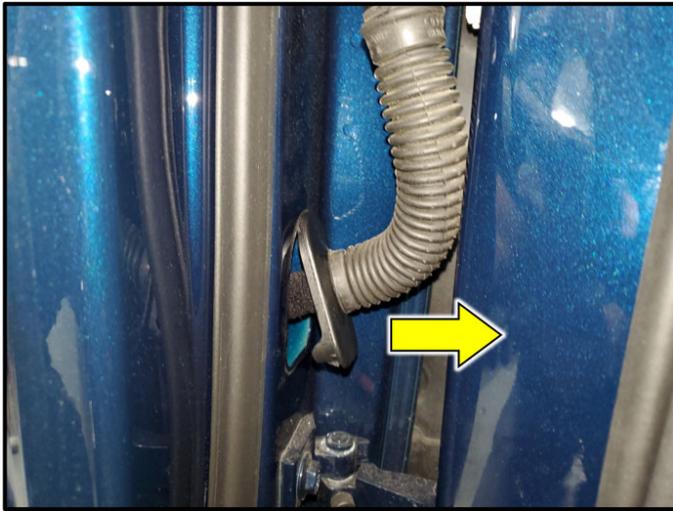
- Pull the door harness away from the door in <direction of arrow>.
- Then pull door harness back into the door.
- **Pay very close attention to how the door harness is routed around the lower part of the window regulator. Take photos so that the door wire harness is positioned correctly when installed.**

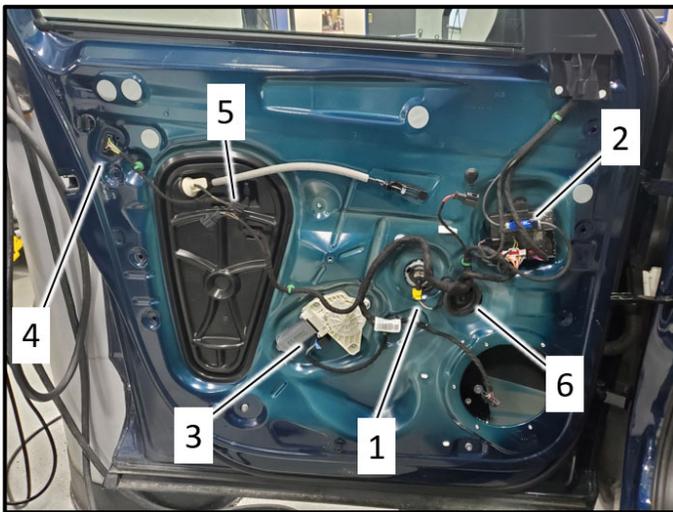
- Take photos of door harness routing.
- Disconnect connector from Thorax Airbag Crash Sensor <1>.

- Disconnect connectors as needed for:
 - Door control module <2>
 - Window motor <3>
 - Door latch <4>
 - Door handle <5>
- Unclip door harness from the door using Pry lever -80-200- (or equivalent)
- Disengage grommet <6> and remove door harness from the door.
- Install new door harness in the reverse order of removal.
- Ensure all locking connectors are fully seated and locked.
- Ensure grommet <6> is fully seated.

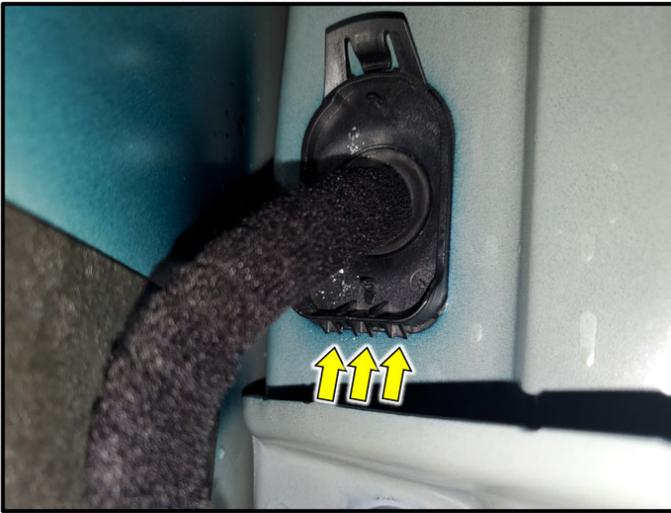
- Secure door harness into the door.
- Ensure locking tabs <arrows> are fully engaged.

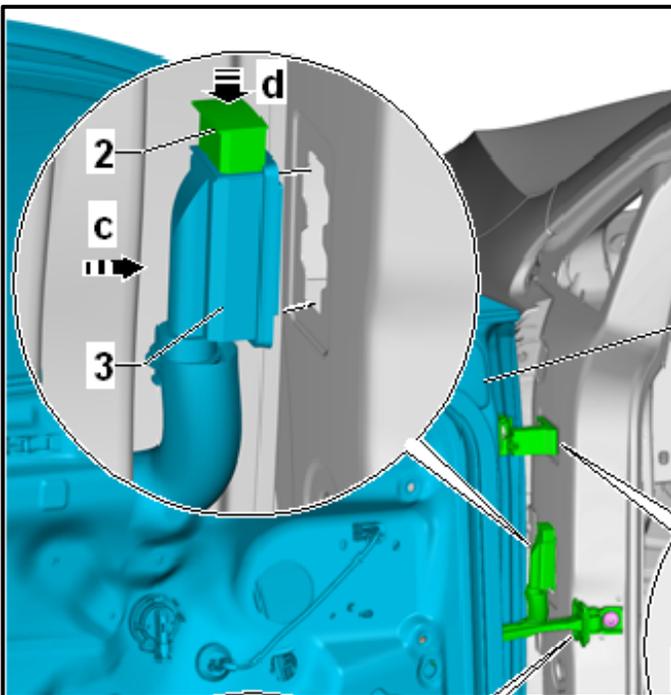
- Connect connector <3> in direction of <arrow c>.
- Press connector lock <2> down in direction of <arrow d>.

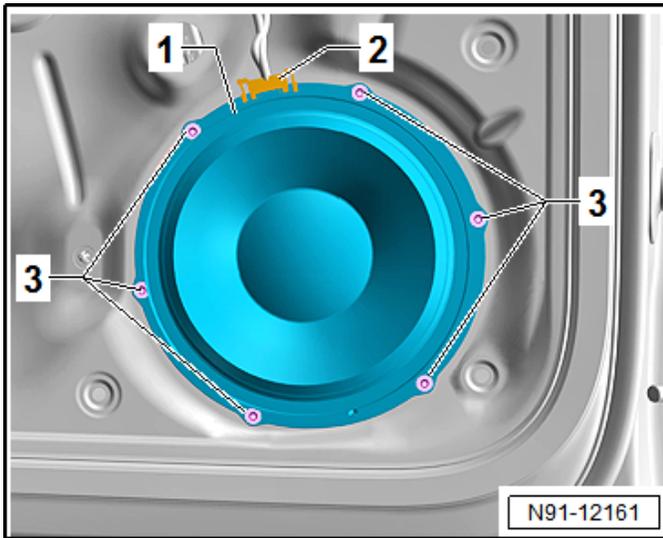
Reinstall door speaker:

- Installation is the reverse order of removal.
- Secure the pop rivets with the Pop Rivet Nut Pliers -VAS5072A- (or equivalent).

Part Number	Part Description
WHT-005-353	Pop-rivet (x6)

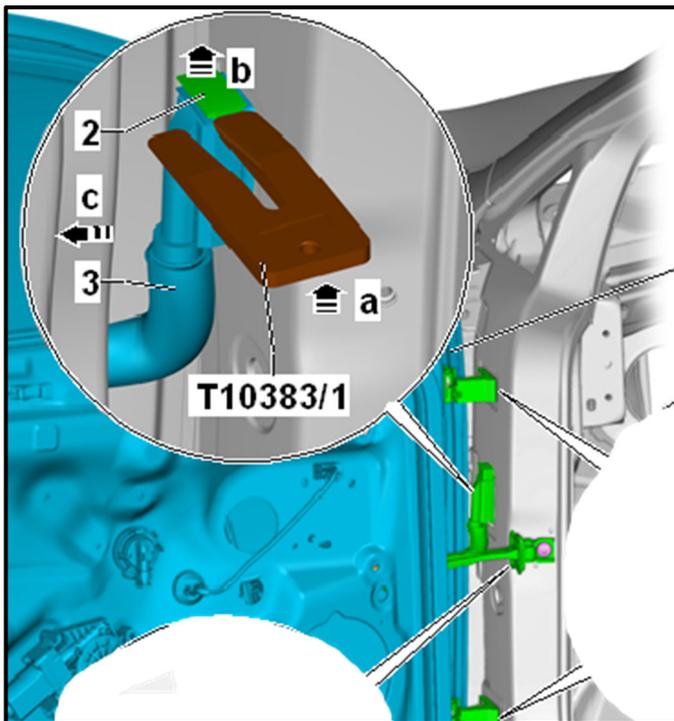
Disconnect connector:

The procedure for the driver side front door harness is described. The procedure for the front passenger side is similar.

- Pull connector lock <2> upward in direction of <arrow b>.
- Using Wedge -T10383- may assist in releasing the connector lock.
- Pull the harness <3> out from the A-pillar in direction of <arrow c>.

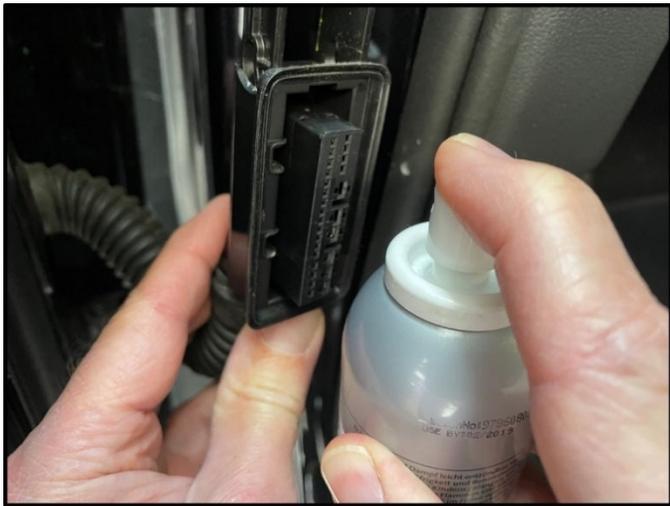
Clean connector housings:

- Spray isopropyl alcohol onto the door wiring harness connector housing and the body side connector housing as shown.
- Allow the cleaner to dry completely.

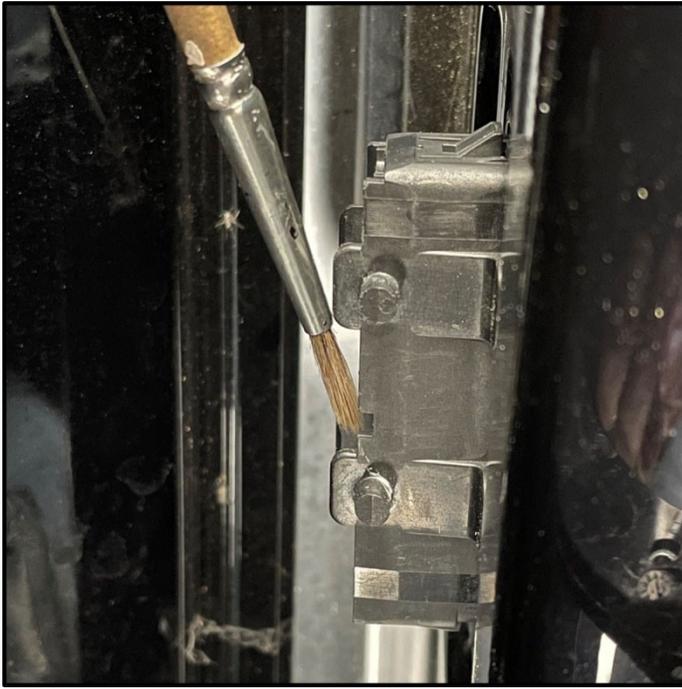
- Apply grease to the terminals in the body side wiring harness connector.
- Ensure both sides of each terminal are covered.
- There is no need to apply grease to the coaxial connection (if equipped).
- Use a small inspection mirror to ensure all terminals are covered.

Apply lithium grease to connector pins:

Use only the lithium grease specified. Alternative grease part numbers or locally sourced lithium grease must NOT be used.

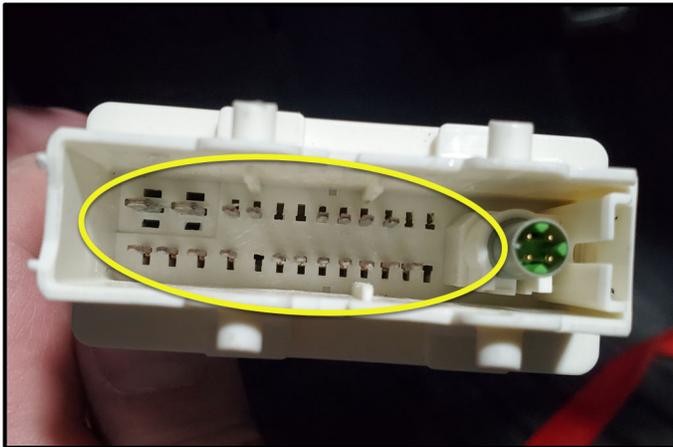
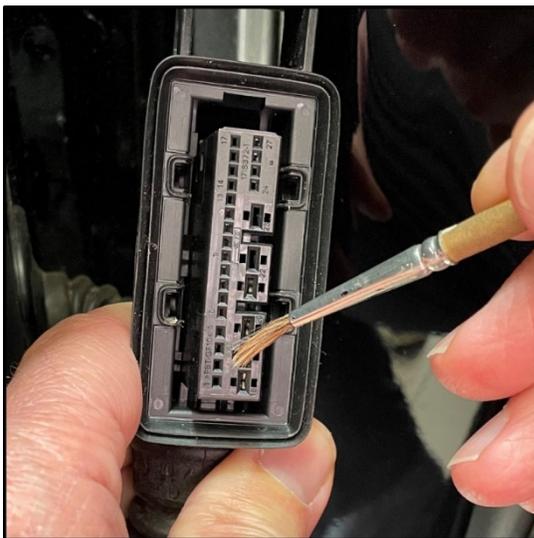
- Apply grease to the terminals in the door wiring harness connector.

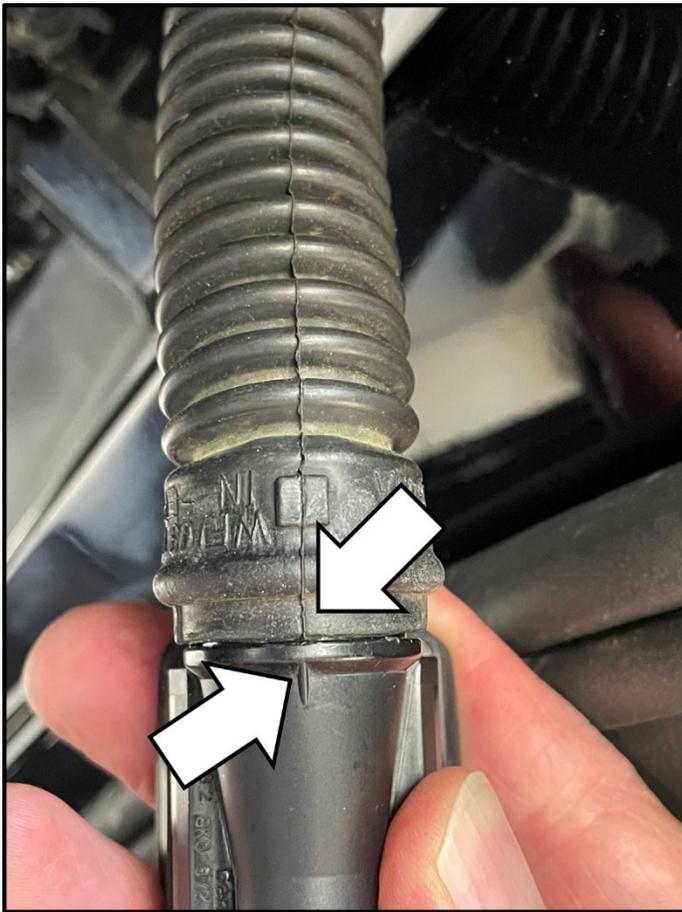
When re-installing the boot, ensure the boot is not twisted.
Line up the markings <arrows> on the boot and the housing.

- Reinstall boot onto the connector housing in the reverse order of removal so it is fully seated onto the connector housing.

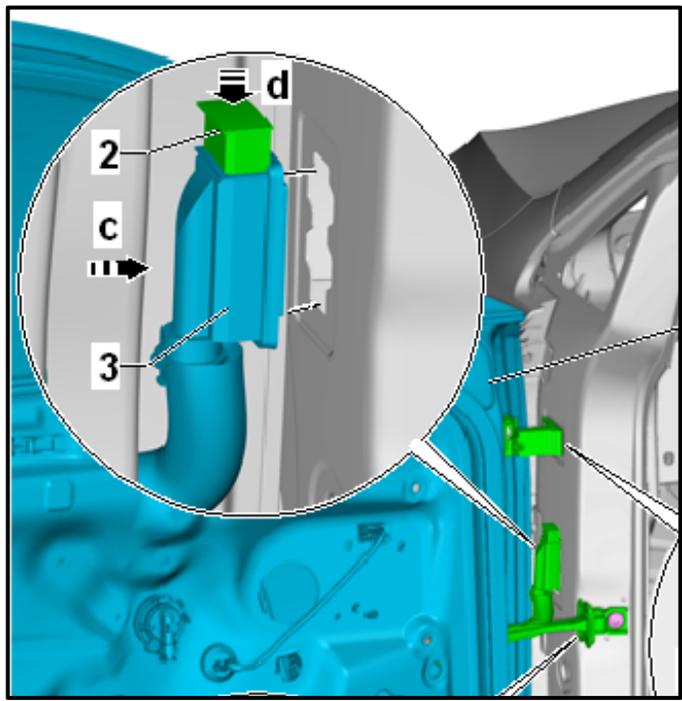
Reconnect connector:

- Reconnect door harness connector <3> in direction of <arrow c>.
- Press connector lock <2> down in direction of <arrow d>.
