Safety Recall

Code: 93O2

Subject Flexible Printed Circuit Solder – HV Battery

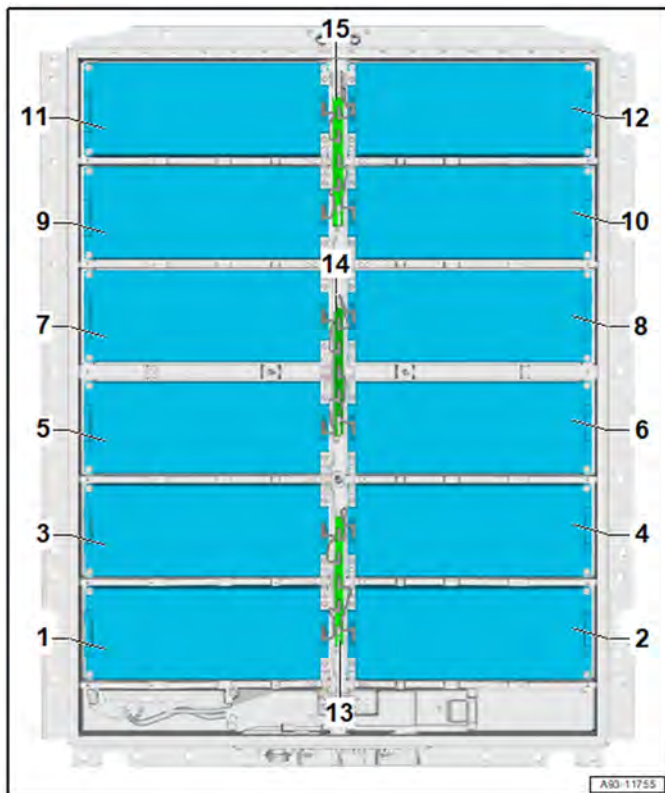
Repair Overview

- **All vehicles** – perform a test plan to check for cell modules with an increased self-discharge. If a module is identified by the test plan as needing replacement, it will be replaced while the HV battery is open.
- **Criteria 04 vehicles** - replace one, pre-identified, cell module inside the high voltage battery.
- **Criteria 05 vehicles** - replace two, pre-identified, cell modules inside the high voltage battery.

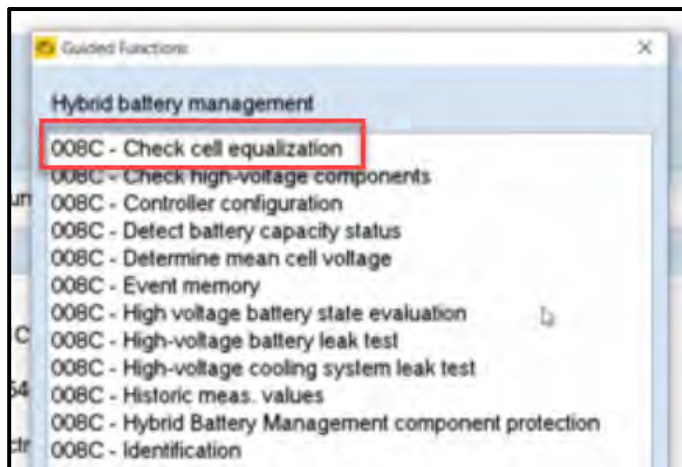
Identify cell module which requires replacement:

- Use the chart found in one of the 93O2 attachment tabs in ELSA or in ServiceNet to determine the serial number of the module that requires replacement for the VIN you're working on.

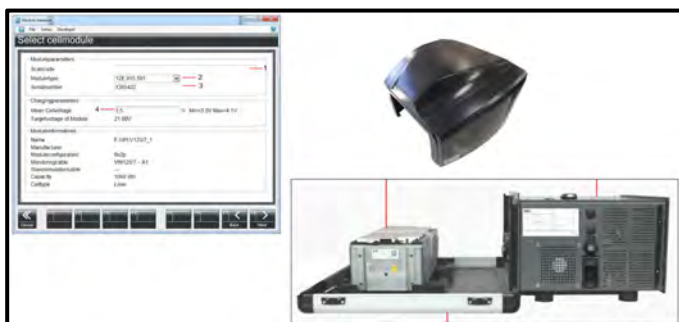
Perform cell balancing on new cell module:

- Check Measured Value Block (MVB) “maximum voltage for battery cells, IDE08217.
- The voltage reading listed will be entered in the DSS Manager program when balancing the new cell module.

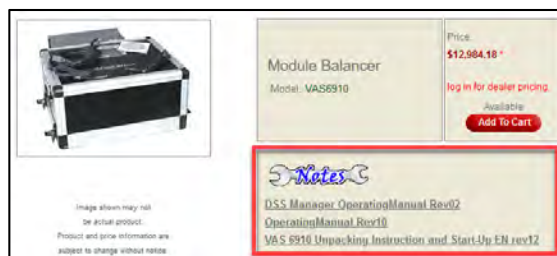
- Follow the VAS6910 operating instructions in conjunction with the DSS Manager program to perform the cell balancing on the new cell module.

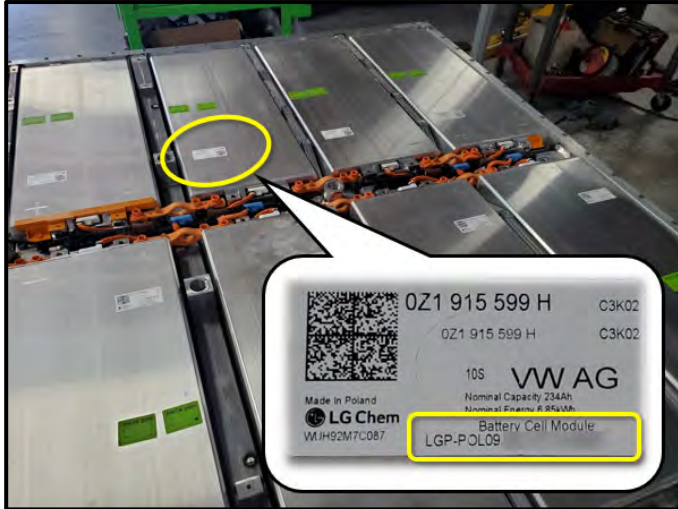
Identify cell module which requires replacement:

- Use the chart found in one of the 93O2 attachment tabs in ELSA or in ServiceNet to determine the serial number of the module that requires replacement for the VIN you're working on.
- Identify the module that requires replacement and clearly mark its location.

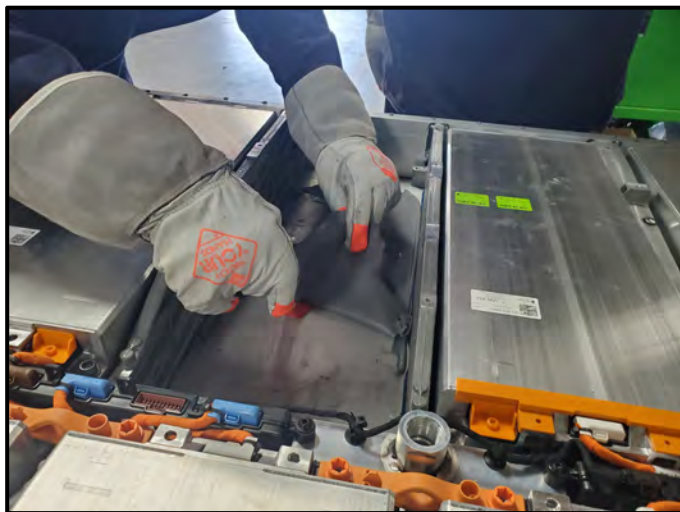
Remove the cell module:

- See ELSA Repair manual: *Repair Manual > Motor > Electric Drive Rear Wheel Drive EIP220 and All Wheel Drive EIA200, EIP220 > 93 Electric drive > High-Voltage Battery Components > Battery Module, Removing*
- Ensure the shock protection is installed on ALL open high-voltage connections.

The cell module can be freed from the adhesive bond from either end of the cell module.

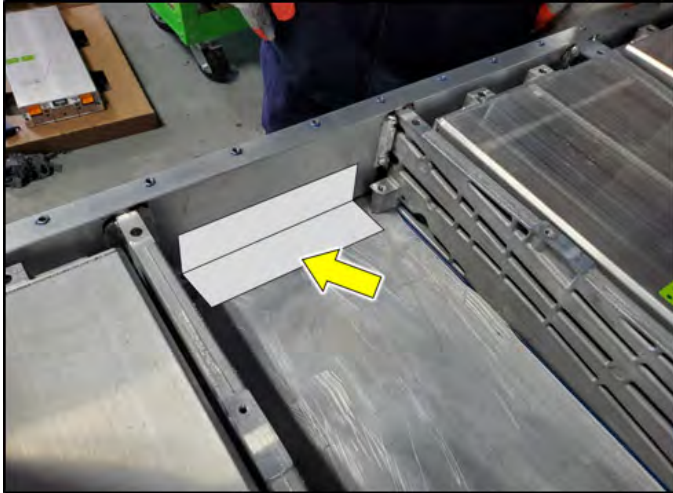
Installing new cell module(s):

- Reference ELSA Repair manual: *Repair Manual > Motor > Electric Drive Rear Wheel Drive EIP220 and All Wheel Drive EIA200, EIP220 > 93 Electric drive > High-Voltage Battery Components > Battery Module, installing*
- Note the following when installing the new cell module(s):
- Peel off the protective backing and apply the separating foil <arrow> as needed along the outer frame edges, in the area where the cell module is mounted.

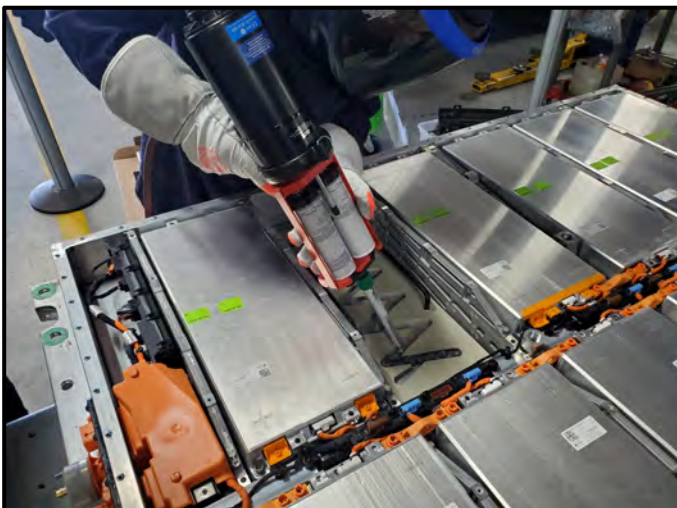
- Double check the expiration date of the paste before applying.
- Use Double Cartridge Adhesive Gun -VAS5237- to apply the heat paste.

- Before applying the heat paste, release a small amount through the applicator to ensure the paste is mixing properly.

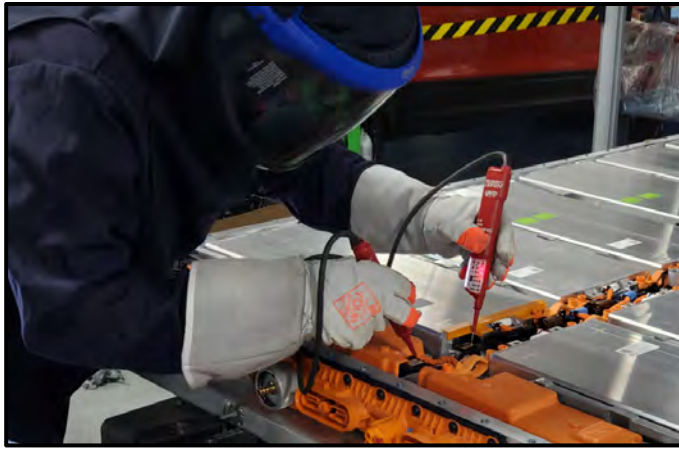
- Torque bolts <3> for the high-voltage connection <4> to 8 Nm.

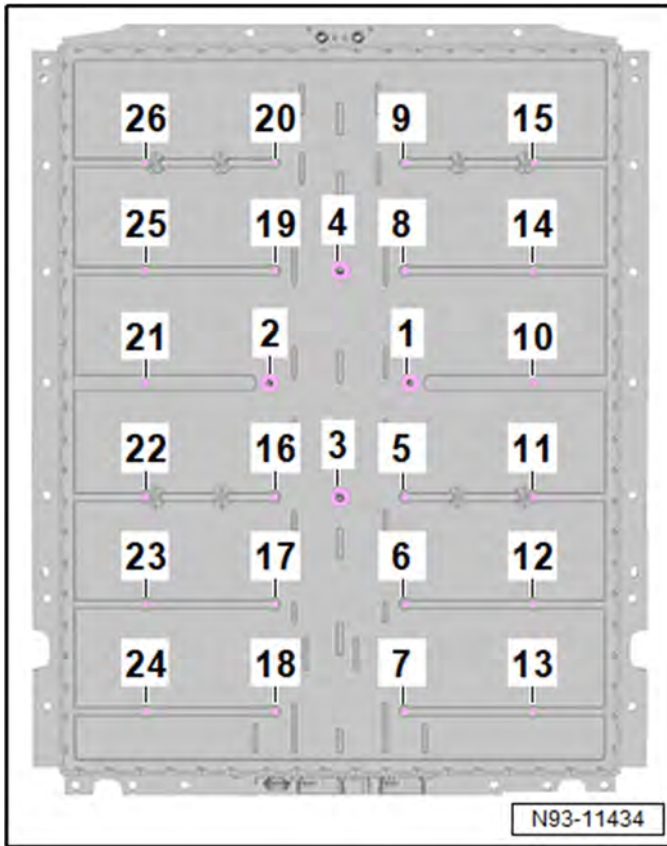
Install and seal high-voltage battery cover:

Part Number	Part Description
1EA-804-841-AC	Cover (if necessary)
D -454-300-H2	Sealant
1EA-802-131-A	Connection element (qty. 2) Position <1>
1EA-802-132-A	Connection element (qty. 2) Position <2>
WHT-008-738-A	Middle bolts (qty. 22) Position <3>
WHT-009-218	Perimeter bolts (qty. 82) Position <4>

- Torque the new fasteners in the following order:
 1. Connection element bolts <1 through 4> to 100 Nm.
 2. Middle bolts <5 through 26> to 5.5 Nm + 90°.

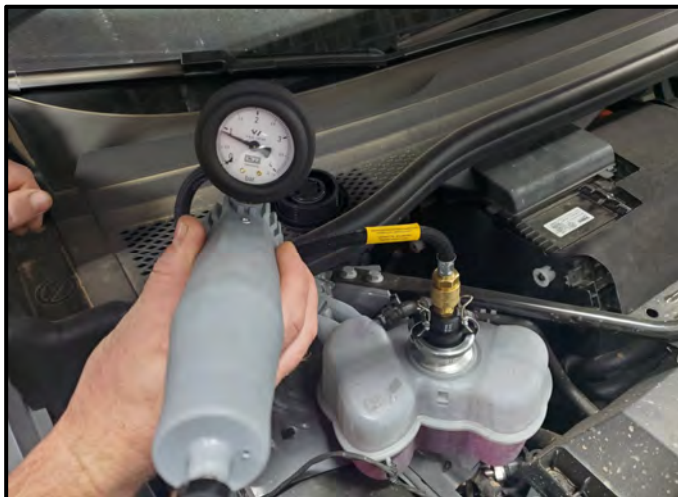
Fill cooling system:

- Top off coolant.
- Select “Self Test” and populate test plan, “0001 – Fill/bleed cooling system.”
