Safety Recall

Code: 93O2

Subject	Flexible Printed Circuit Solder – HV Battery															
Release Date	December 06, 2022															
Affected Vehicles

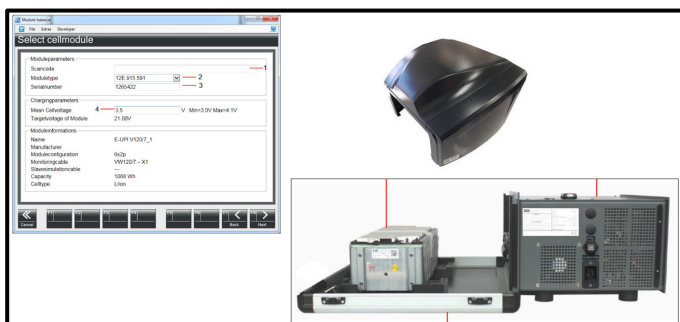
Perform cell balancing on new cell module:

- Check Measured Value Block (MVB) “maximum voltage for battery cells, IDE08217.
- The voltage reading listed will be entered in the DSS Manager program when balancing the new cell module.
- Follow the VAS6910 operating instructions in conjunction with the DSS Manager program to perform the cell balancing on the new cell module.

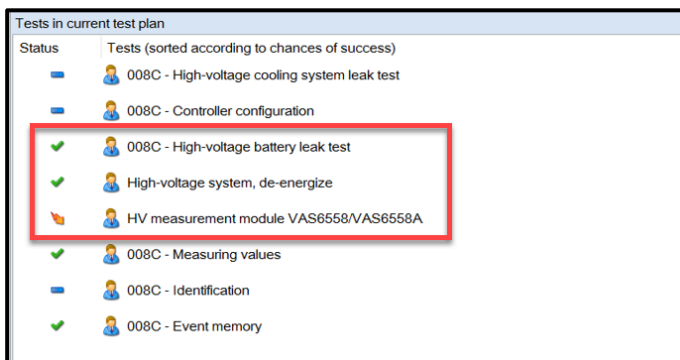
Populate Guided Functions test plans:

- Perform a diagnostic scan of the vehicle.
- Select “Self Test” and populate the following Guided Function test plans:
 - High-voltage system, de-energize
 - 008C – High-voltage battery leak test
 - HV measurement module VAS6558/6558A

Tests in current test plan	
Status	Tests (sorted according to chances of success)
	008C - High-voltage cooling system leak test
	008C - Controller configuration
	008C - High-voltage battery leak test
	High-voltage system, de-energize
	HV measurement module VAS6558/VAS6558A
	008C - Measuring values
	008C - Identification
	008C - Event memory

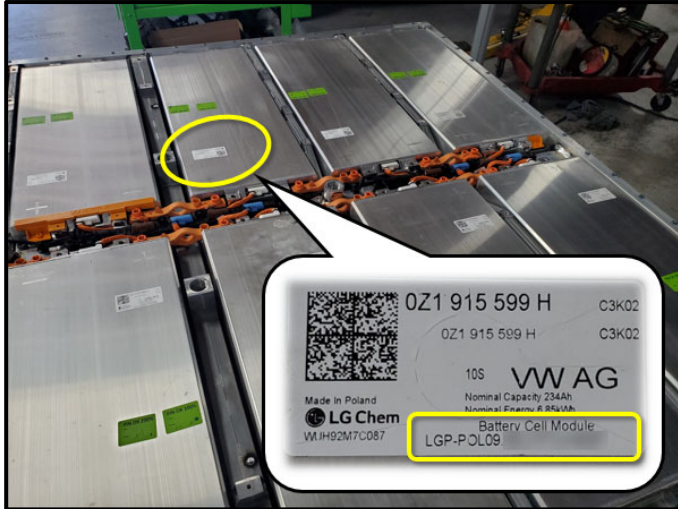
Identify cell module which requires replacement:

- Use the chart found in one of the 9302 attachment tabs in ELSA or in ServiceNet to determine the serial number of the module that requires replacement for the VIN you're working on.
- Identify the module that requires replacement and clearly mark its location.

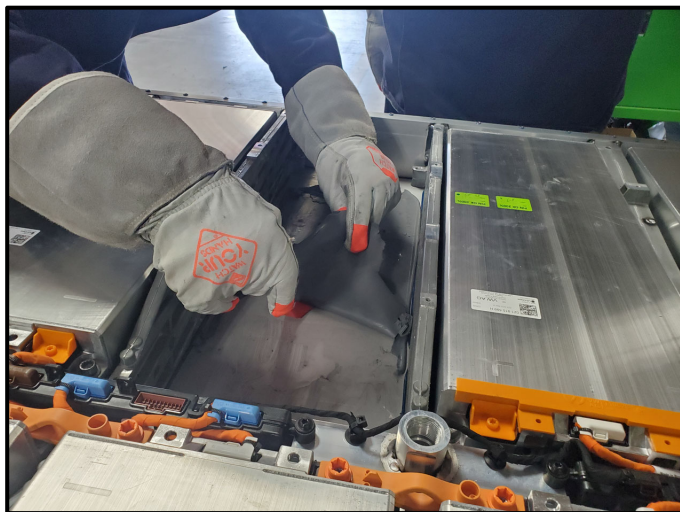
Remove the cell module:

- See ELSA Repair manual: *Repair Manual > Motor > Electric Drive Rear Wheel Drive EIP220 and All Wheel Drive EIA200, EIP220 > 93 Electric drive > High-Voltage Battery Components > Battery Module, Removing*
- Ensure the shock protection is installed on ALL open high-voltage connections.

Pay close attention to the wiring harnesses, so they are not damaged or pinched during removal.

The cell module can be freed from the adhesive bond from either end of the cell module.

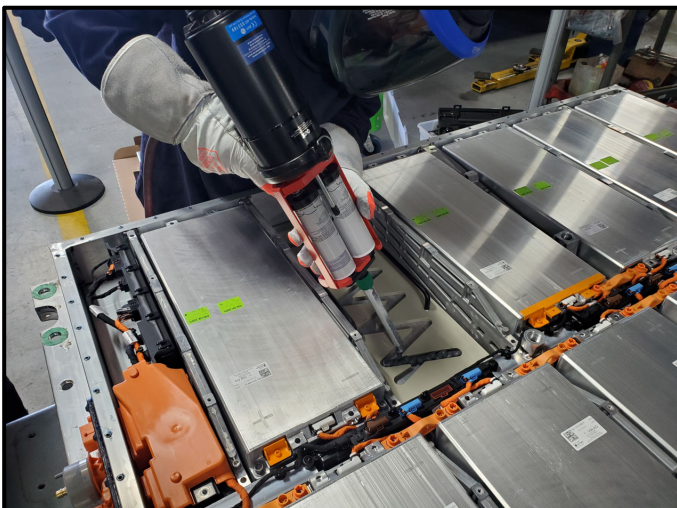
- Double check the expiration date of the paste before applying.
- Use Double Cartridge Adhesive Gun -VAS5237- to apply the heat paste.

- Before applying the heat paste, release a small amount through the applicator to ensure the paste is mixing properly.

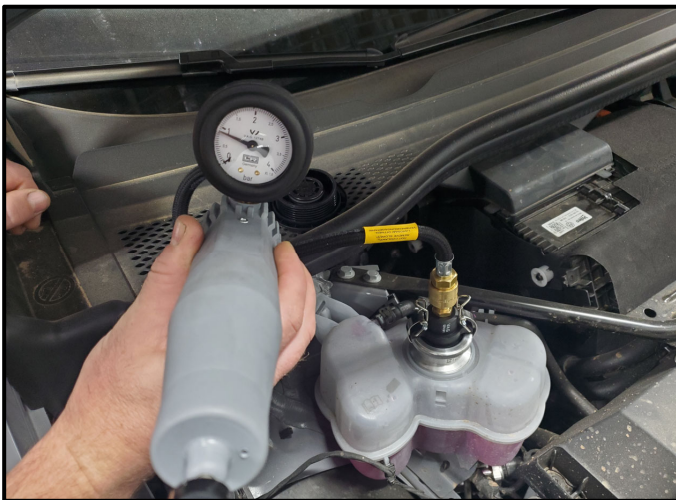
- Connect the Cooling System Tester -VAG1274B- and create a pressure of 1.0 bar using the hand pump.
- Run the test plan “0001 – Fill/bleed cooling system” and follow the on-screen prompts.
- Once the test is successfully completed, repeat the test plan a second time.
- Top off coolant.

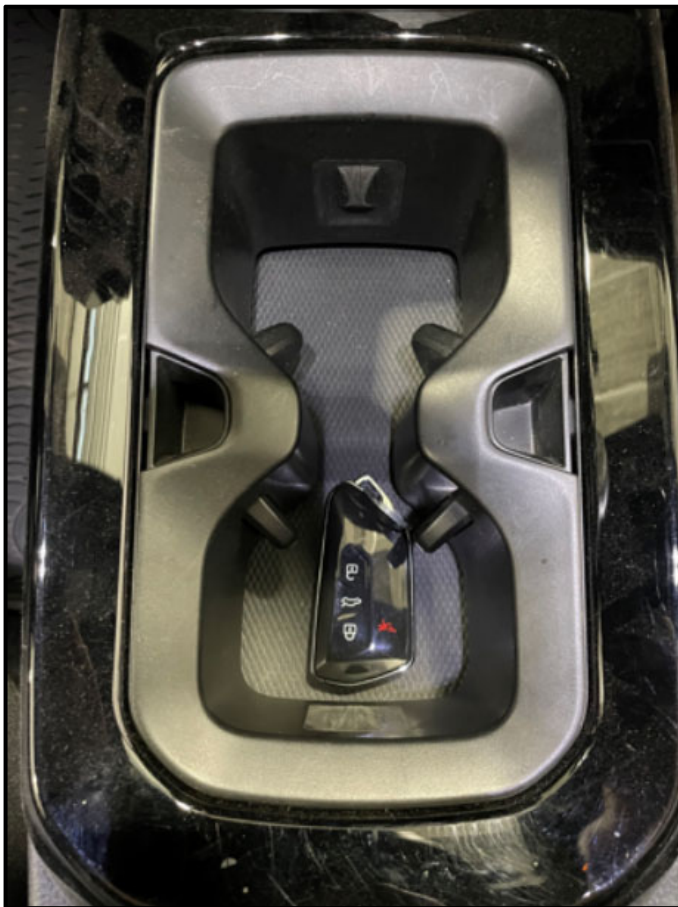
- Place the vehicle key over the reader coil in the center console cupholder.
- Any additional keys must be a minimum of 20 meters away from the vehicle.

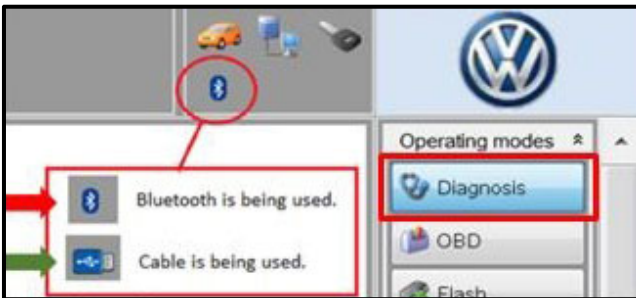
- Confirm that scan tool is communicating with the diagnostic head by USB <Green Arrow>.
 - If the Bluetooth symbol is shown <Red Arrow> then disconnect the diagnostic head from the vehicle and reconnect the USB cable to the diagnostic head and then reattach to the vehicle.
- Upon ODIS startup, verify the “Diagnosis” operating mode is selected <as shown>.
