HYUNDAI Technical Service Bulletin	GROUP RECALL	NUMBER 22-01-058H
	DATE JULY, 2022	MODEL(S) PALISADE (LX2)
SUBJECT: 7" LCD INSTRUMENT CLUSTER REPLACEMENT (RECALL 230)

This bulletin provides the procedure to remove and replace the instrument cluster.

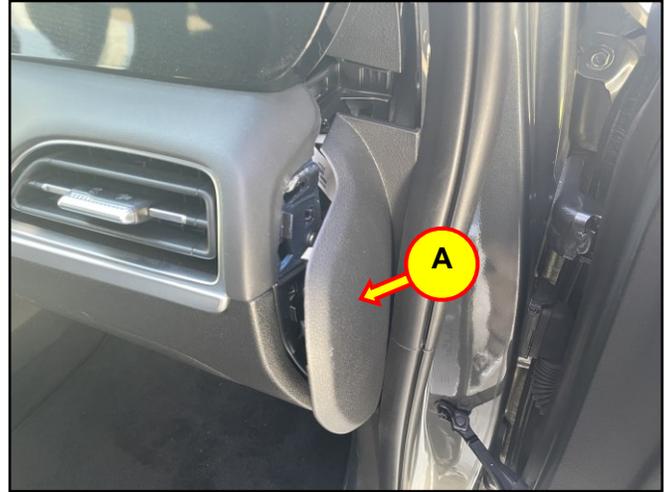
1. With ignition in the OFF position, use a flathead screwdriver or panel popper and carefully remove the front passenger side panel (A).

Be careful when removing the cluster fascia or panels to avoid/prevent breaking and scratches.

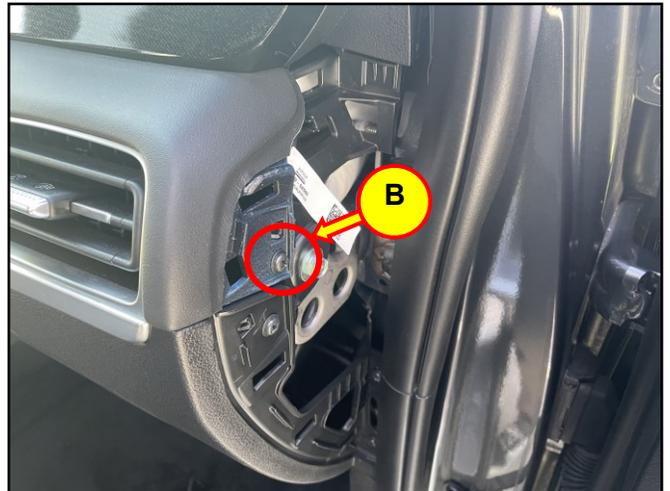
2. Remove the Phillips screw (B).

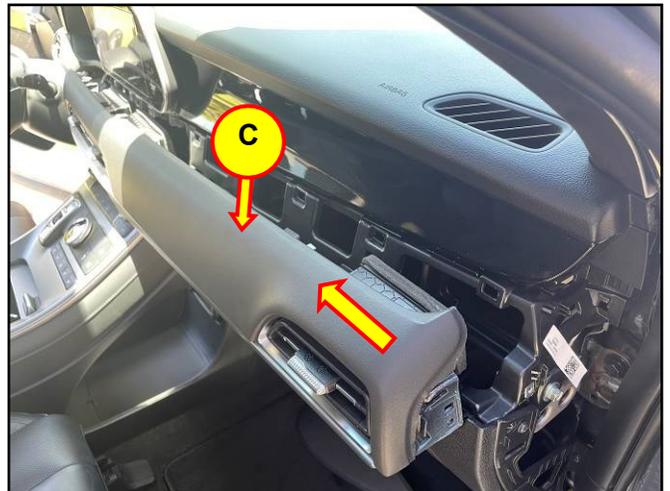
3. Carefully remove the center dash fascia (C).

Start pulling outward from the right side and slowly move towards the left to the steering wheel.

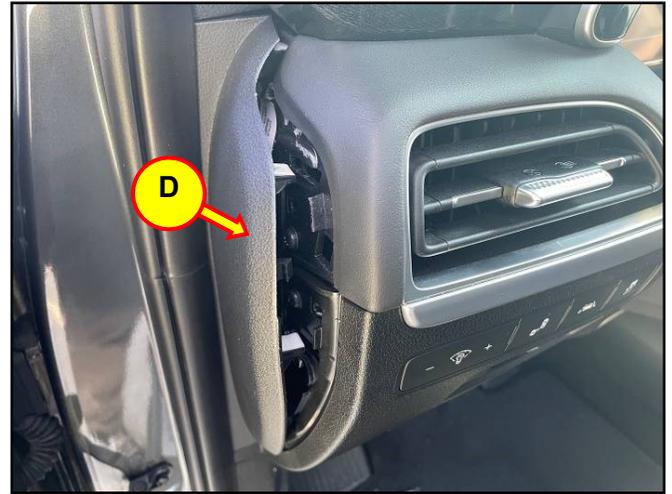
4. Use a flathead screwdriver or panel popper and carefully remove the front driver side panel (D).

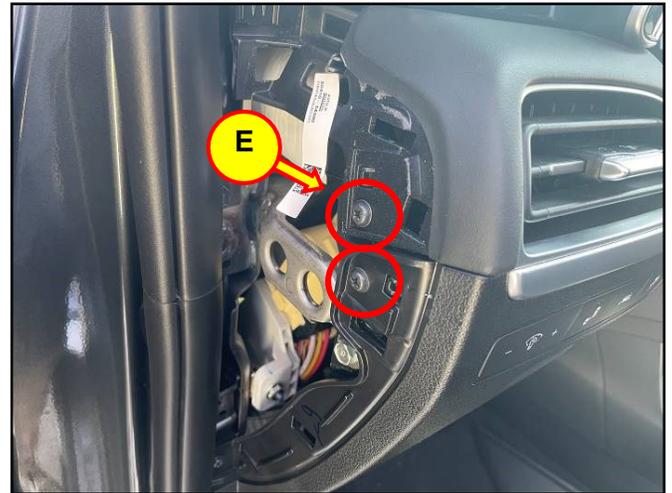
5. Remove the two Phillips screws (E).

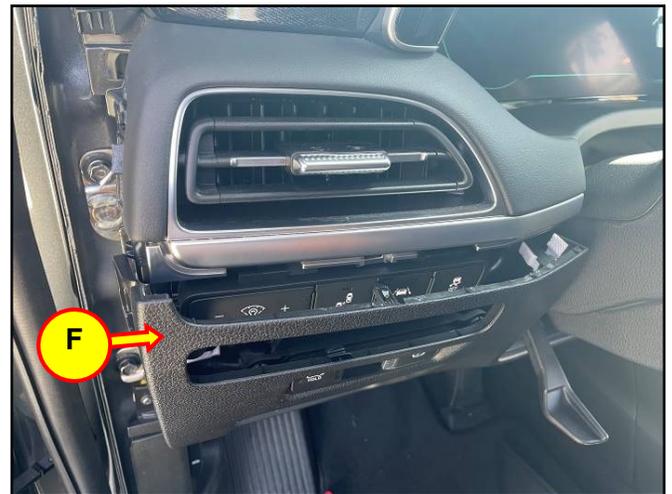
6. Carefully loosen the lower panel (F) as shown in the picture to the right.

This step does not require complete removal of the lower panel.

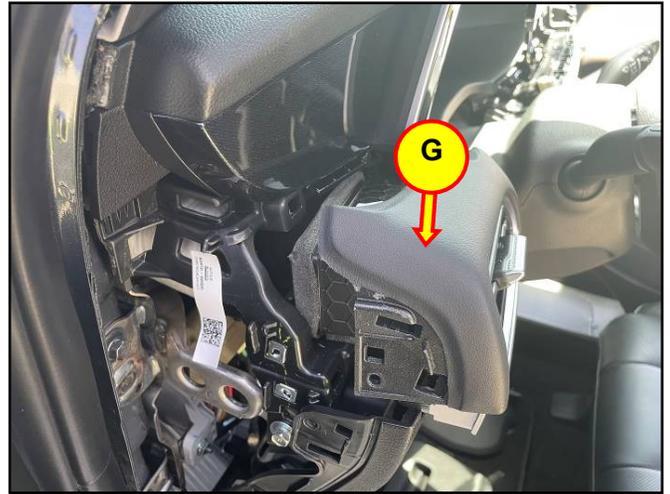
- Carefully remove the front driver side air vent (G).

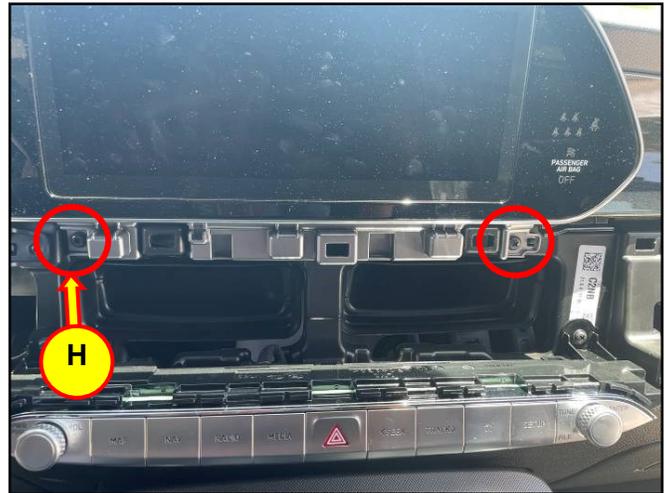
- Remove the two Phillips screws (H) underneath the radio screen.

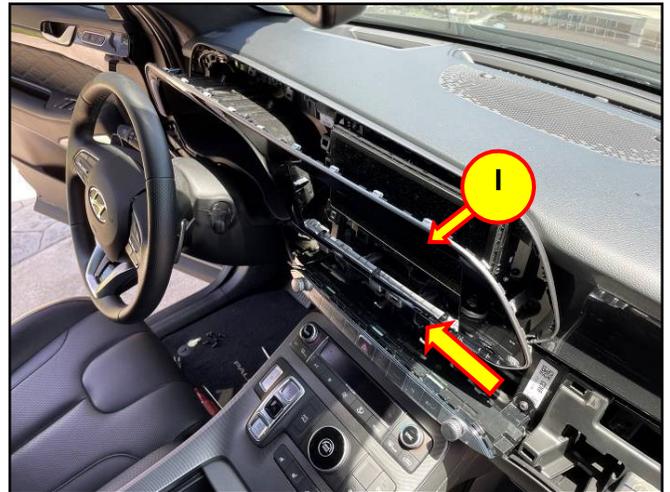
- Carefully loosen the cluster/radio fascia (I).

Be careful when loosening the cluster/radio fascia as it is extremely fragile.

Start pulling outward from the right side and slowly move towards the left to the steering wheel.

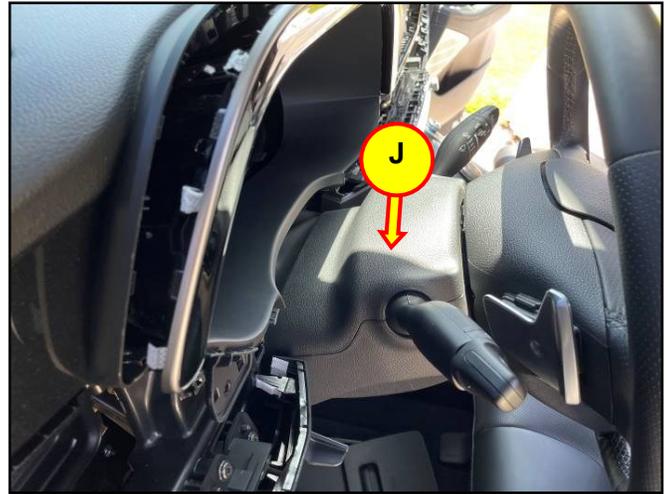
10. Loosen the upper half panel of the steering wheel cover (J).

Remove the cluster/radio fascia.

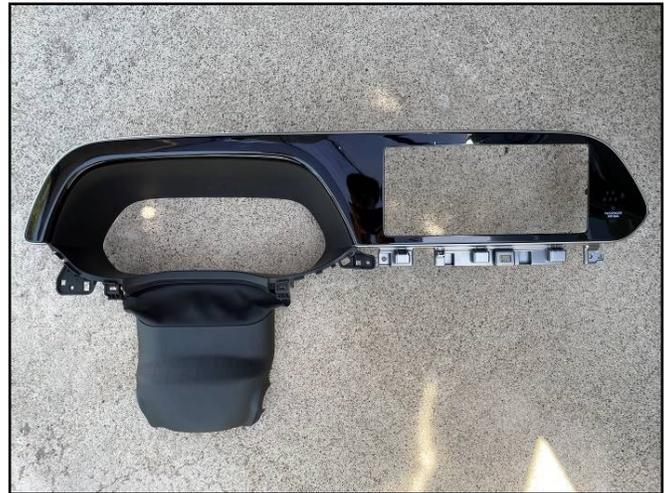
Cluster/Radio fascia removed.

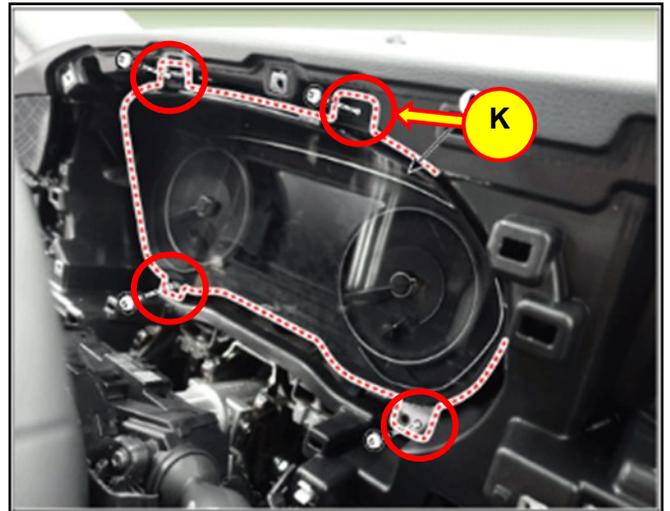
11. Remove the cluster from the housing after removing the four Phillips screws (K).

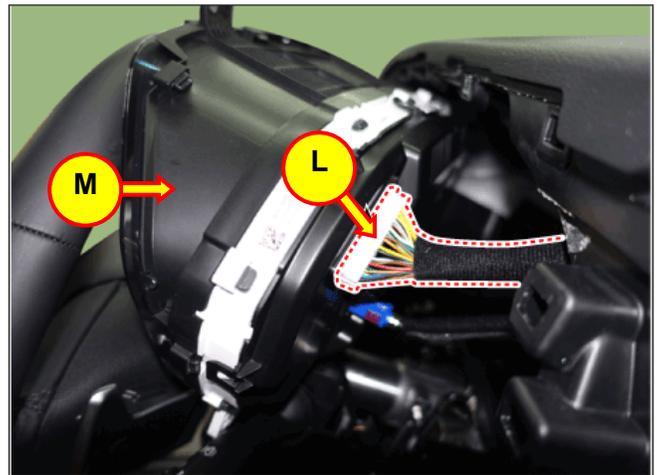
- Disconnect the instrument cluster connector (L) and then remove the cluster (M).

Keep the old instrument cluster close by because the entire procedure involves swapping of the old and new clusters back and forth. This procedure will occur during the mileage writing.

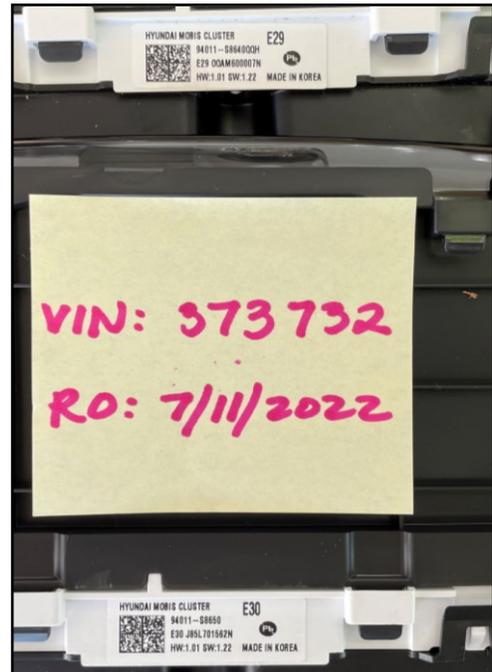
- Place the old and new instrument cluster next to each other with the serial number visible.

Write the last six digits of the VIN and date of repair onto a piece of paper and place it in between the two clusters.

Using STUI, take a picture of the instrument clusters. Upload the photo to STUI.

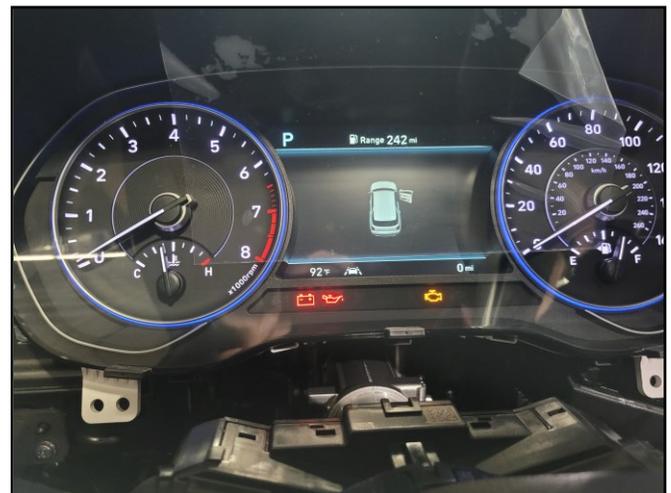
- Install the new instrument cluster and turn the ignition to the ON position.

A “Coding Error” message may display, which means the instrument cluster requires variant coding. Regardless if the “Coding Error” message display or not, variant coding is required.

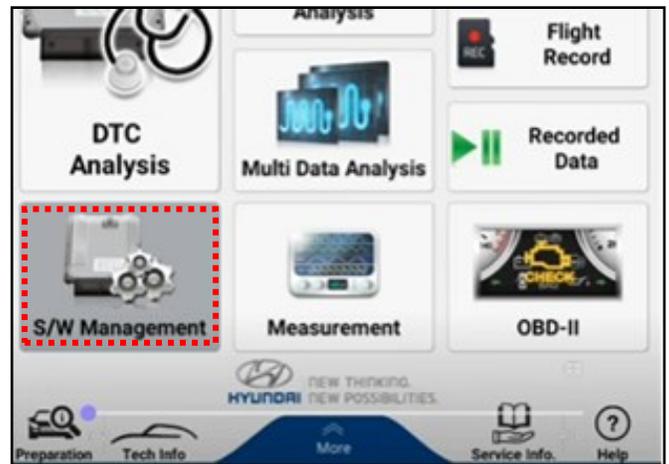
15. Connect/Pair the GDS to the vehicle.

Select "S/W Management".

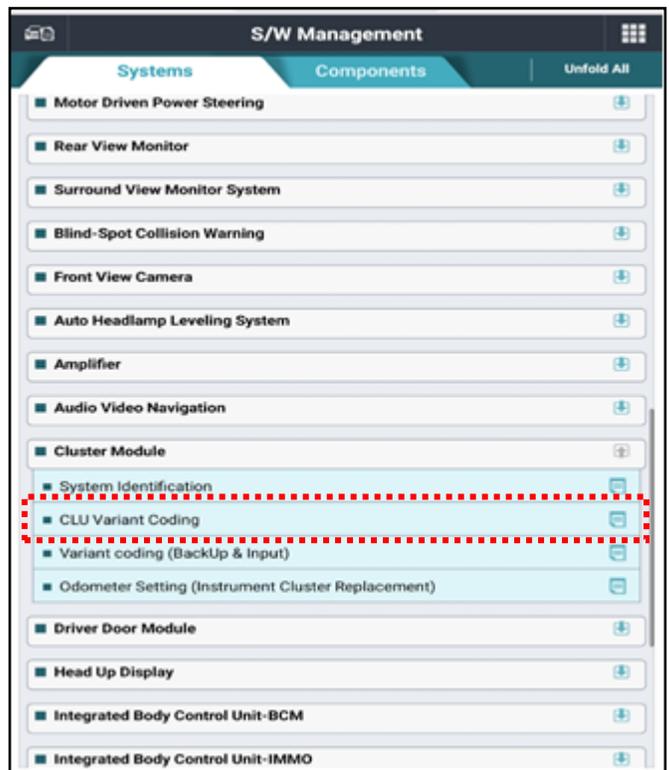
16. Scroll down the list to select "Cluster Module", and then select "CLU Variant Coding".

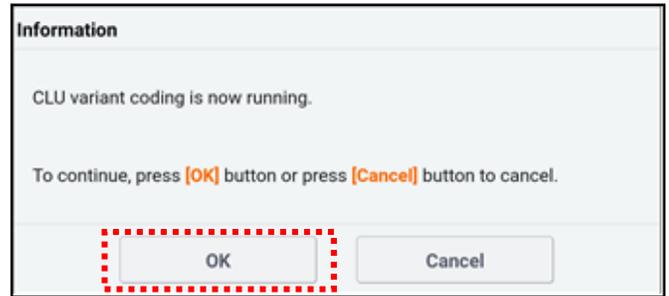
19. Select "OK" to start the variant coding process.

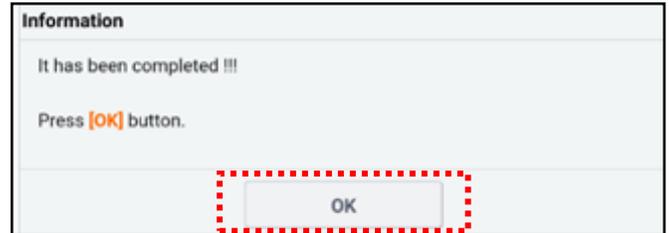
20. The instrument cluster is now variant coded.

Select "OK" to confirm.

If applicable, the "Coding Error" message should disappear from the instrument cluster.

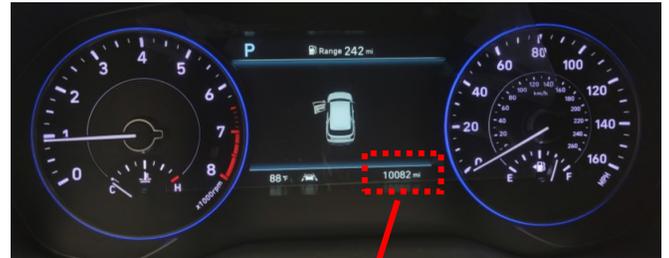
21. Remove the new instrument cluster, and reinstall the old instrument cluster.

Write down or take a picture of the mileage.

In this example the mileage is 10082.

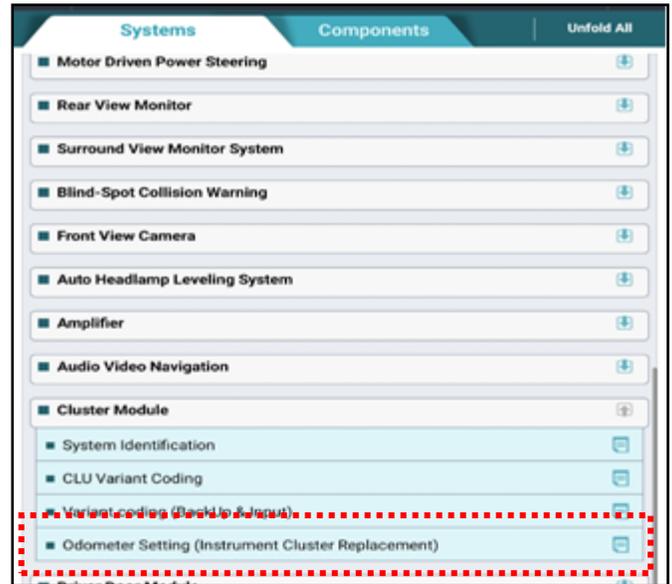
22. Under “Cluster Module” category, select “Odometer Setting (Instrument Cluster Replacement)”.

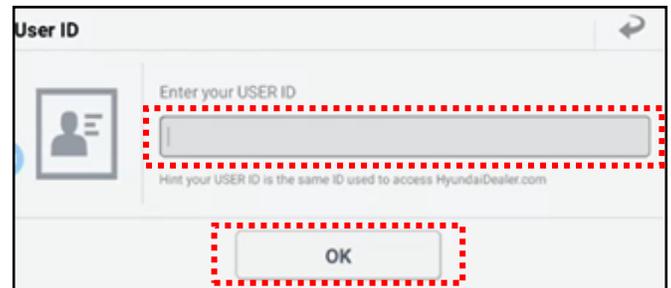
23. Enter the technician’s log in ID and then select “OK”.

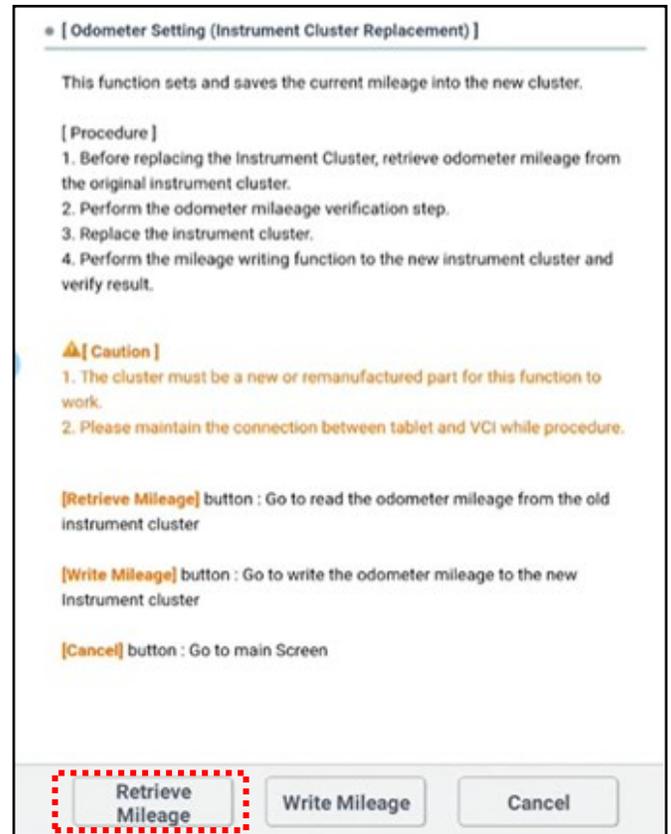
24. Select “Retrieve Mileage”.

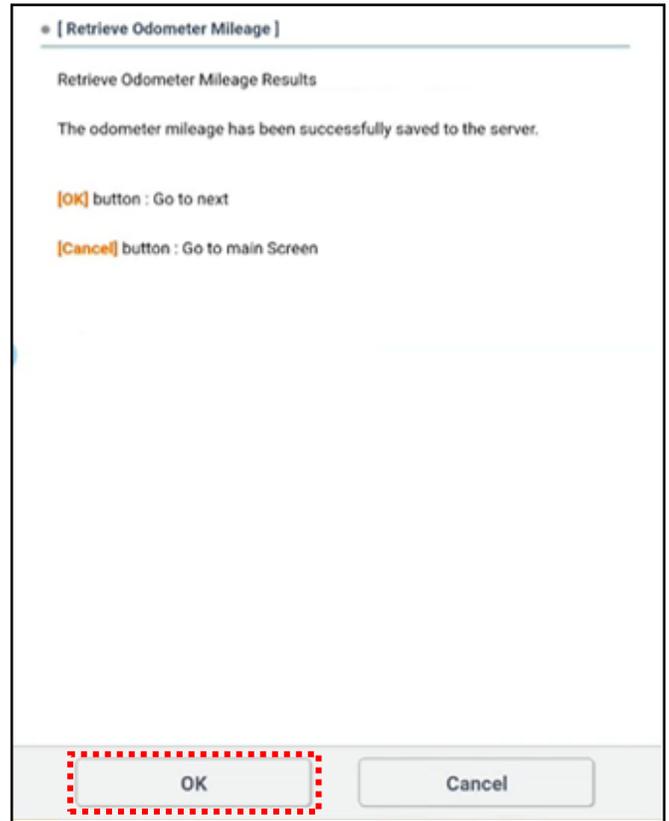
25. Select "OK".

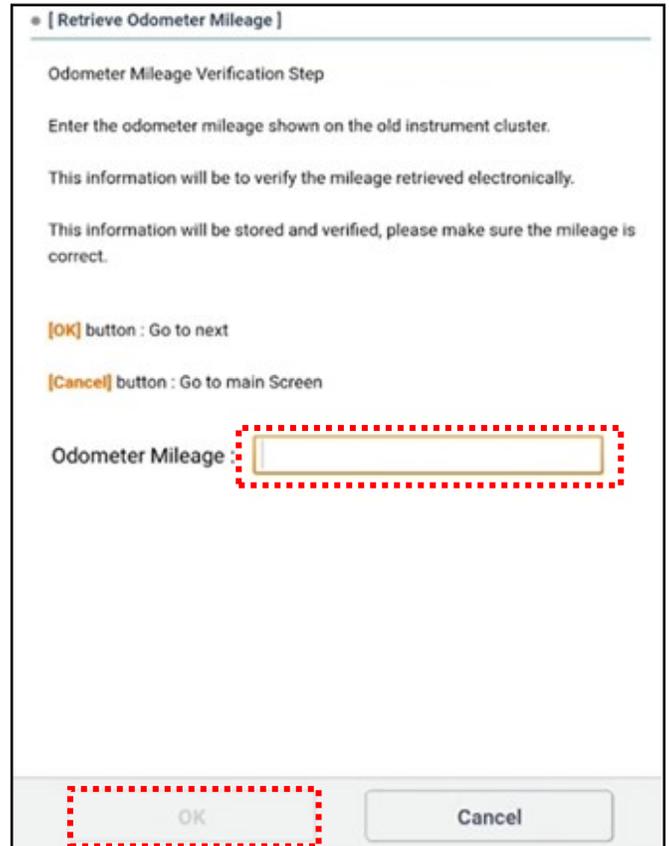
26. Enter the mileage from the old instrument cluster and then select "OK".

Ensure the correct mileage is entered before selecting "OK".

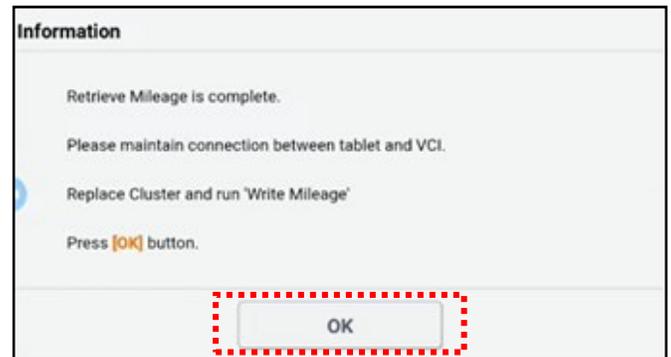
- 27. Pop up message confirming the retrieval of the mileage from the old instrument cluster was successful.

Select "OK".

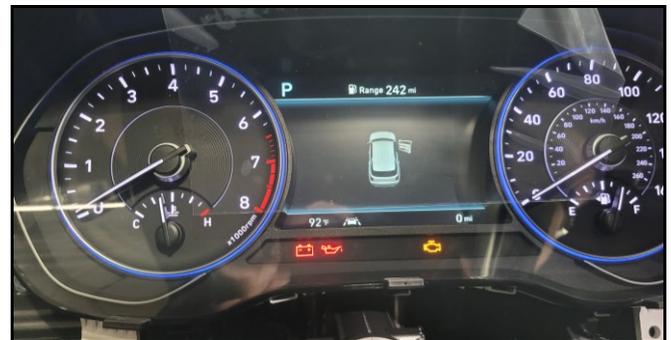
- 28. Remove the old instrument cluster and reinstall the new instrument cluster.

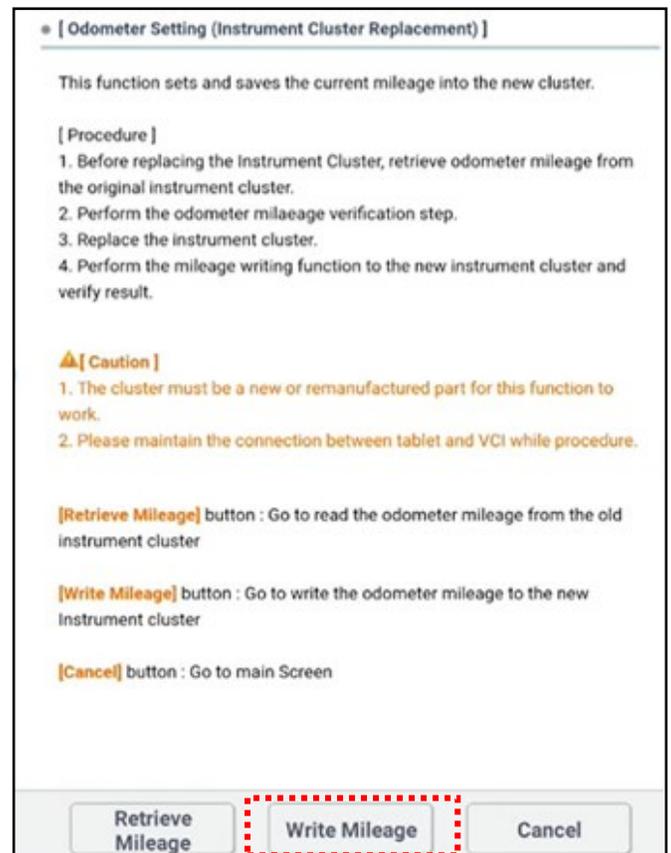
- 29. After installing the new instrument cluster, select "Write Mileage".

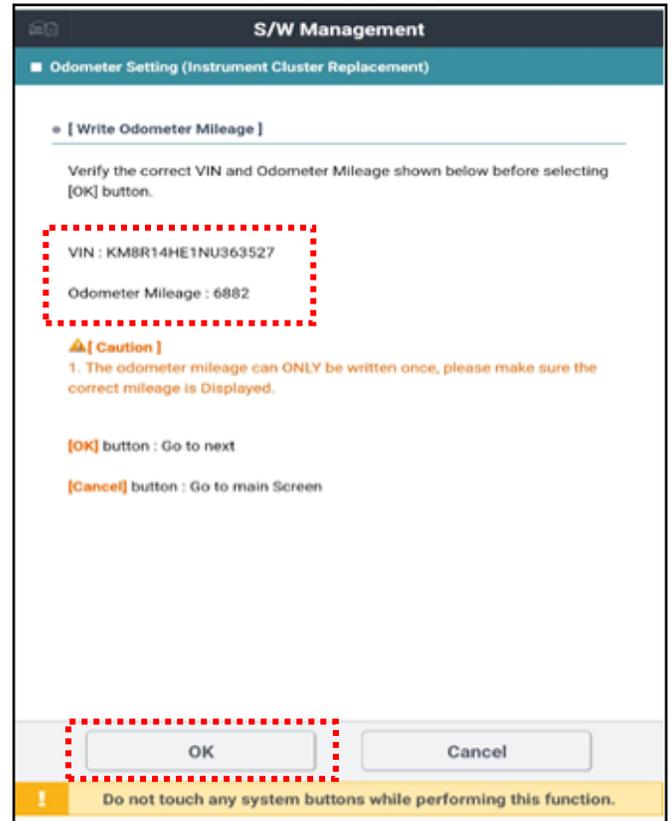
30. Confirm the VIN and mileage are correct before selecting "OK".

This step is very important, so completely ensure the VIN and mileage are correct.

The odometer mileage can ONLY be written one time. If the incorrect mileage was written onto the instrument cluster, then another new part will need to be replaced along with rewriting the mileage.

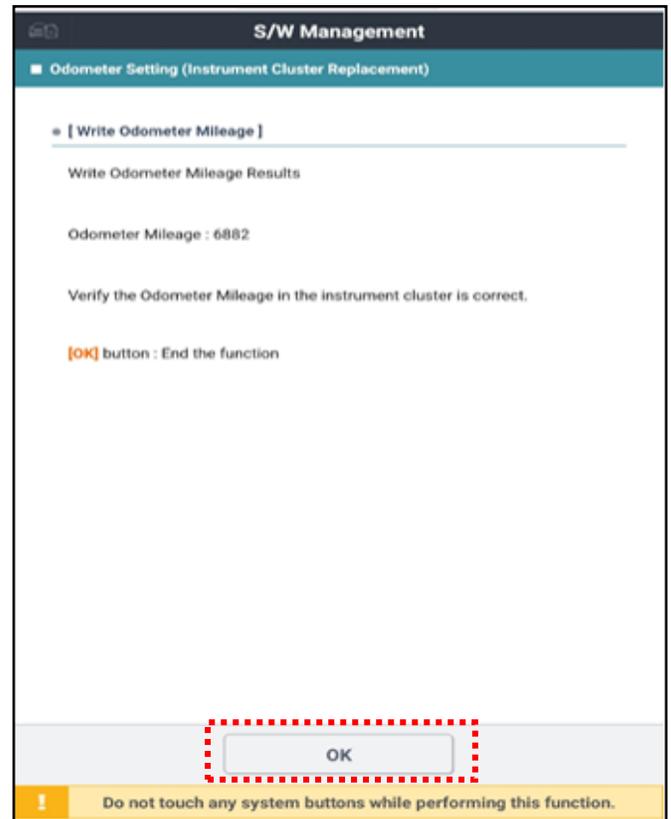
31. Mileage writing is completed.

Select "OK".

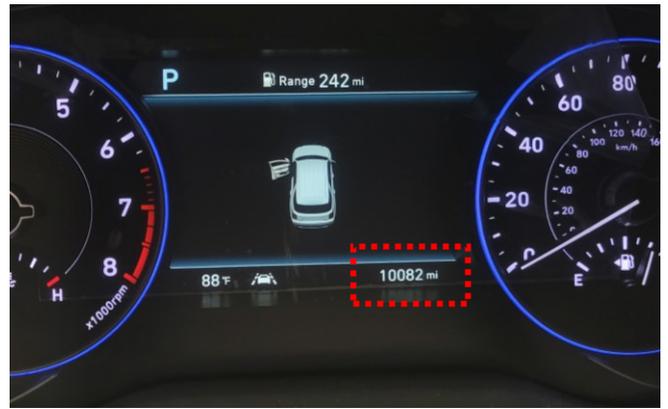
32. Confirm the mileage displayed on the new instrument cluster is correct.
