# Recall Campaign Bulletin

Campaign No. 2023110006, July 2024

SUBJECT: **Various Models**  
**Model Year 2019 – 2022**

**SIM Card Communication Module – Wave 4**

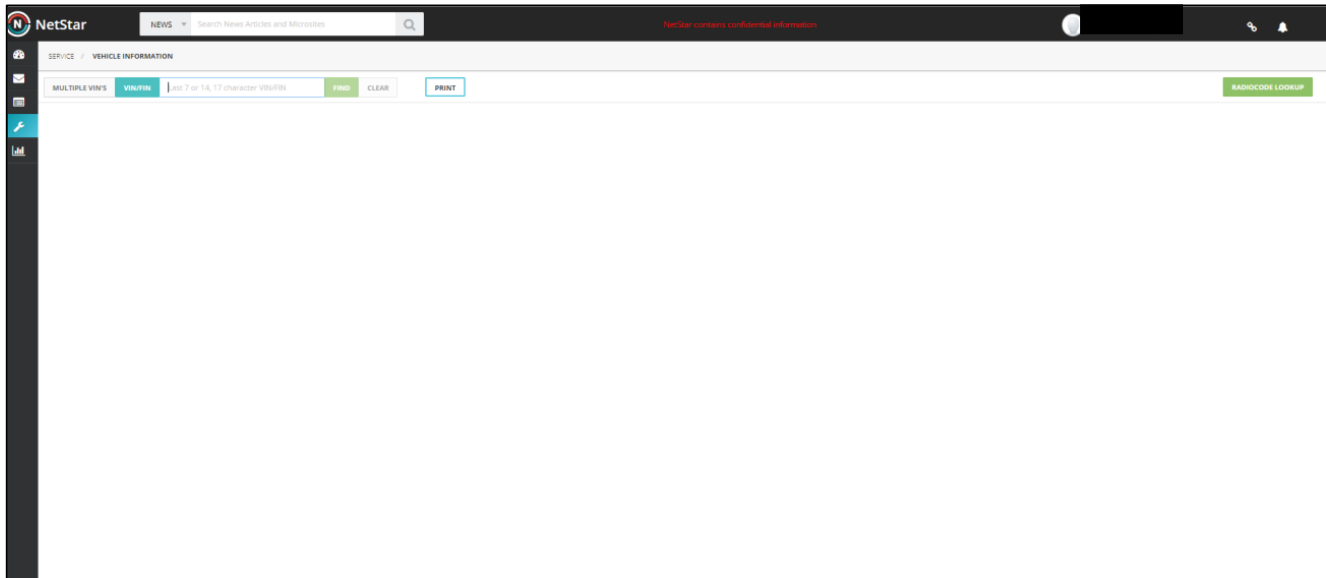
Figure 4

1. Log in to "NetStar" and call up the Vehicle Master Inquiry (VMI) screen (**Figure 4**).

3. Click on the "OTA update" link (Figure 4).

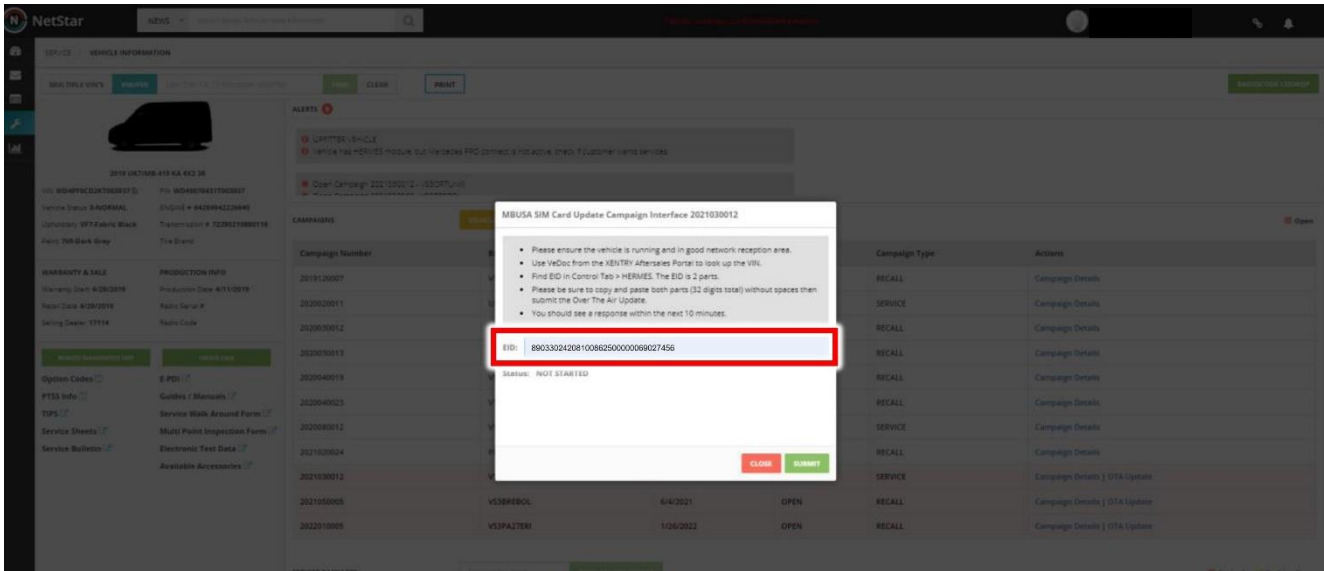
Figure 8 – EID1 + EID2 input

5. Enter the valid EID number and click on "Submit" (Figure 8).

**i** To do this, enter the **EID1 + EID2** numbers from VeDoc **without spaces or special characters** as shown. (e.g.: 89033024208100862500000069027456 – **EXAMPLE ONLY**).
