Compliance Recall

Code: 91DV

Subject Rearview Camera Software

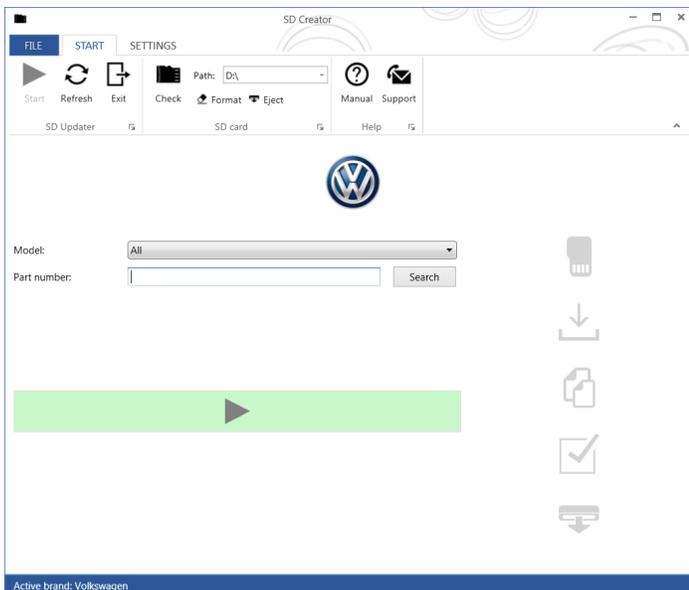
Required USB Drive

- The required software will have to be downloaded onto a USB (or USB-C) drive using the SD Creator program
- **Reference the latest version of TSB 2054866 for additional information on the use of the SD Creator program.**

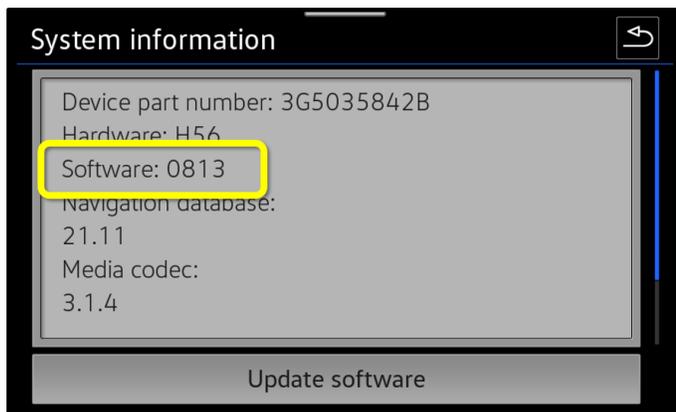
- Check the current software version.
 - Click Menu
 - Settings
 - System Information
- If software version is 0813 or higher:
 - **The current software version must be documented.**
 - Proceed to Section C.
- If software version is lower than 0813:
 - MIB3 system requires updating.
 - Proceed to the next step.
- Open the hood.
- Open the battery cover.
- Switch the ignition on.
- Apply the parking brake.
- Switch off all consumers (headlights, heated seats, climate control, etc.).
- Attach a Battery Tester/Charger **capable of minimum 70 Amp continuous supply** to the vehicle battery.

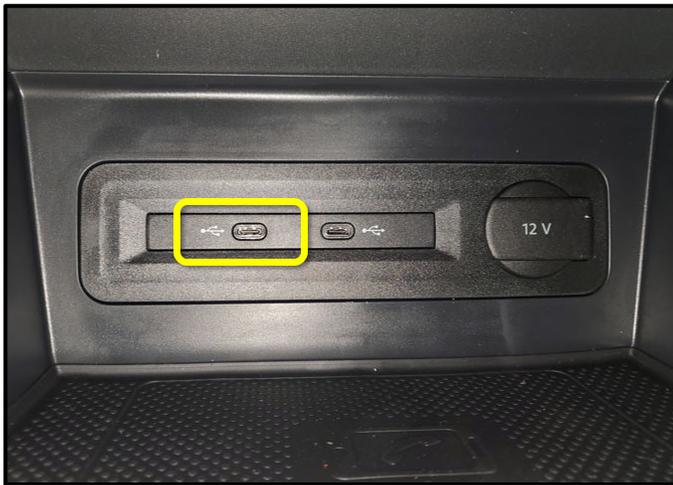
- Insert the USB drive in port 1 of the USB connection in front center console storage compartment.

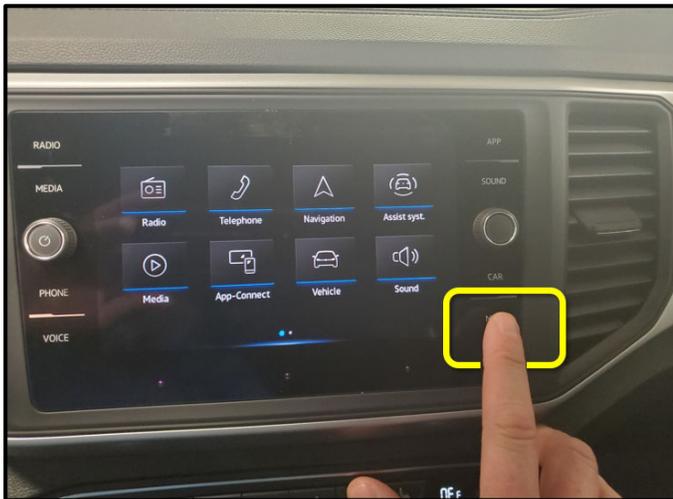
- Press and hold the "MENU" button located on the Radio for 5 seconds, wait until service mode is available.

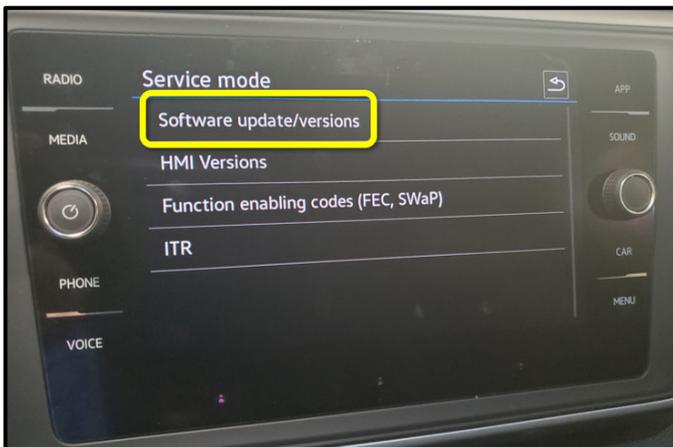
- Select the option "Software Update/Versions."

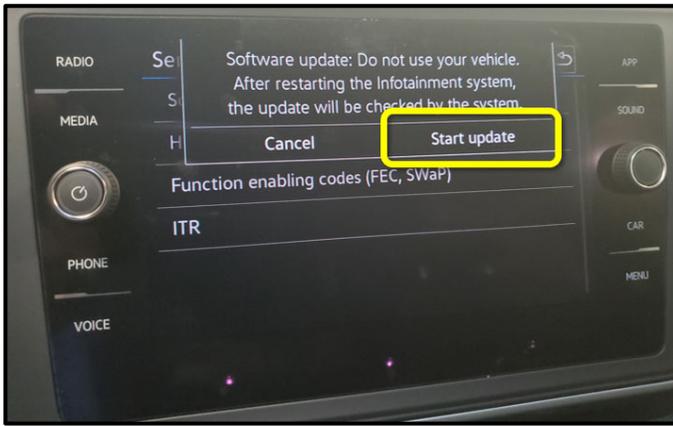
- Select “Start update.”

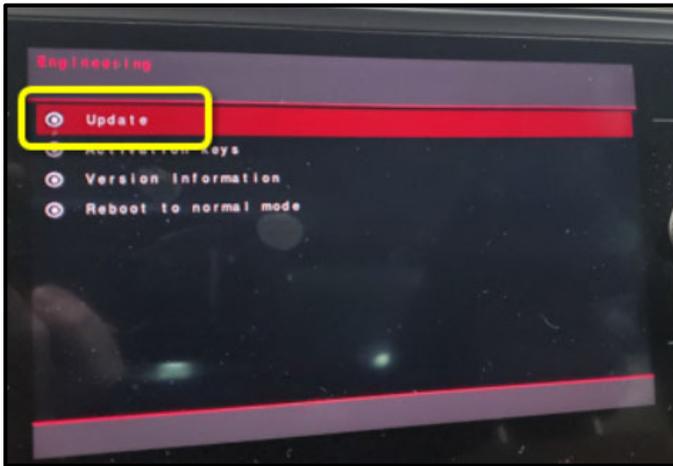
- Select Update.

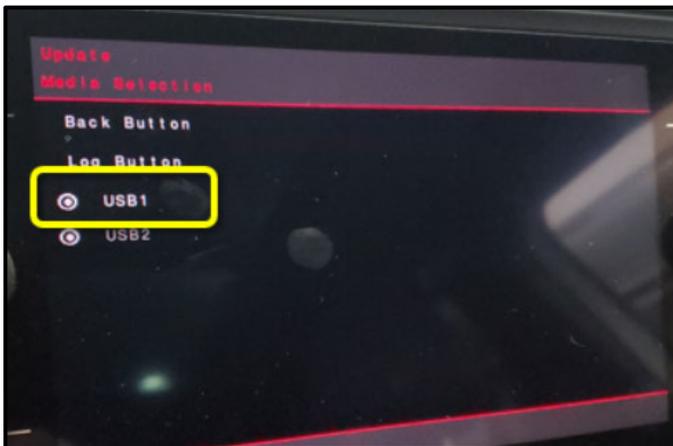
- Select the option USB 1.

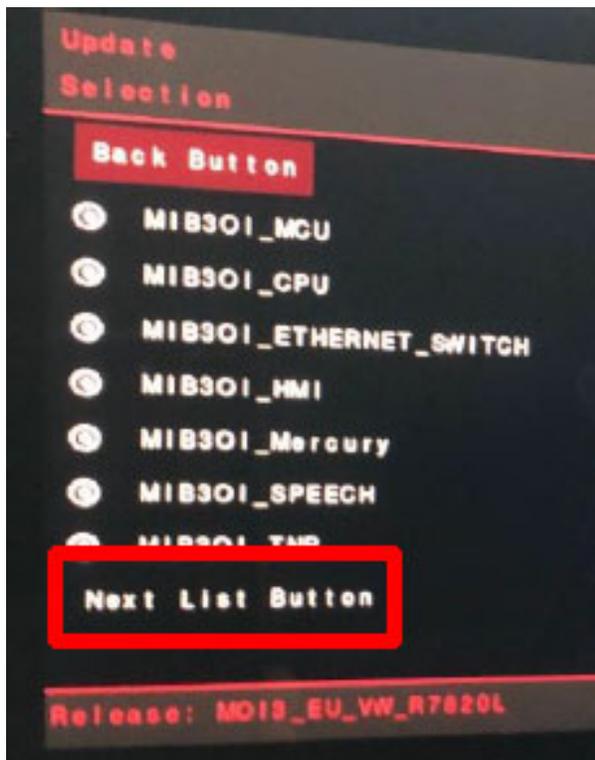
- Select "Next List Button" option (if present).

If the "Next List Button" is not present, proceed to the next step.

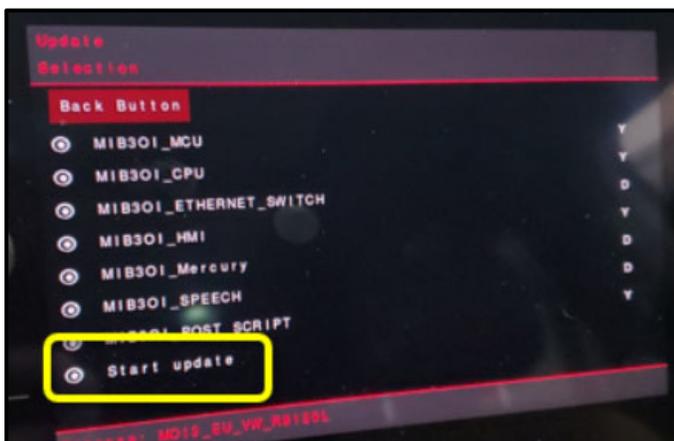
- Select "Start Update."

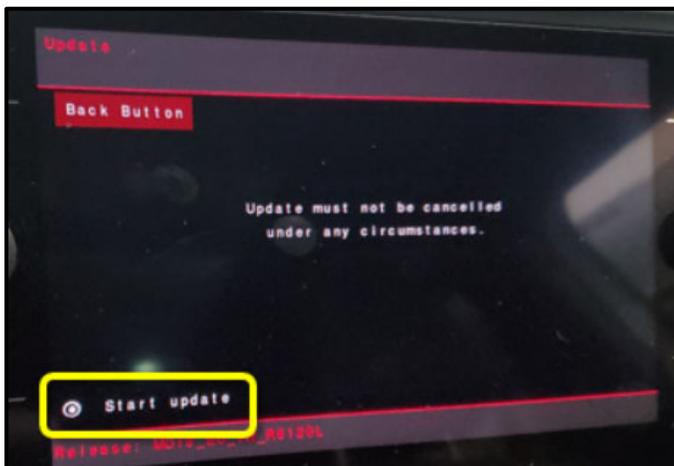
- Select "Start Update."

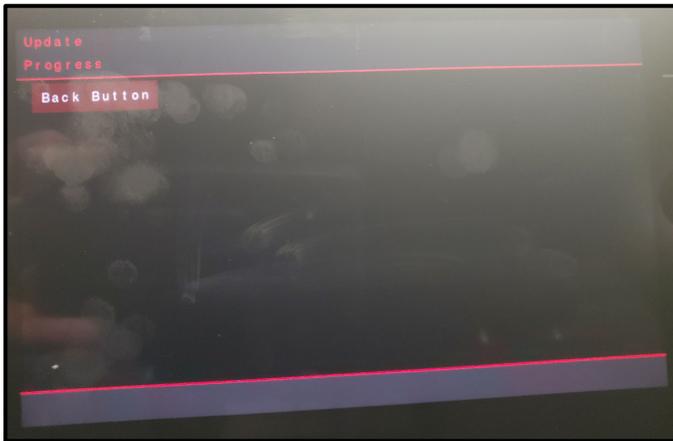
! NOTE
After starting the update, this screen may appear and remain for up to 5 minutes.

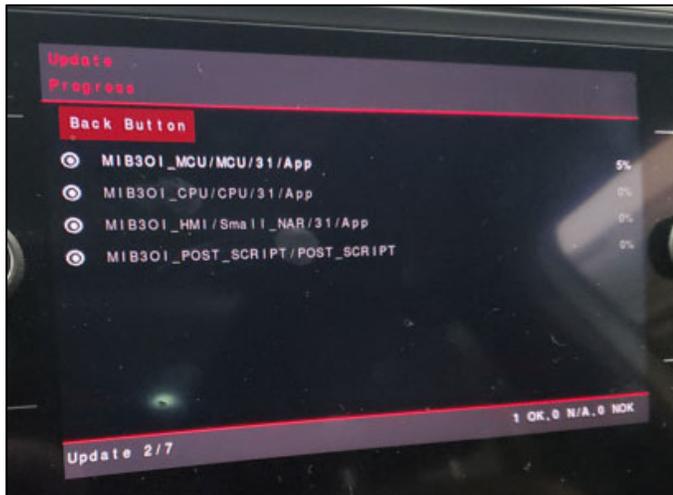
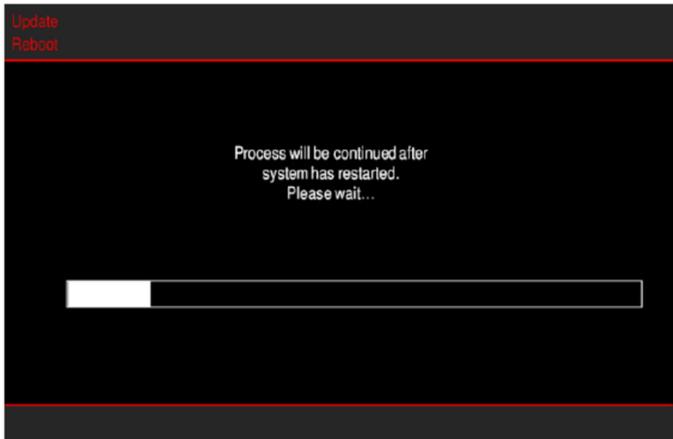
- Example Software Update progress screens shown here.

! NOTE
The screen may go blank a few times during the update.

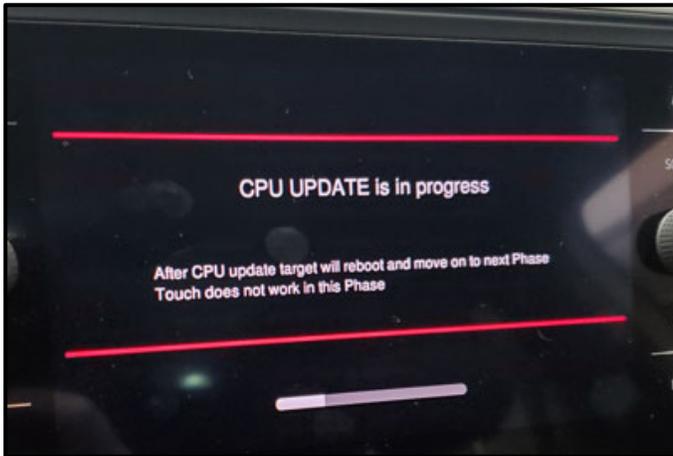
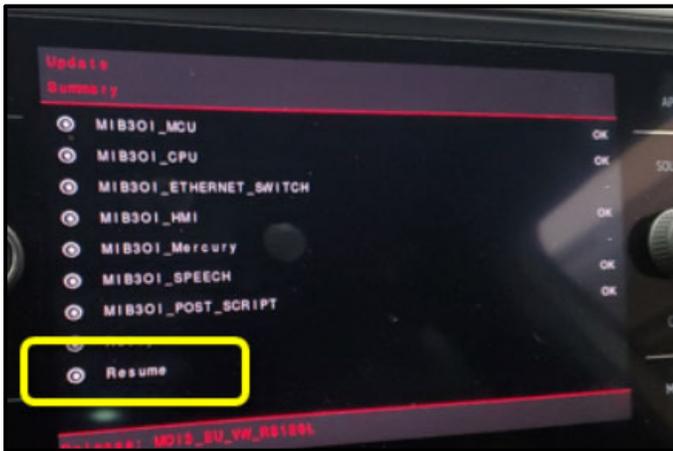
- When the Update Summary screen appears, select “Resume.”

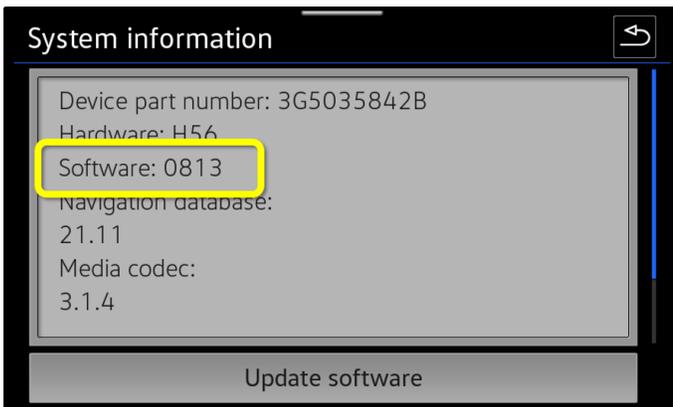
- Confirm the software is updated to version 0813.
 - Click Menu
 - Settings
 - System Information
- Switch off ignition
- Remove USB drive.

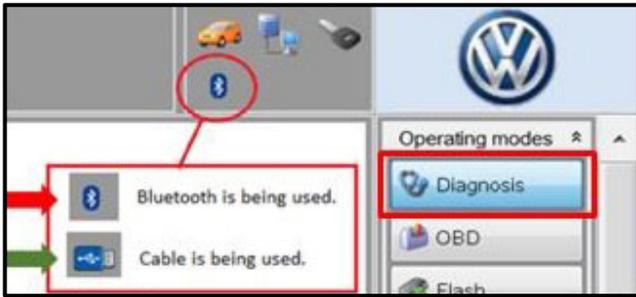
- Confirm that scan tool is communicating with the diagnostic head by USB <Green Arrow>.
 - If the Bluetooth symbol is shown <Red Arrow> then disconnect the diagnostic head from the vehicle and reconnect the USB cable to the diagnostic head and then reattach to the vehicle.
- Upon ODIS startup, verify the “Diagnosis” operating mode is selected <as shown>.

- ✓ **The VAS Diagnostics Interface MUST ONLY be connected to the tester with a USB cable.**
 - Performing a software update using a Bluetooth or WiFi connection increases the risk of losing connection during the update, which could result in damage to the control module. It also greatly increases the time required to perform the update. Requests for additional time or parts will be denied if the GFF log shows the update was performed using Bluetooth or WiFi.

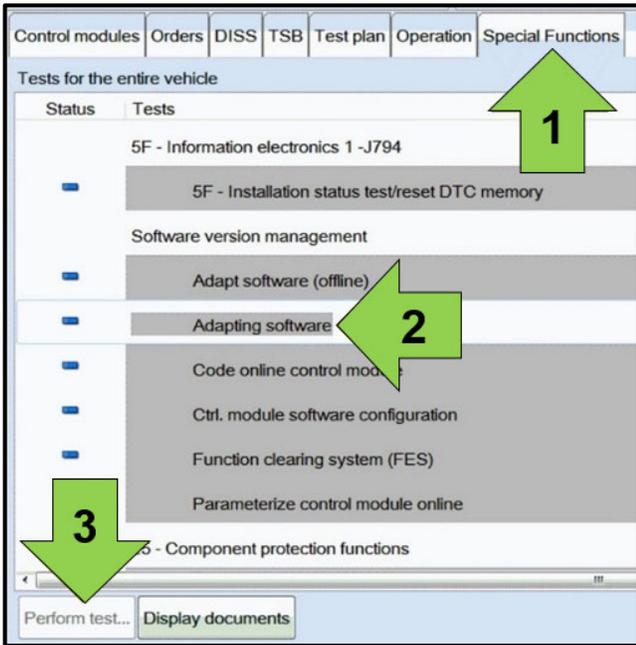
- Once the GFF scan is complete, select “Special functions” <arrow 1>, then “Adapting software” <arrow 2>, then select “Perform test” <arrow 3>.

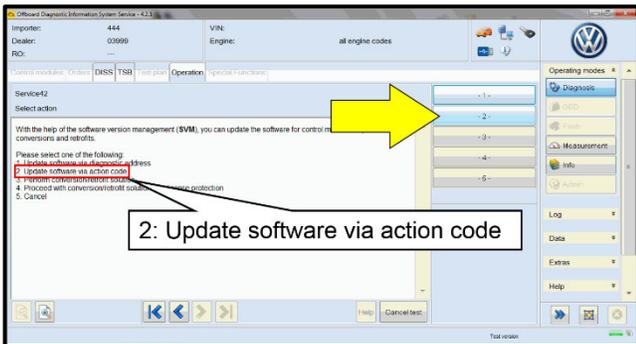
- Select the correct option to “Update software via action code” OR “Software update via measured code”.

NOTE
The different options to perform the SVM operation may vary based on model.

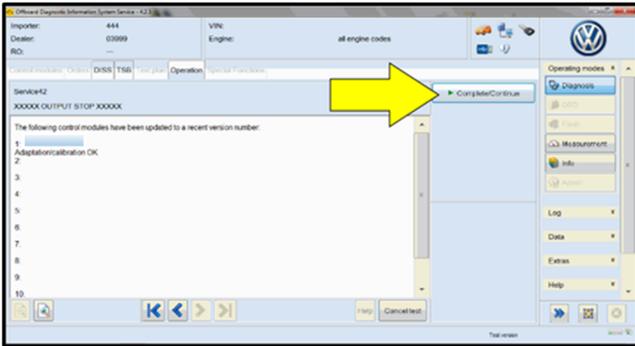
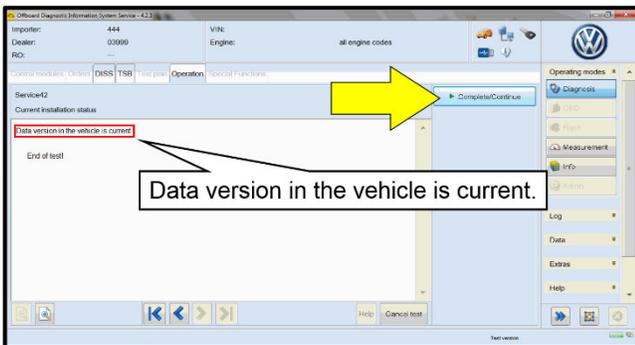
- Select "Accept" <arrow> and follow the on screen prompts.
- Select Complete/Continue <arrow> after each operation is completed.

- When the SVM update is complete a confirmation message is displayed <as shown>.
- Select "Complete/Continue" <arrow>.

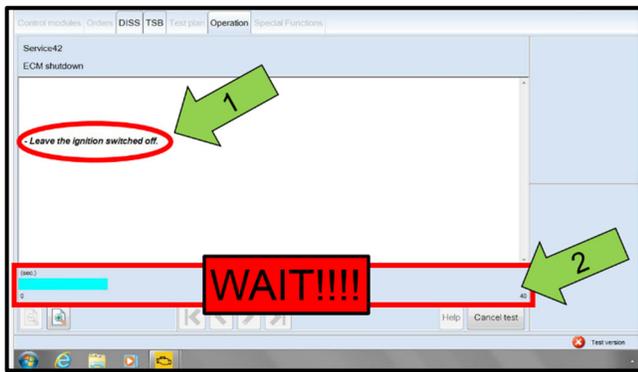
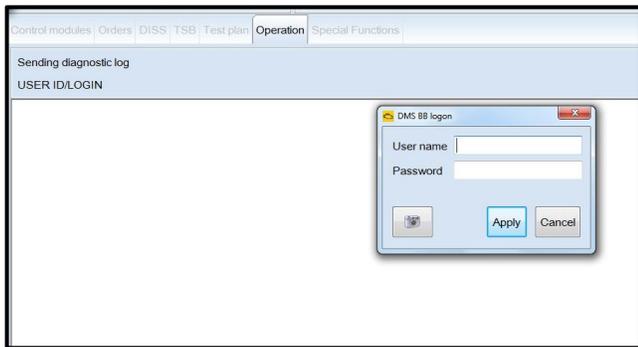
- It is **IMPERATIVE** that **ALL** of the ignition cycle on/off delay requests are fulfilled in their entirety during this flash process <arrow 1>.
- Failing to wait for the ignition on/off timing cycle to complete (progress bar and countdown timer <arrow 2>) before cycling the ignition on/off **MAY** damage a control module.
- Damage to control modules as a result of failing to wait the specified time displayed by the progress bar and countdown timer <arrow 2> are **NOT** covered under this action.
