VOLUNTARY RECALL CAMPAIGN

VOLUNTARY SAFETY RECALL CAMPAIGN INFOTAINMENT SYSTEM REBOOTS EVERY 4-5 MINUTES

CAMPAIGN ID #: PC902
APPLIED VEHICLES: 2022 Pathfinder (R53)
2021-2022 Rogue (T33)

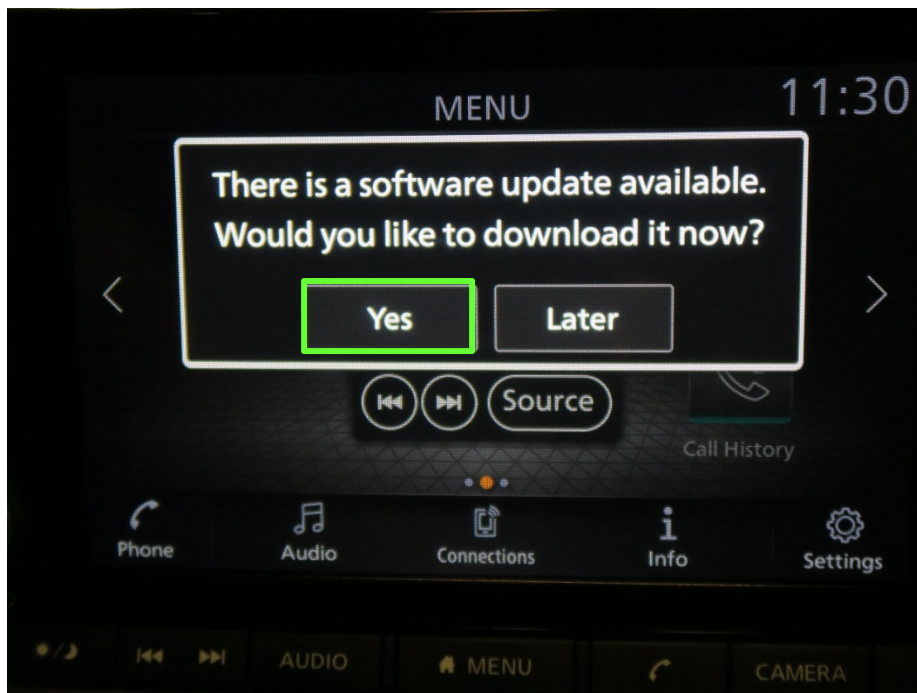
- If at any time during the following procedure the pop-up screen shown in Figure 1 **APPEARS**, then:
 - Select “Yes” and the Over-The-Air (OTA) download will complete using screen prompts.
 - **In this case, the UPDATE PROCEDURE is complete, no further action is required.**
 - Go to **CLAIMS INFORMATION** to submit a claim for the completion of the OTA download.
- If the Over-The-Air (OTA) pop-up screen in Figure 1 **DOES NOT APPEAR**, then :
 - **Continue to step 2 on page 3 to put the AV Control Unit into System Diagnostic Menu.**

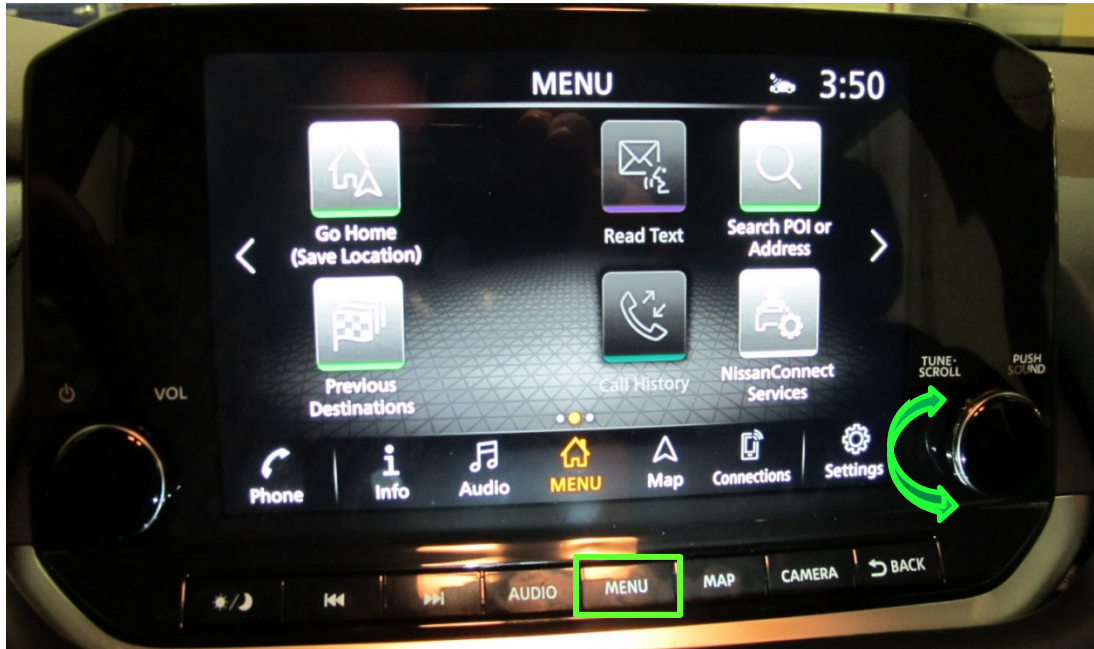
Figure 2

2. Put the AV Control Unit into System Diagnostic Menu.
 - Push the MENU button while turning the Tune/Scroll button at least three (3) clicks counter clockwise, then three (3) clicks clockwise, then three (3) clicks counter clockwise.

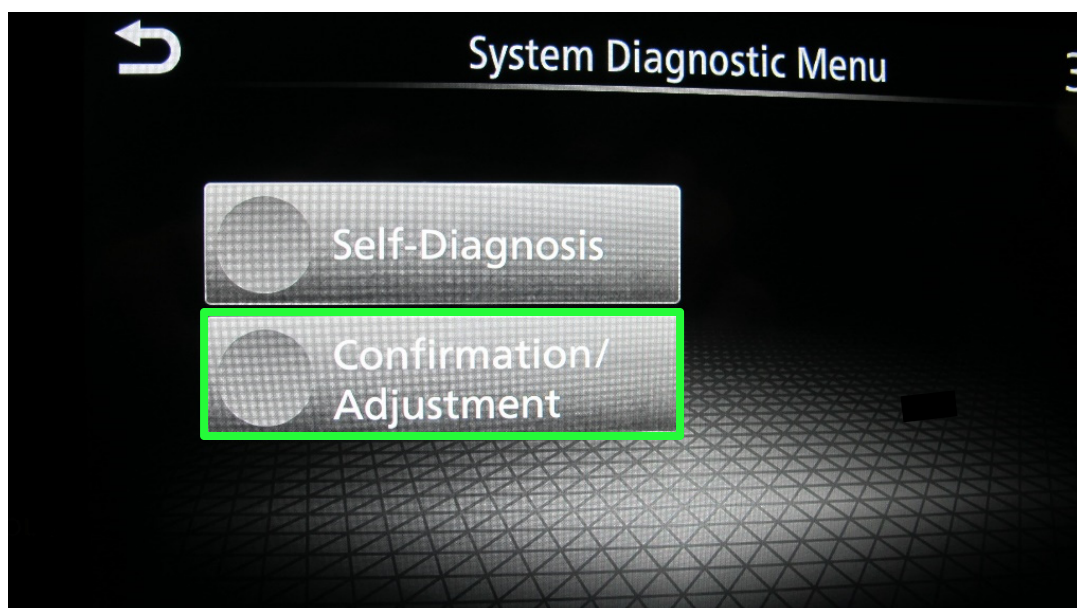
Figure 3

3. Select **Confirmation/Adjustment** on the **System Diagnostic Menu**.

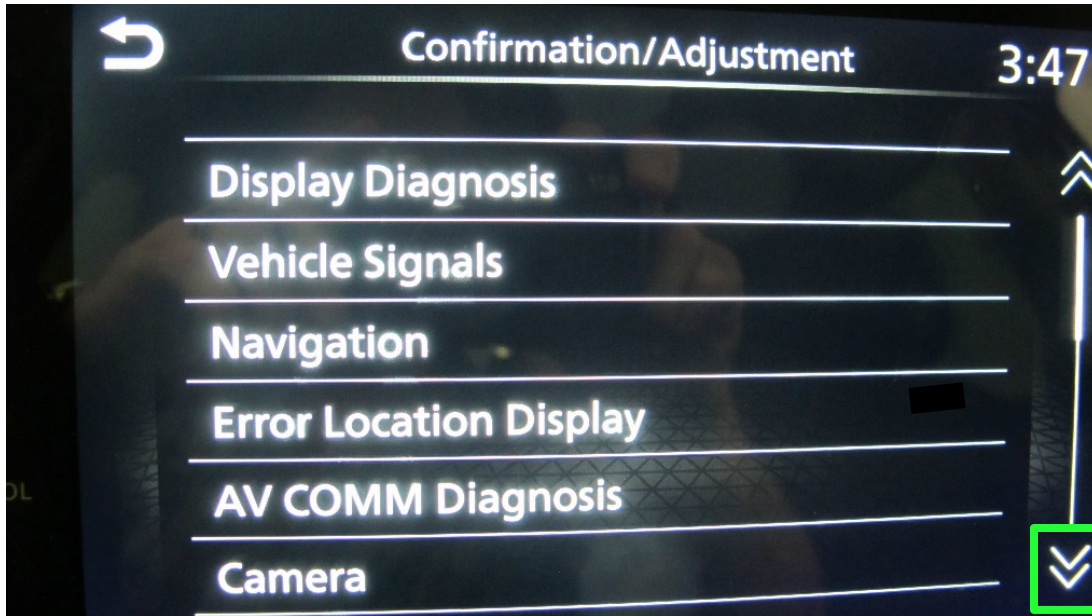
Figure 4

4. Select down arrow on the bottom right corner of the screen to move to the next screen.

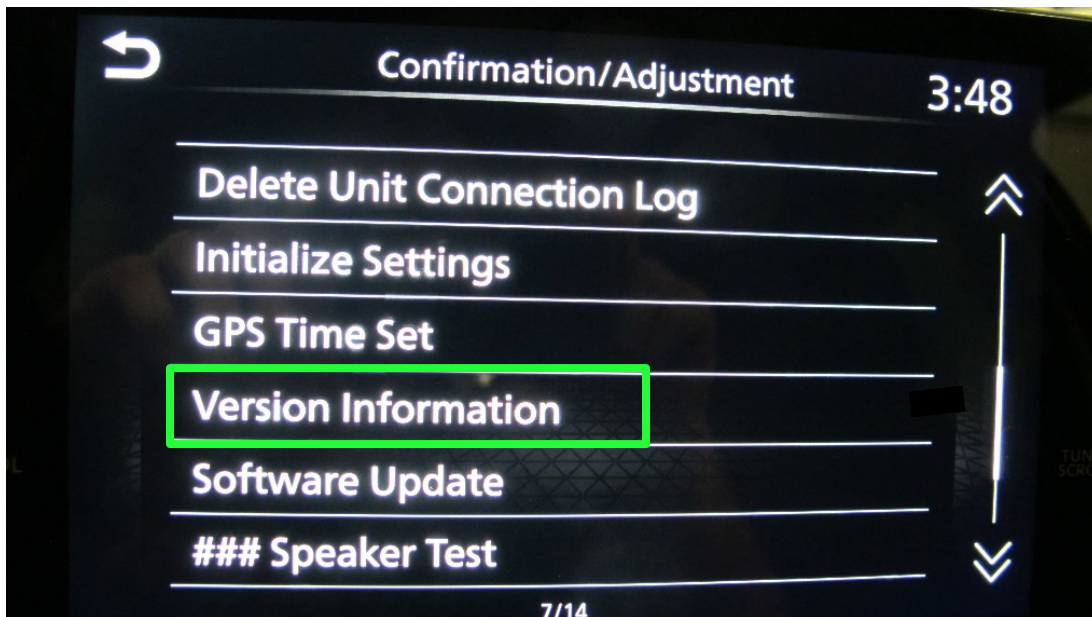
Figure 5

5. Select **Version Information**.

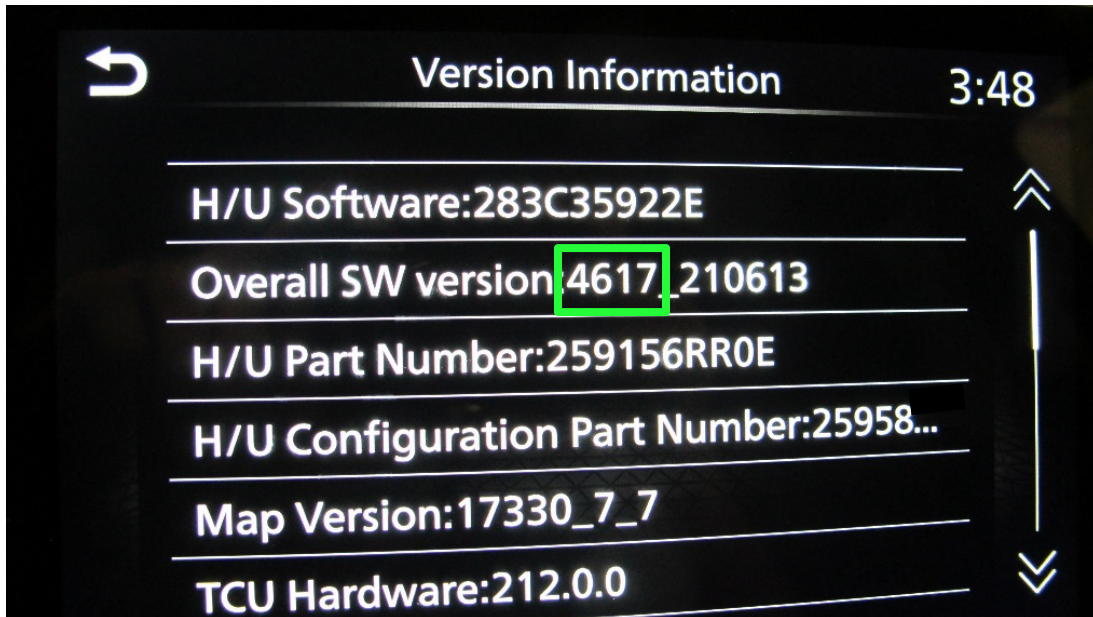
Figure 6

6. Write down the first four digits of **Overall SW version** on the Repair Order.

7. Compare the first four digits of **Overall SW version** that was written on the Repair Order to the **Overall SW Version** listed in **Table A**.

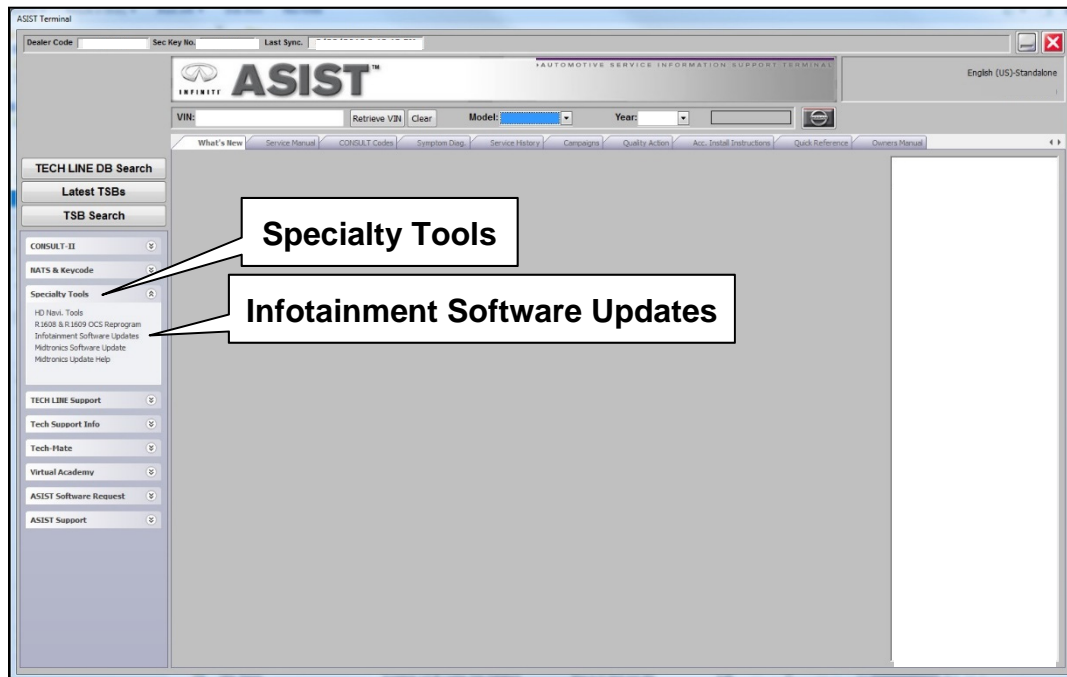
Figure 8

10. Select **Specialty Tools**, and then select **Infotainment Software Updates**.

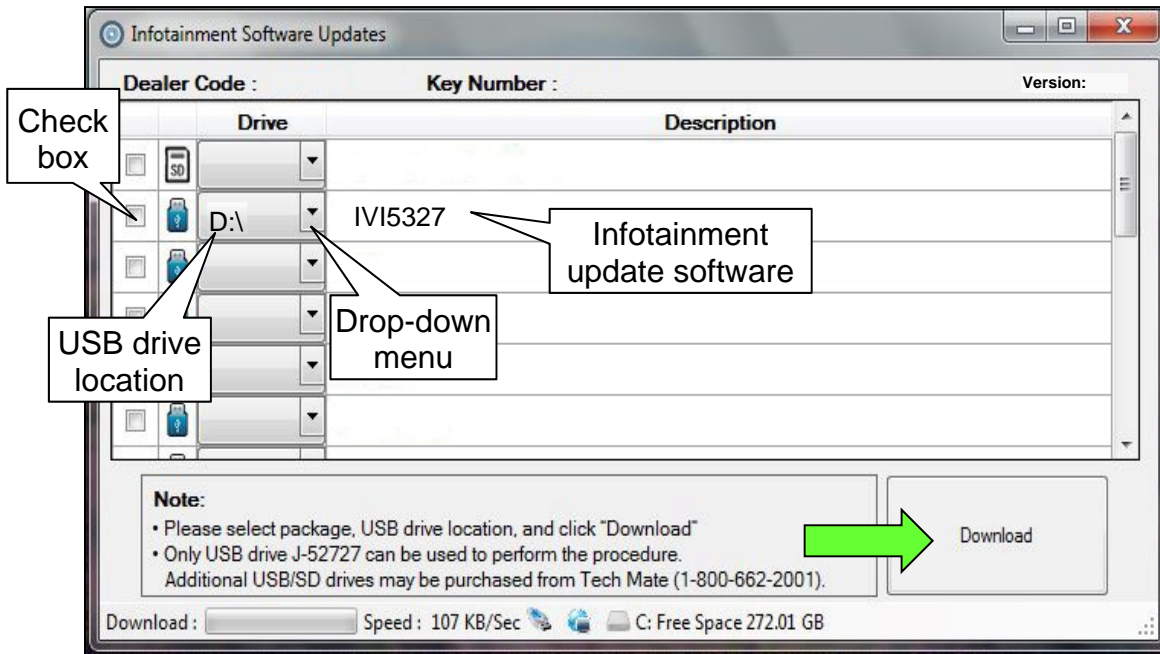
Figure 9

- Use the drop-down menu and select the location of the USB drive that was inserted in step 8 on page 7.

13. Select **Download** (Figure 9 on page 8), and then wait for the download to complete.

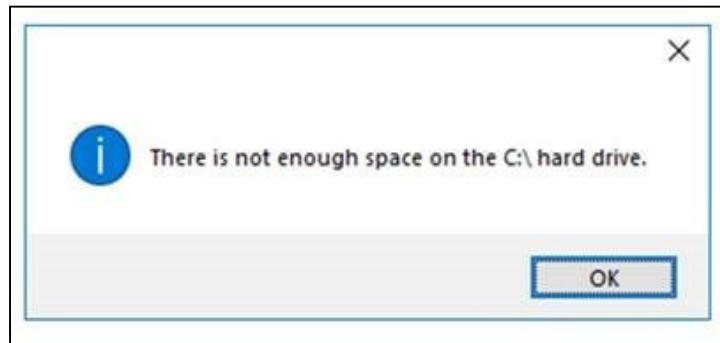
Figure 10

- The update software is estimated to take **4 hours** to download to the USB drive.
- If, while attempting to download the software to the CONSULT PC, you receive the message shown in Figure 10:
 - a. First attempt to clear space on the CONSULT PC hard drive.
 - b. If space cannot be cleared and a second CONSULT PC is available with space, use it and start over from step 8 on page 7.

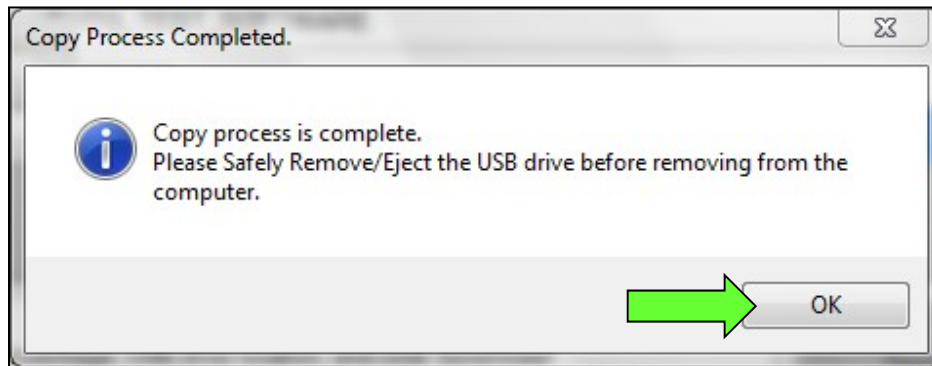
Figure 11

14. Select **OK**.

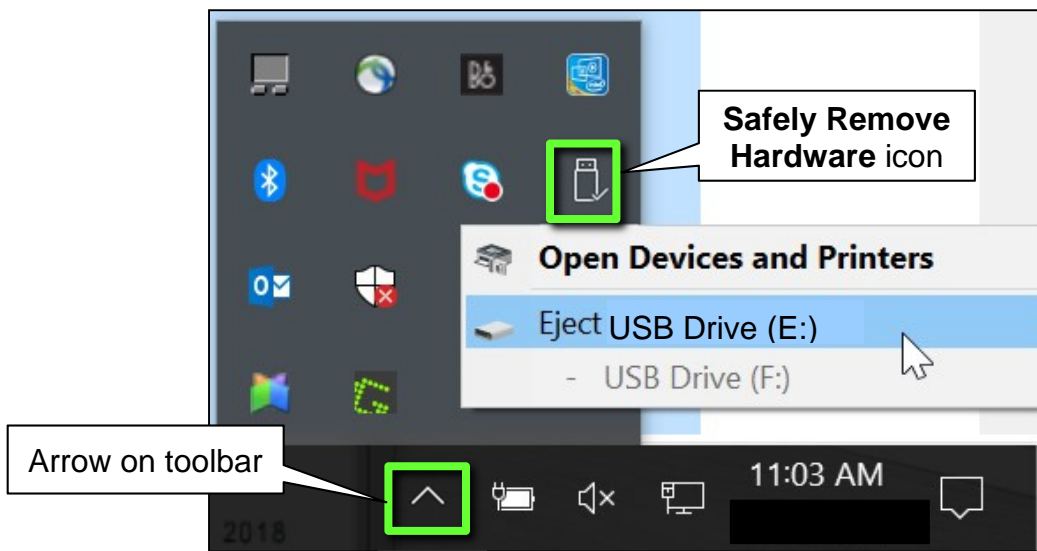
Figure 12

15. Once the transfer is complete, safely remove the USB drive from the CONSULT PC.
 - a. From the PC toolbar, select the **Safely Remove Hardware** icon.
 - The icon is on the toolbar, or can be found after selecting the arrow.
 - b. Select the USB drive to be removed, and then remove the USB drive from the CONSULT PC.

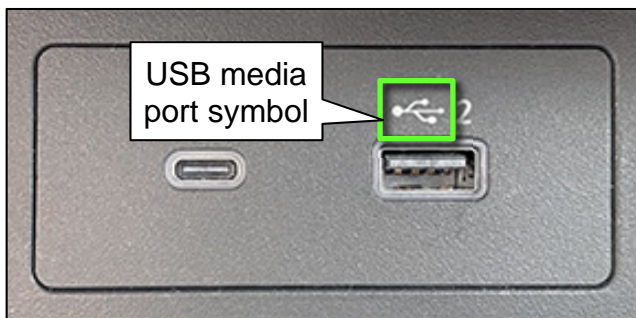
Figure 13

16. Close all ASIST **Infotainment Software Update** screens.
17. Set the parking brake.
18. Start the engine, and then wait 60 seconds for the system to load.
HINT: The engine needs to idle for the duration of the update to retain battery charge.
19. Insert the USB drive with the infotainment update software into the vehicle's USB media port (Figure 13).
 - Do not remove the USB drive during the update to the vehicle until instructed to.

Do not insert the USB drive into a charging port. If used, the update software and/or USB drive may become damaged. Only insert the USB drive in a USB media port.

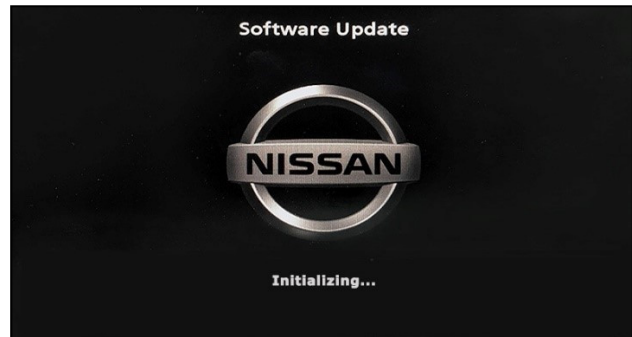
20. Wait approximately 10-30 seconds for the screen in Figure 15 to appear.

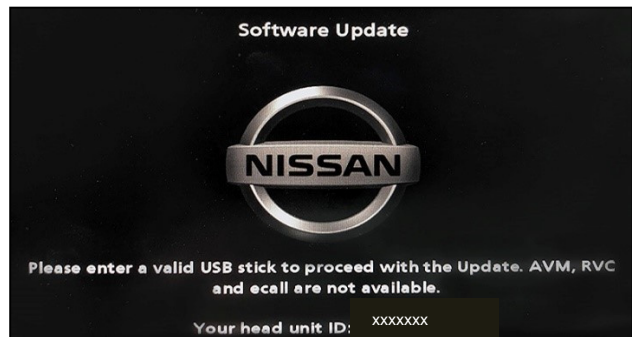
- The screen in Figure 16 may briefly appear. **Do not remove the USB drive.** The audio system will detect the USB drive and continue the update.

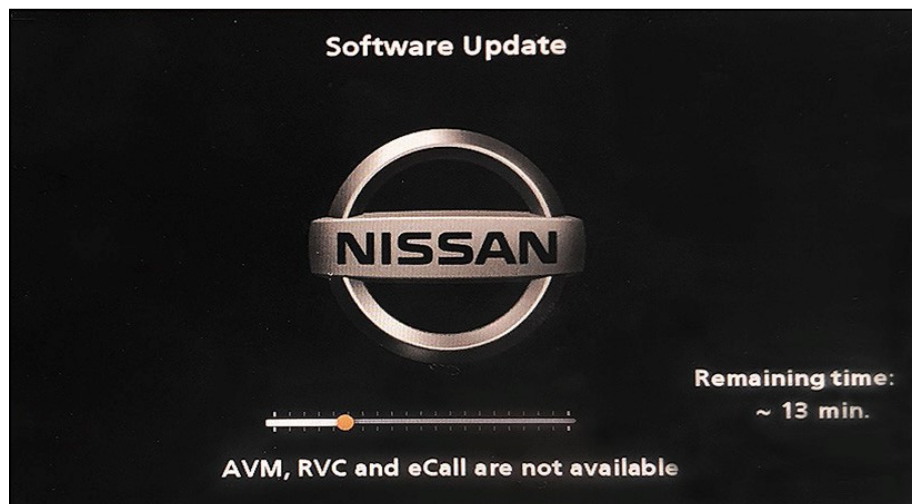
Figure 17

21. Wait for the update to complete.
- Follow the on-screen instructions while waiting.

HINT: The update may take 15-25 minutes.

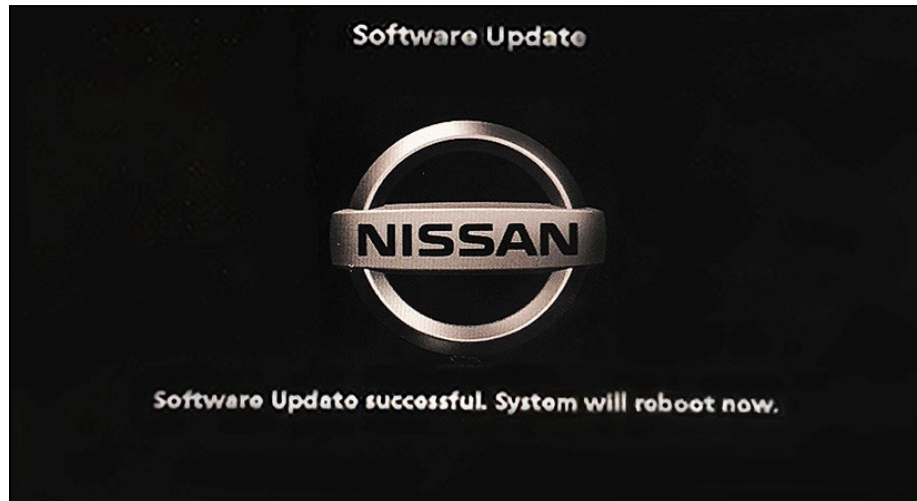
Figure 18

22. Once the update is complete (Figure 18), remove the USB drive; the system will reboot (restart).

HINT: The system will not reboot until the USB drive is removed.

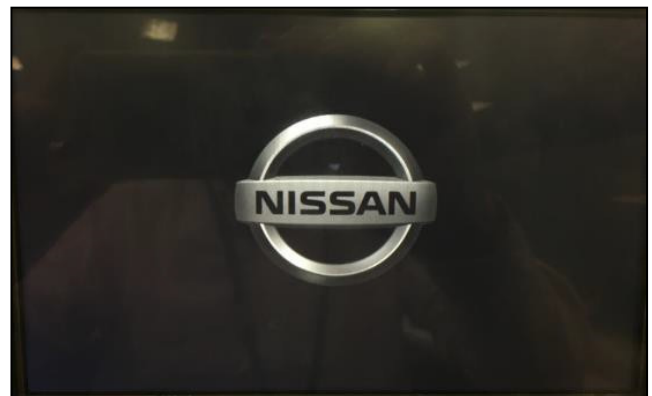
Figure 19

23. Allow the reboot to complete (approximately 30 seconds).
 - The Nissan logo will be displayed during the reboot.
24. Turn the ignition OFF.

29. Turn the ignition ON (engine OFF) and wait for the Nissan logo to appear (Figure 19 on page 13).
 - If the Nissan logo does not appear (this might take up to 30 seconds), start over from step 24 on page 13.

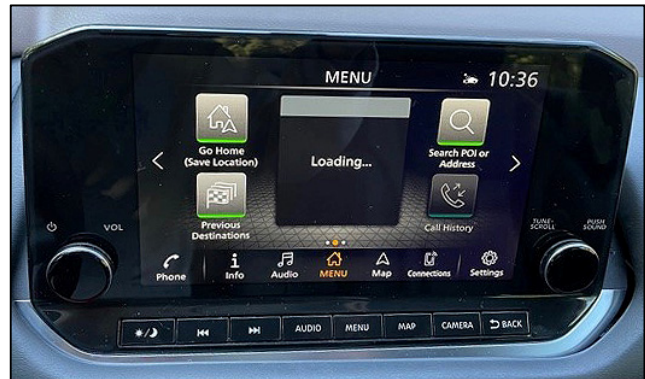
30. After the Nissan logo appears, wait about 1 minute.
 - The MENU (Home) screen in Figure 20 will be displayed.
