# VOLUNTARY RECALL CAMPAIGN

## VOLUNTARY SAFETY RECALL CAMPAIGN INFOTAINMENT SYSTEM REBOOTS EVERY 4-5 MINUTES

**CAMPAIGN ID #:** PC901  
**APPLIED VEHICLES:** 2022 Frontier (D41)  
2022 Pathfinder (R53)  
2021-2022 Rogue (T33)  
2022 Titan (A61)

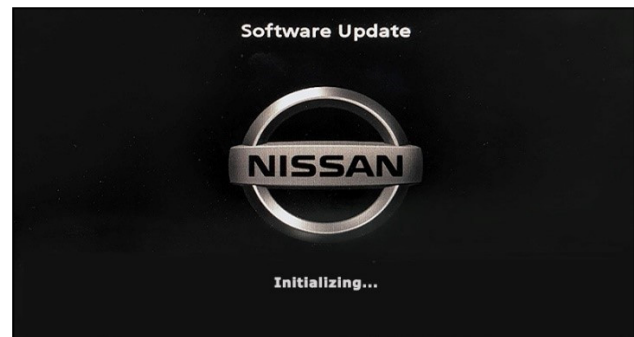
12. Wait approximately 10-30 seconds for the screen in Figure 9 to appear.

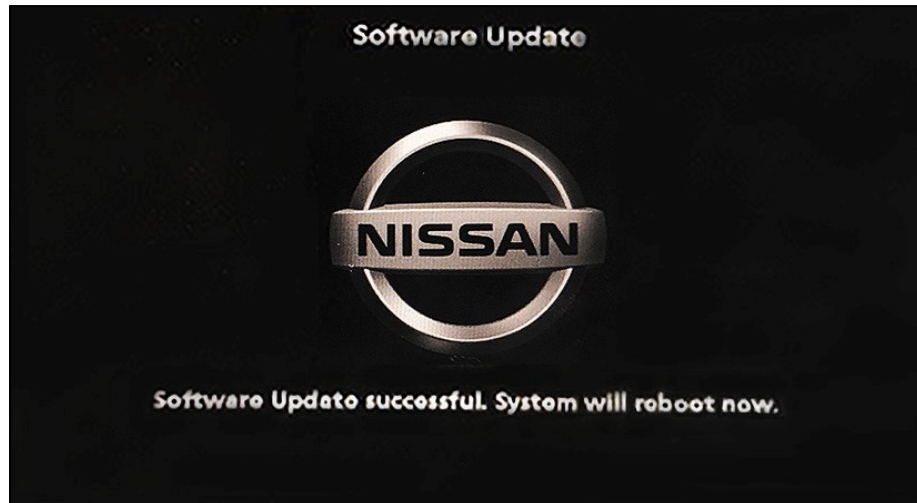
Figure 12

14. Once the update is complete (Figure 12), remove the USB drive; the system will reboot (restart).

**HINT:** The system will not reboot until the USB drive is removed.
