# SAFETY RECALL BULLETIN

SUBJECT:			No: <b>SR-22-004</b>
<b>INAPPROPRIATE CVT ECU SOFTWARE PROGRAMMING – SAFETY RECALL CAMPAIGN</b>			IATE: <b>AUGUST 2022</b>
			MODEL: <b>SEE BELOW</b>
<b>CIRCULATE TO:</b>	<input checked="" type="checkbox"/> GENERAL MANAGER	<input checked="" type="checkbox"/> PARTS MANAGER	<input checked="" type="checkbox"/> TECHNICIAN
<input checked="" type="checkbox"/> SERVICE ADVISOR	<input checked="" type="checkbox"/> SERVICE MANAGER	<input checked="" type="checkbox"/> WARRANTY PROCESSOR	<input checked="" type="checkbox"/> SALES MANAGER

This Campaign Bulletin provides instructions to reprogram the CVT-ECU with updated software.

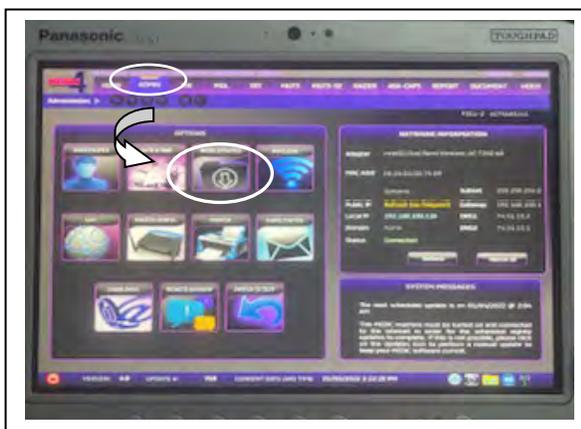
3. Select the MEDIC 3.5/4 Admin tab and click on "Updates".

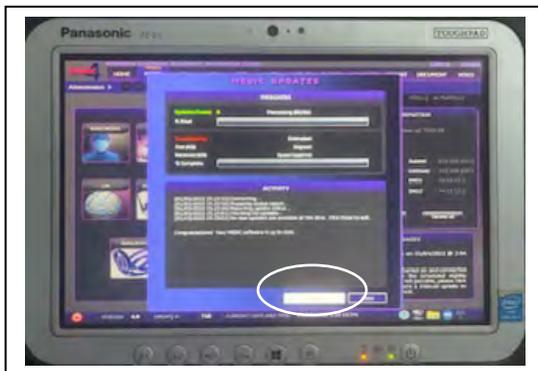
4. If the MEDIC update screen advises updates are available, click the "Begin" button. After all updates are complete, **GO TO THE REPROGRAMMING PROCEDURE.**

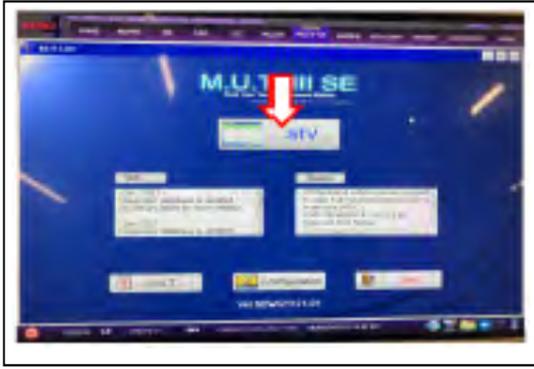
- a. Press the MUT-III SE STV icon.

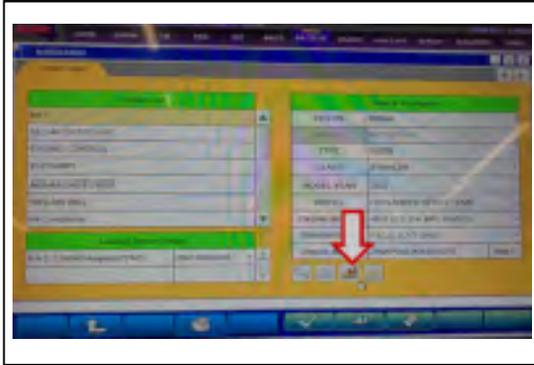
- b. Press the ECU Reprogramming button.

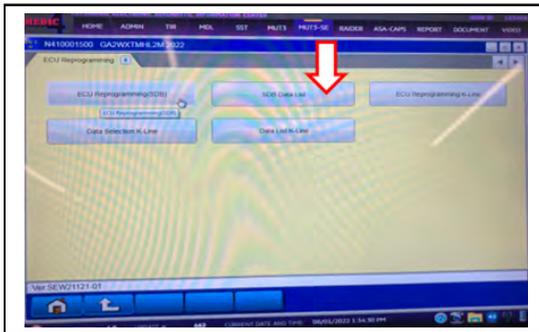
- c. Press SDB Data List, select the reprogramming data system and press the OK button.

- d. Confirm that the database number displayed in the upper right above the chart is **N220701** or higher.

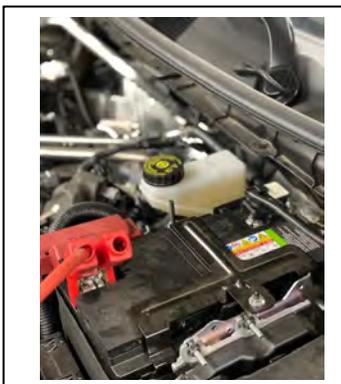
**NOTE:** Due to limited space it may be easiest to connect the battery charger cable onto ground point.

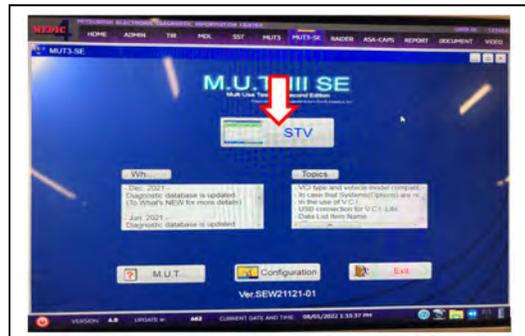
- Using MEDIC, from the main page, click the "MUT-III SE STV" icon at the top center of the screen to open MUT-III SE.

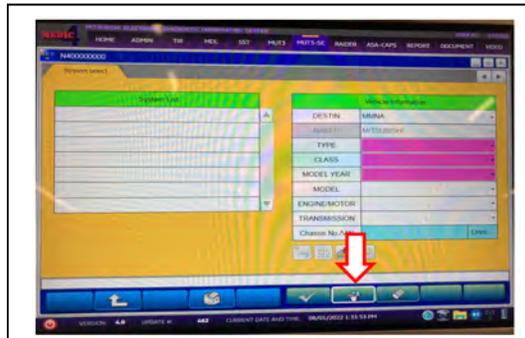
- Press the Model Information Display button (car icon) and verify that all of the vehicle information is correct.

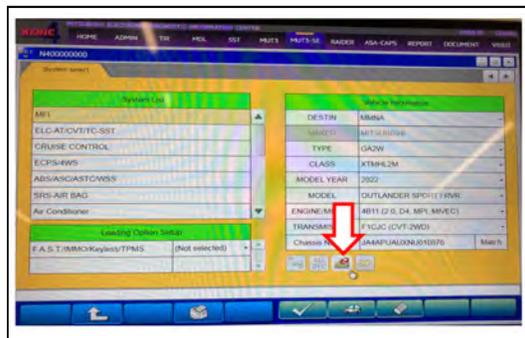
- Press the Reprogramming icon.

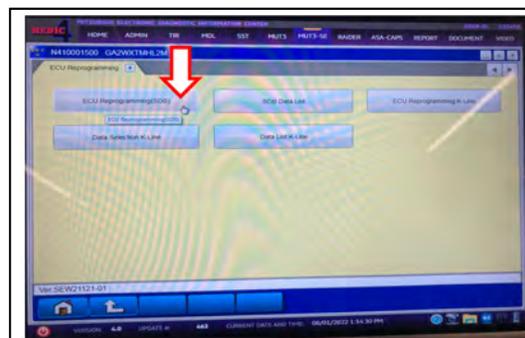
- Press on ECU Reprogramming (SDB).

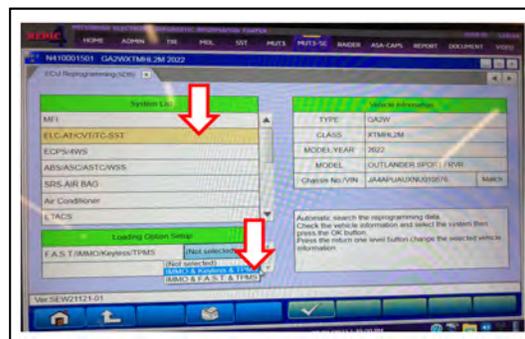
- Press ELC-AT/CVT/TC-SST from the System list and then the IMMO & Keyless & TPMS from the Loading Option Setup.

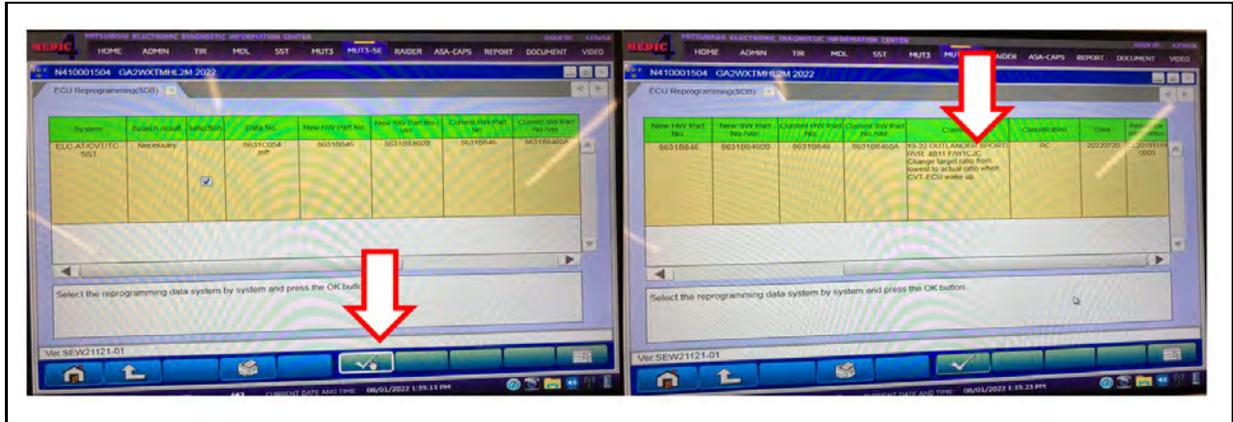
8. The Automatic ECU Reprogramming (SDB) database screen will display.
  - Verify that the NEW ECU Software (2019–2022 Outlander Sport/RVR 4B11 F/W1CJC. Change target ratio from lowest to actual ratio when CVT-ECU wake up.) Refer to the Software Chart on page 1 if necessary.)
  - Press the OK button.

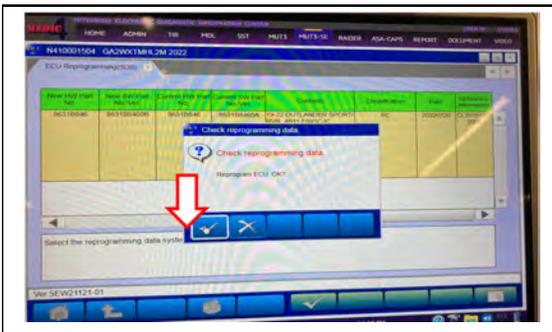
9. Press the OK button to start reprogramming.

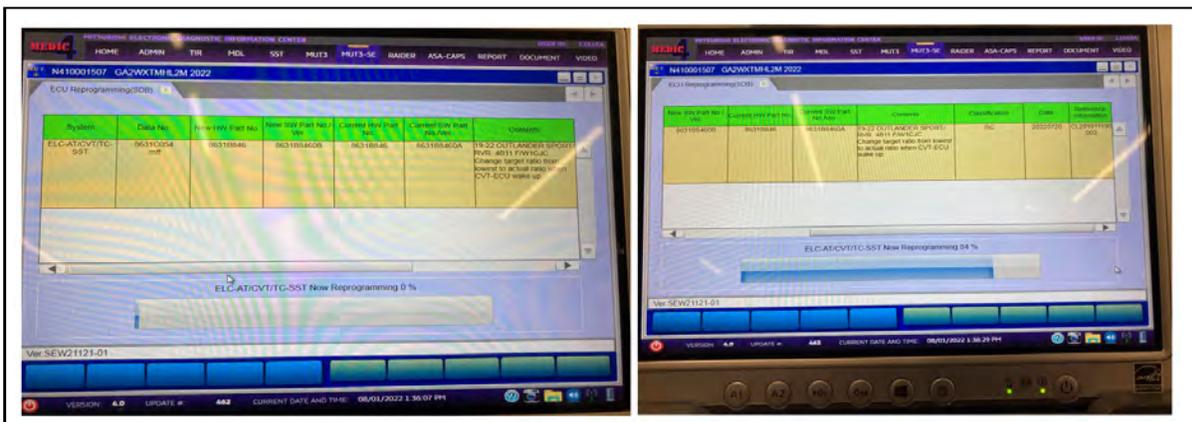
10. Once the reprogramming is initiated, the screen will indicate the reprogramming progress. It may take 4-5 minutes to complete.

**NOTE:** Do not disturb the cables or turn off the ignition during reprogramming to prevent damage to the ECU.

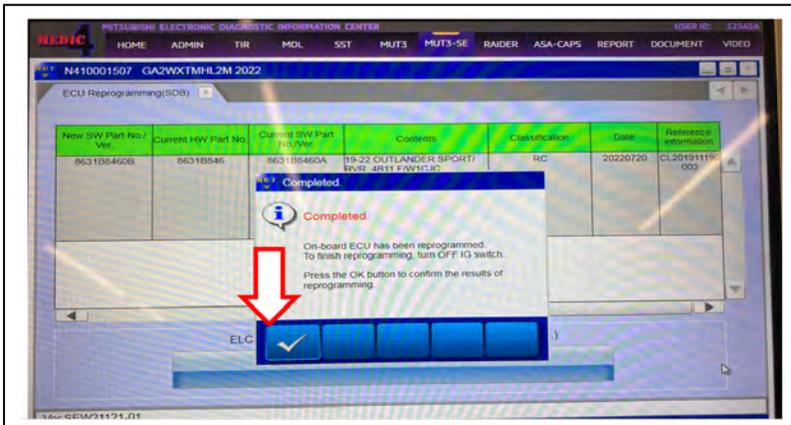
11. Once reprogramming is completed, turn the ignition switch to OFF and then press the OK button to confirm the reprogramming results.

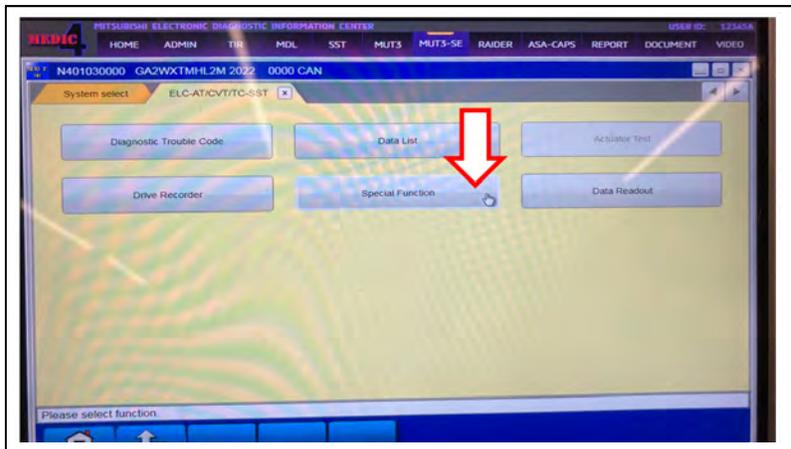
12. Software Verification Procedure: Turn the ignition switch back into the ON position and press the Special Function under the ELC-AT/CVT/TC-SST.

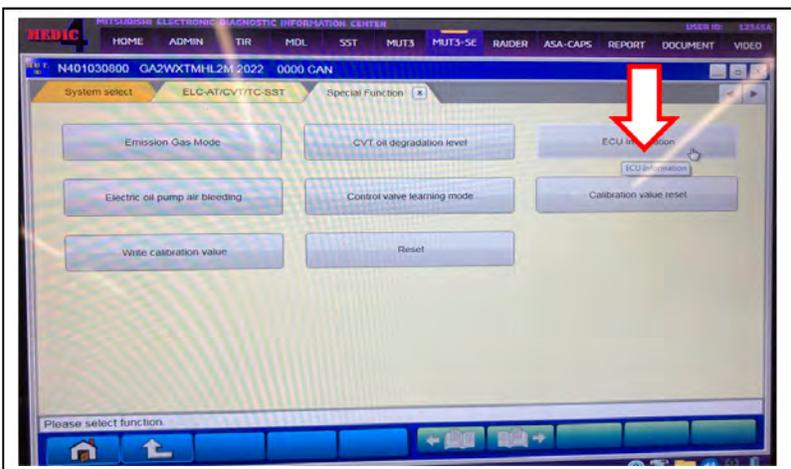
13. Press ECU information found under Special Function.

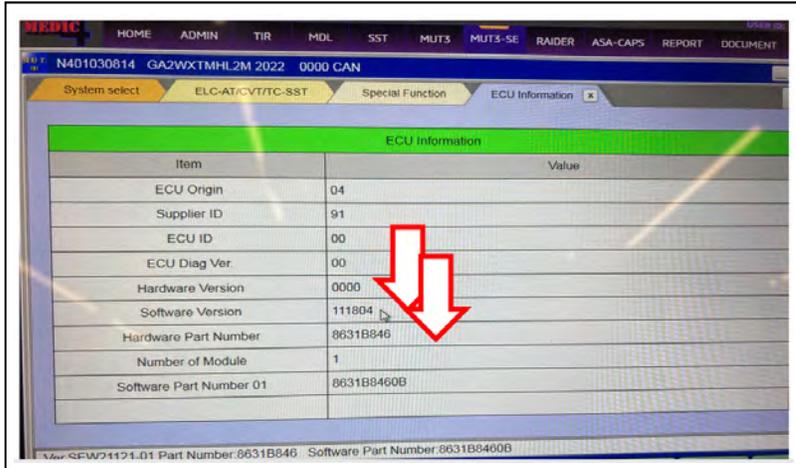
14. Verify that the Software Version has been updated from 111803 or 111903 to 111804 or 111904.

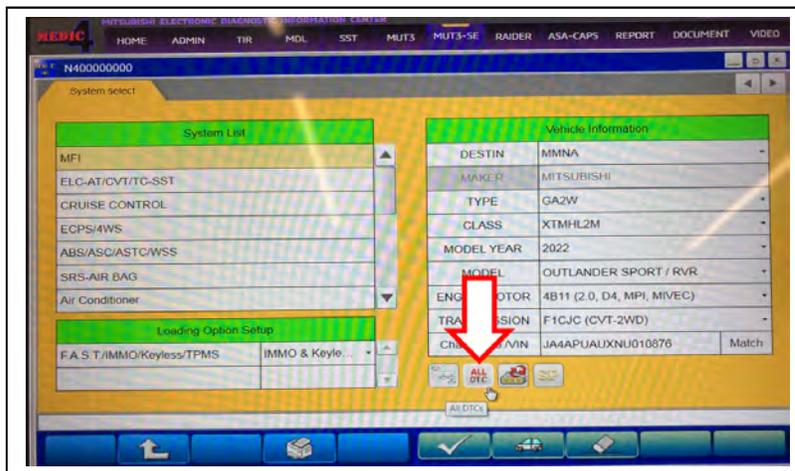
15. Press the ALL DTC button.

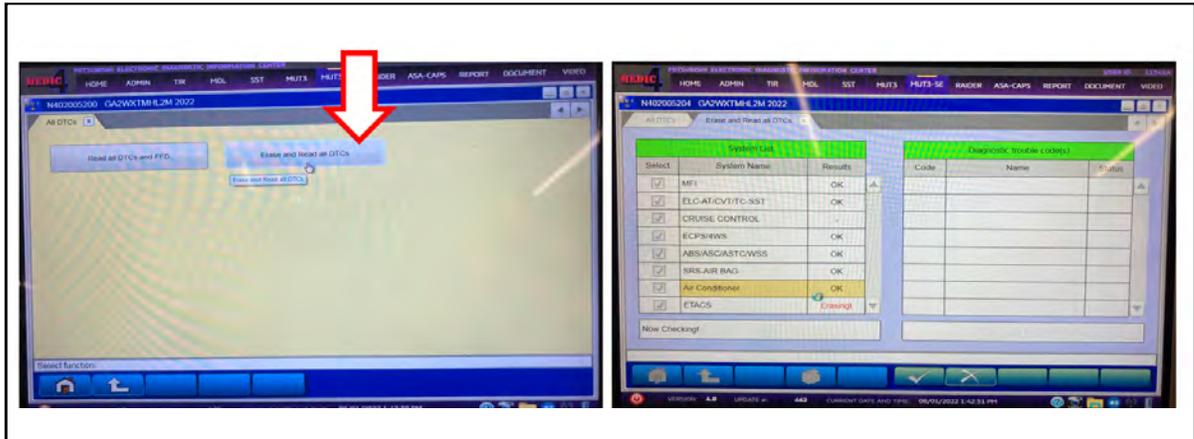
16. Press the Erase and Read all DTCs button to initiate DTC confirmation.

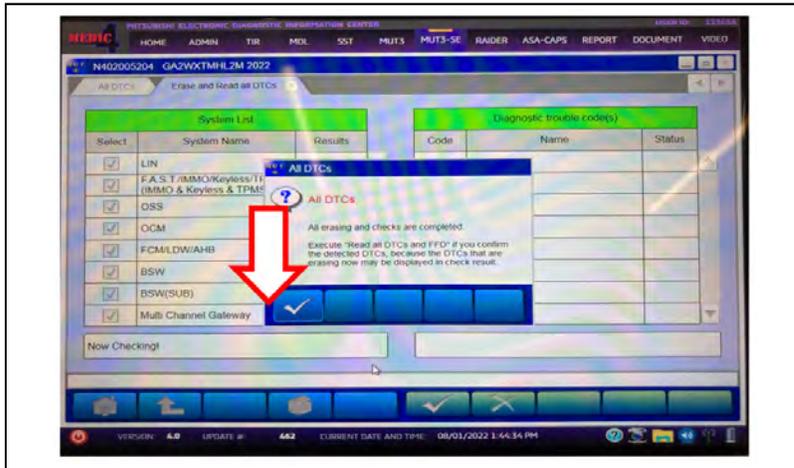
17. Press the OK button to erase all DTCs.

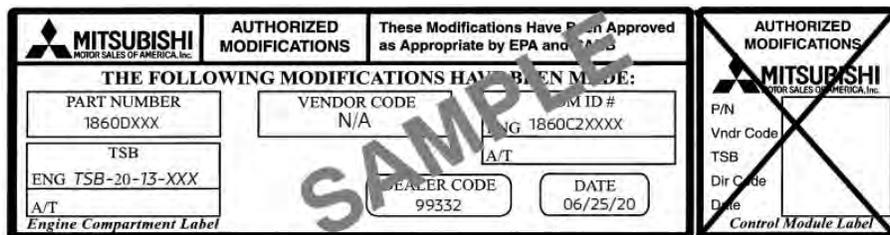
18. Using a ball-point pen, enter the appropriate ECU part number, Software Part Number (ROM ID#), this Technical Service Bulletin number, your dealer code, and the current date on the Engine Compartment/Control Module Label (p/n MSSF024G00). The Vendor Code is not applicable. The label is available from your facing PDC.
