October 2022

Dealer Service Instructions for:

Safety Recall Z86 / NHTSA 22V-638 Rear View Camera

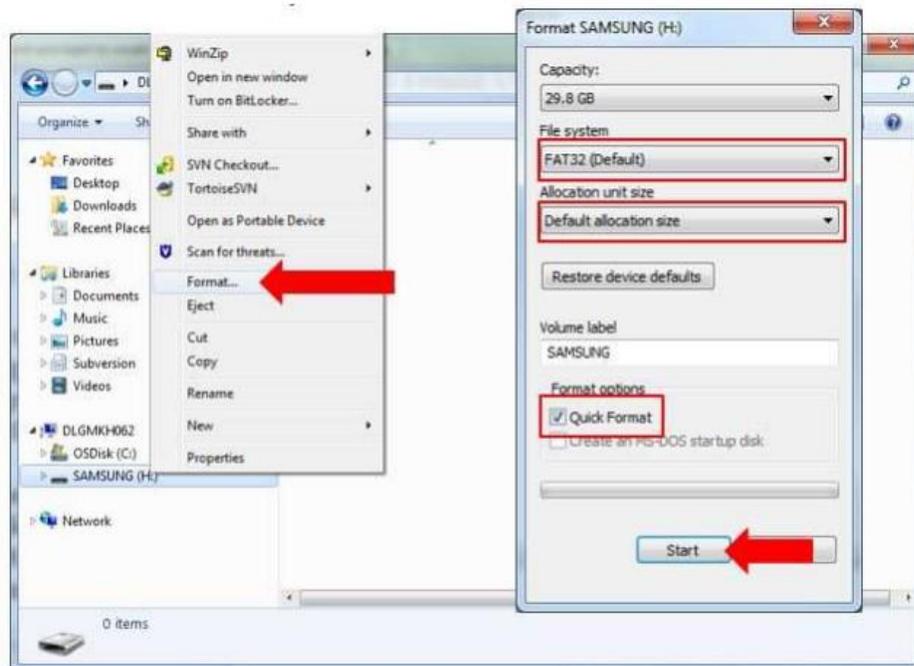
Figure 1 – Formatting the USB Flash Drive

2. Perform the following steps to format the USB flash drive (Figure 1):

- a) Select “FAT32” format.
- b) Select “Default allocation size” under Allocation Unit Size.
- c) Select “Quick Format” under Format Options.
- d) Click “Start”.

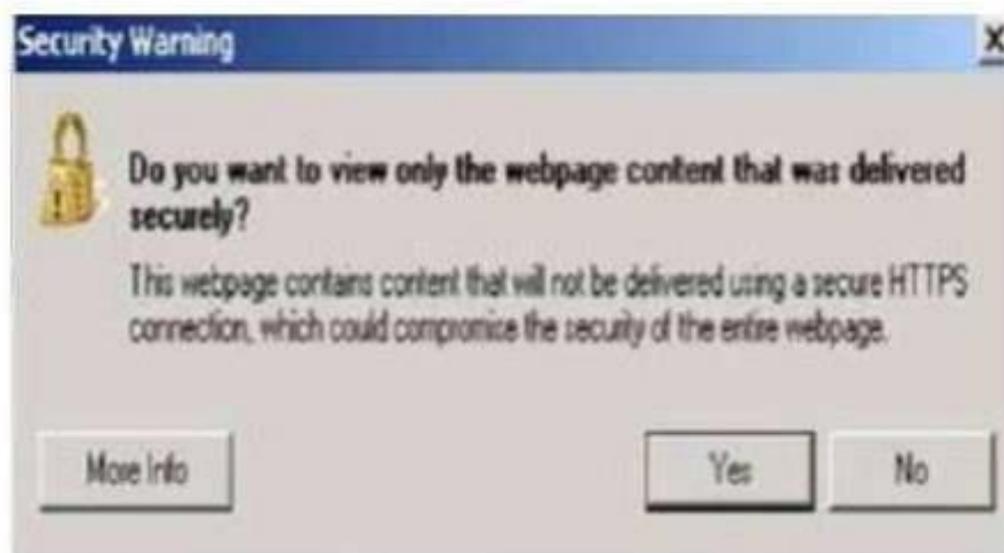
Figure 2 – Pop-Up Security Message

3. Go to DealerCONNECT>Service>Uconnect Command Center>Uconnect>More Information>Dealer software downloads to download the files.
4. If a security message appears “Do you want to view only the web page content that was delivered securely?” (Figure 2). Press “No” to continue.

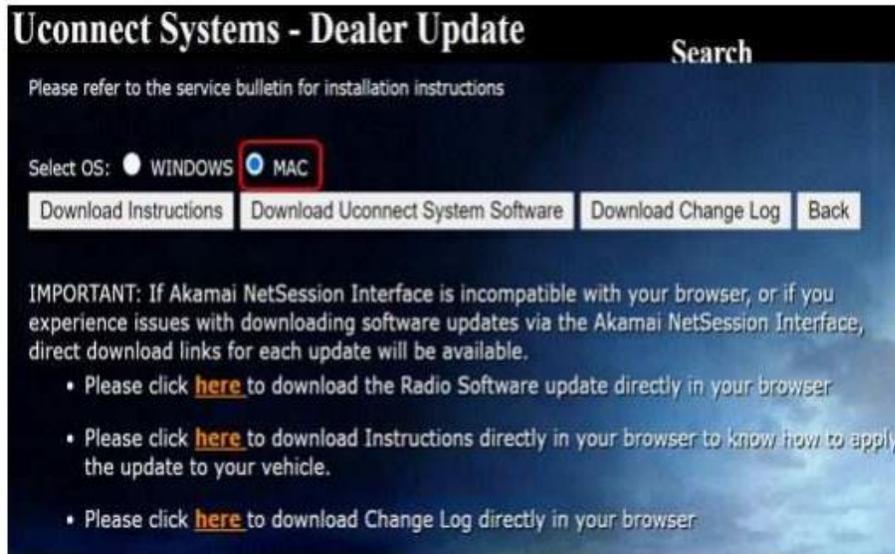
Figure 3 – MAC Download Steps

6. Download the software update file to your local PC’s desktop. Make sure to select the “MAC” radial button for all downloads (Figure 3).

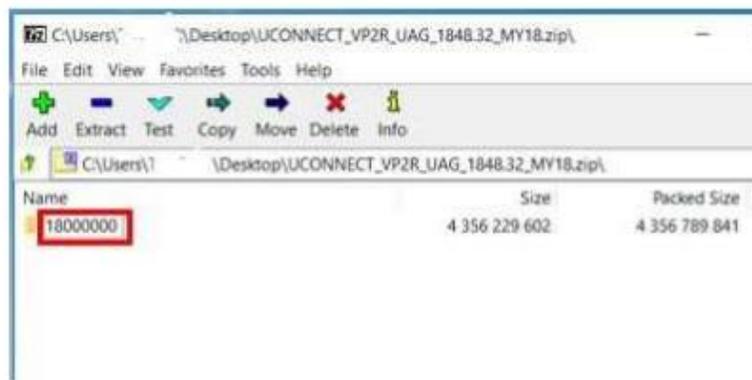
Figure 4 – Extracted File

7. Be sure to download the file to your PC’s desktop and open it (Figure 4).

NOTE: The USB should only contain a folder labeled “18000000” on it after files are extracted to it.

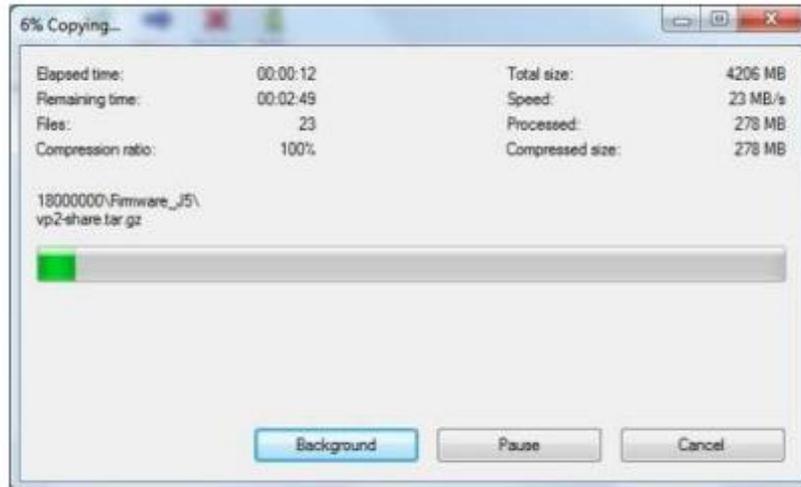
Figure 5 – Extract File to USB

8. Extract the downloaded file to the USB flash drive (Figure 5).

NOTE: It may take a few minutes for an accurate extraction time to be displayed.

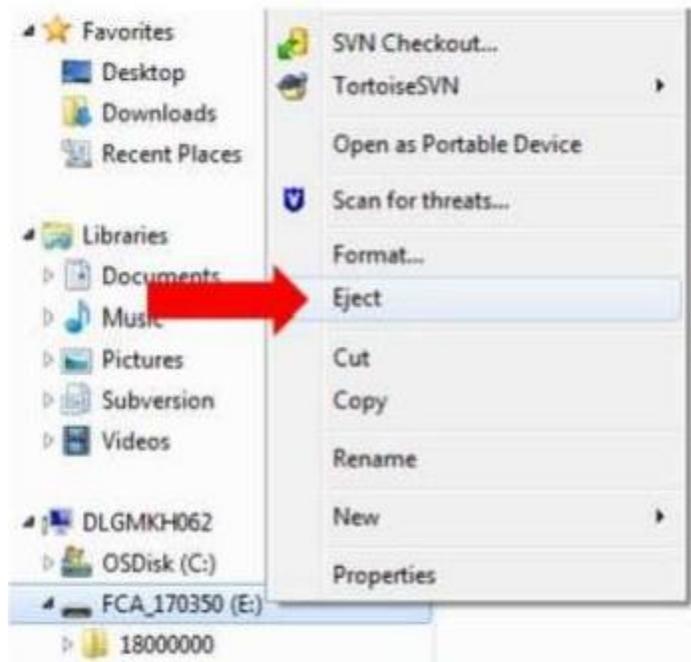
Figure 6 – Ejecting the USB Flash Drive

10. Perform the following steps to properly eject the USB flash drive (Figure 6):
- Right click on the location of the USB flash drive.
 - Click “Eject” to avoid data corruption.
 - Remove the USB flash drive from the PC.

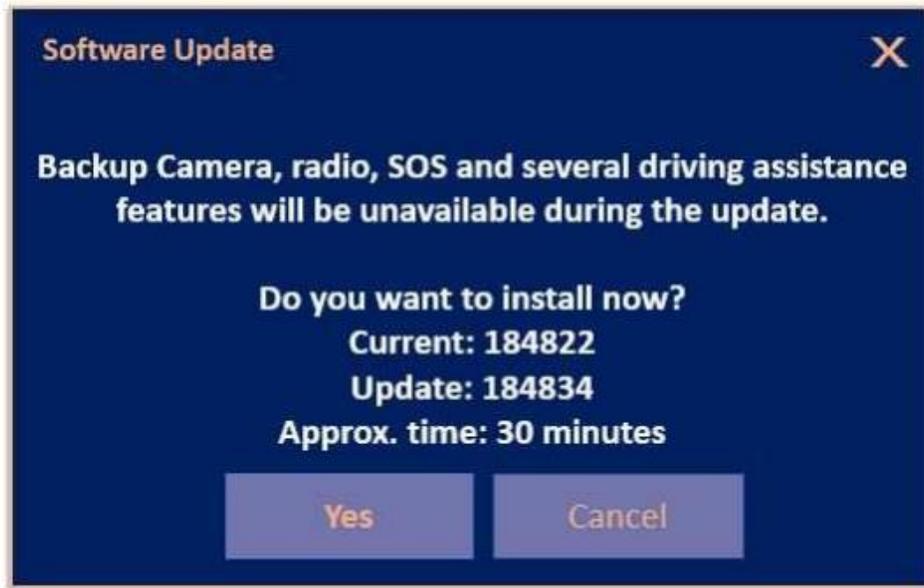
Figure 7 – Update Ready to Install

16. Press “Yes” to start the update. The software update takes approximately 30 minutes to complete (Figure 7).

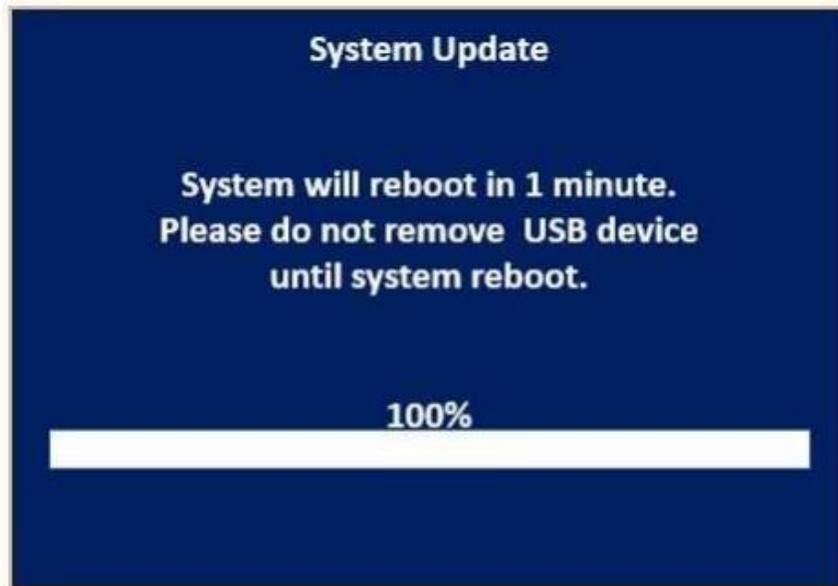
Figure 8 – Do Not Remove Flash Drive

NOTE: Do not remove the USB flash drive before you are instructed to (Figure 8).

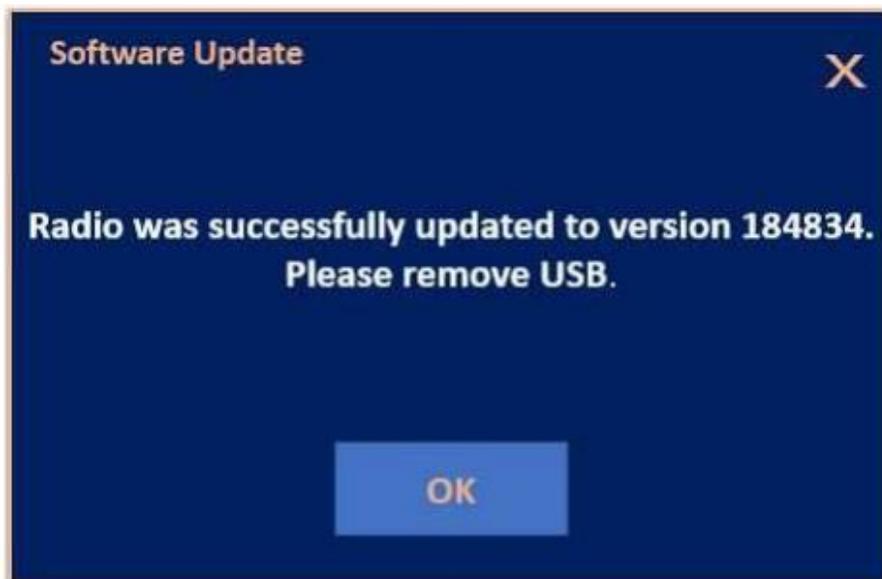
Figure 9 – Update Successful Screen

18. Wait for the "Radio was successfully updated" screen (Figure 9).

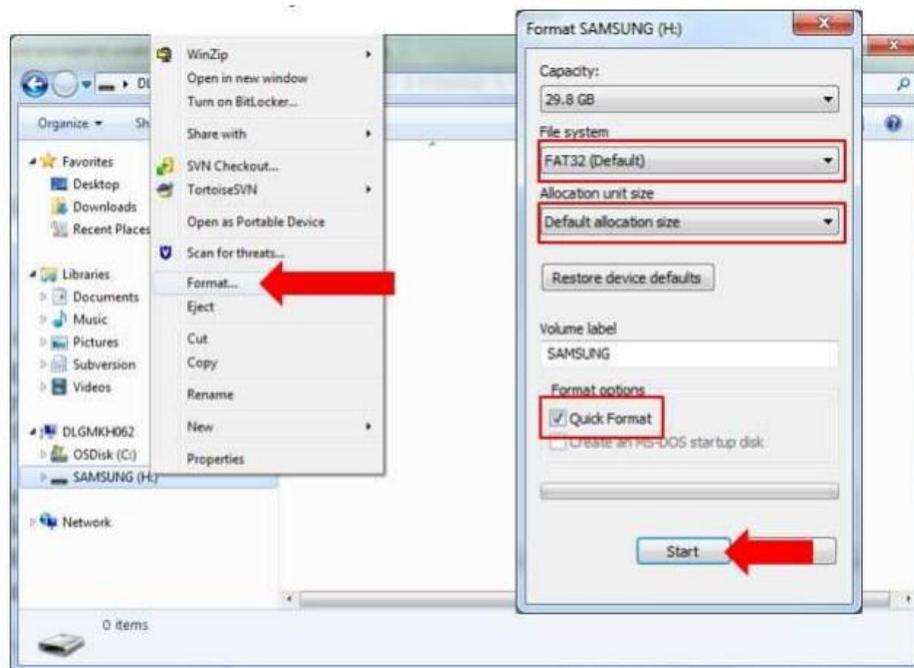
Figure 1 – Formatting the USB Flash Drive

2. Perform the following steps to format the USB flash drive (Figure 1):

- e) Select “FAT32” format.
- f) Select “Default allocation size” under Allocation Unit Size.
- g) Select “Quick Format” under Format Options.
- h) Click “Start”.

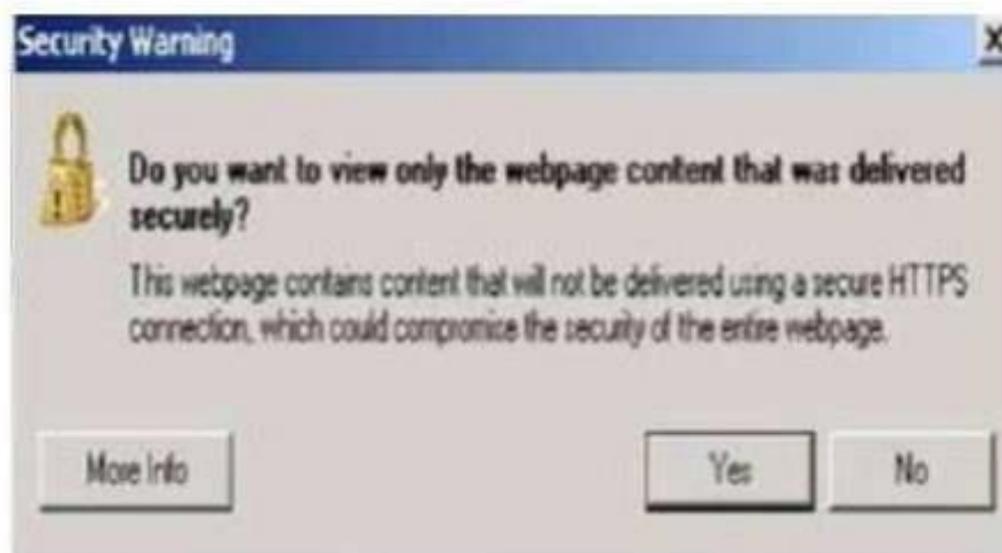
Figure 2 – Pop-Up Security Message

3. Go to DealerCONNECT>Service>Uconnect Command Center>Uconnect>More Information>Dealer software downloads to download the files.
4. If a security message appears “Do you want to view only the web page content that was delivered securely?” (Figure 2). Press “No” to continue.

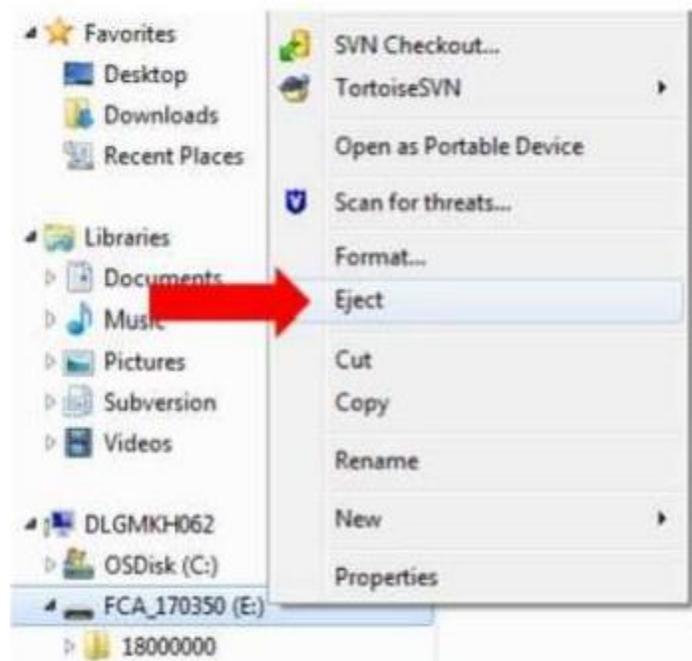
Figure 6 – Ejecting the USB Flash Drive

10. Perform the following steps to properly eject the USB flash drive (Figure 6):

- d) Right click on the location of the USB flash drive.
- e) Click “Eject” to avoid data corruption.
- f) Remove the USB flash drive from the PC.

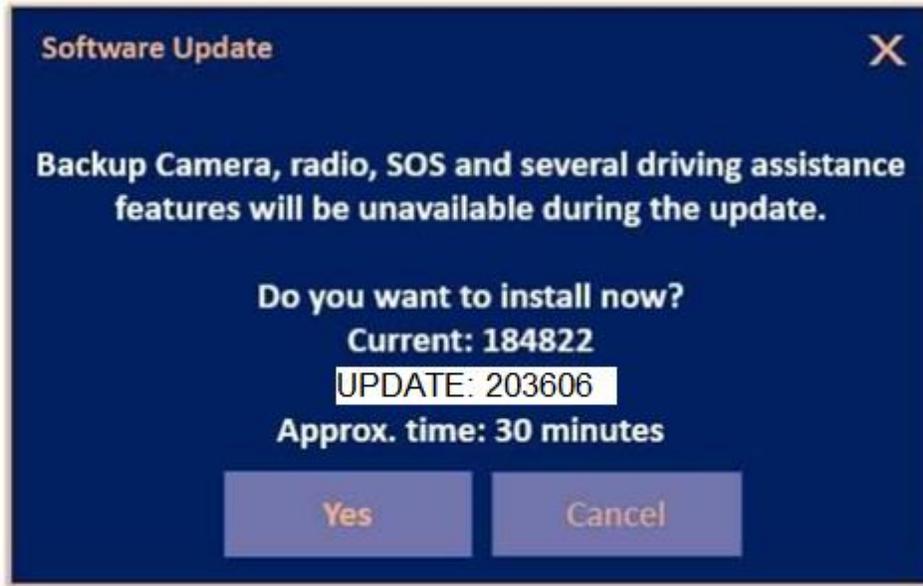
Figure 7 – Update Ready to Install

16. Press “Yes” to start the update. The software update takes approximately 30 minutes to complete (Figure 7).

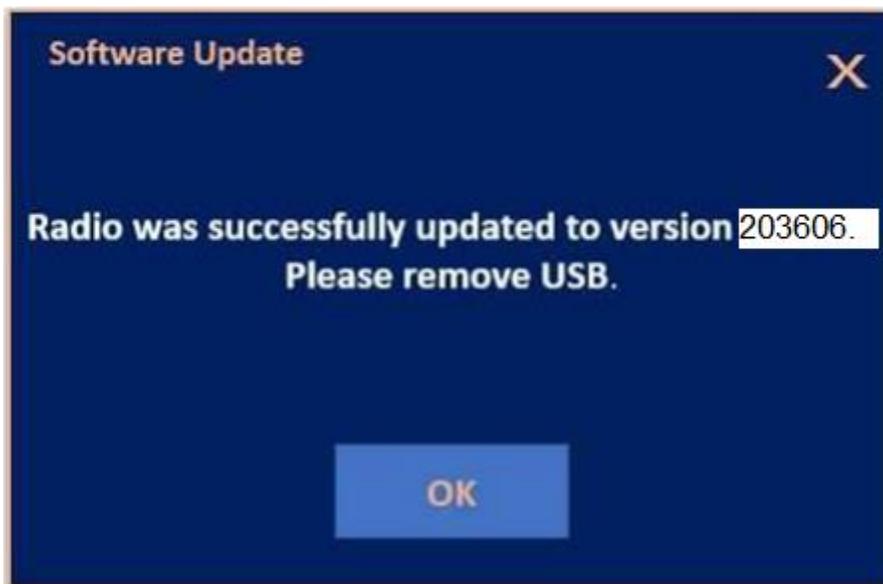
Figure 9 – Update Successful Screen

18. Wait for the "Radio was successfully updated" screen (Figure 9).
