**TECHNICAL INSTRUCTIONS
FOR
SAFETY (NONCOMPLIANCE) RECALL 22TA11**

Electronic Parking Brake (EPB) May Not Engage or Disengage Properly

Certain 2022 Model Year Tundra

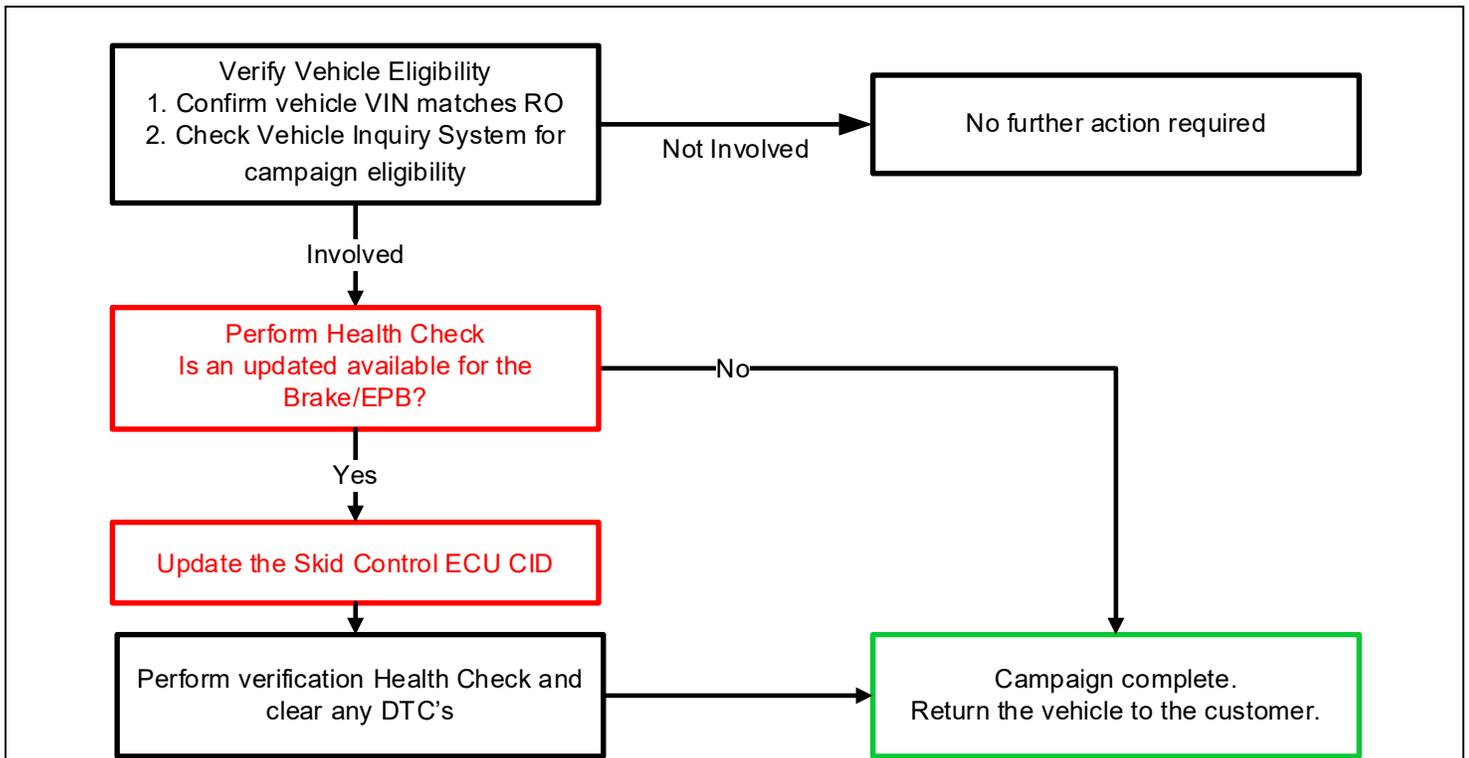
I. OPERATION FLOW CHART

The flow chart is for reference only. **DO NOT** use it in place of the full technical instructions. Follow **ALL** steps as outlined in the full technical instructions to confirm the campaign is completed correctly.

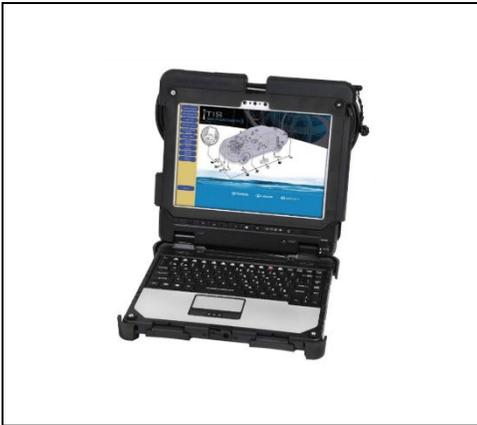
1. CHECK FOR DTC'S

- Using a Techstream, perform a Health Check to check for any Diagnostic Trouble Codes.
- If you see the following DTC's the vehicle may have experienced this concern and may be remedied with the software update.

C061000	Right Electric Parking Brake Actuator Control
C060B00	Left Electric Parking Brake Actuator Control

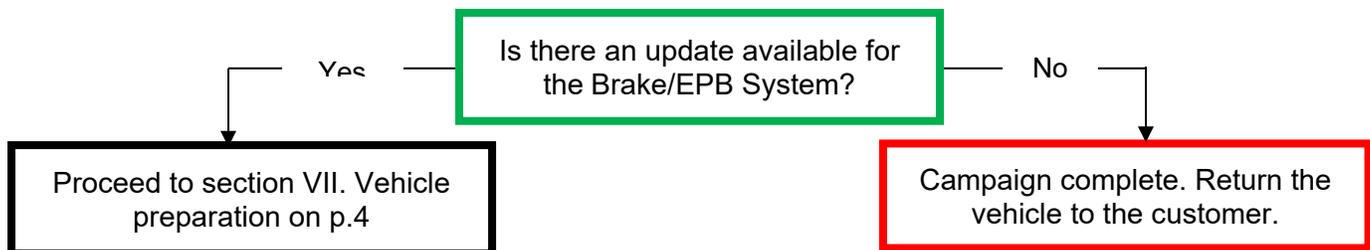
- Locate the Update column for the Brake/EPB System in the Stored Data tab for this vehicle.
- Determine the status of an available update; indicated by a YES or NO.

If the CID's indicate 'Yes', proceed with the update procedure.

System	RoB	Calibration	Update	Configure
Brake/EPB	●	*****	Yes	No
8A270F602100	●	8A270F602100	No	No
897AF0201100	●	897AF0201100	No	No
8679F7816001	●	8679F7816001	No	No
8679F7824011	●	8679F7824011	No	No
8679F7816021	●	8679F7816021	No	No
8646F7805400	●	8646F7805400	No	No
8821F7801100	●	8821F7801100	No	No
8934F7817040	●	8934F7817040	No	No

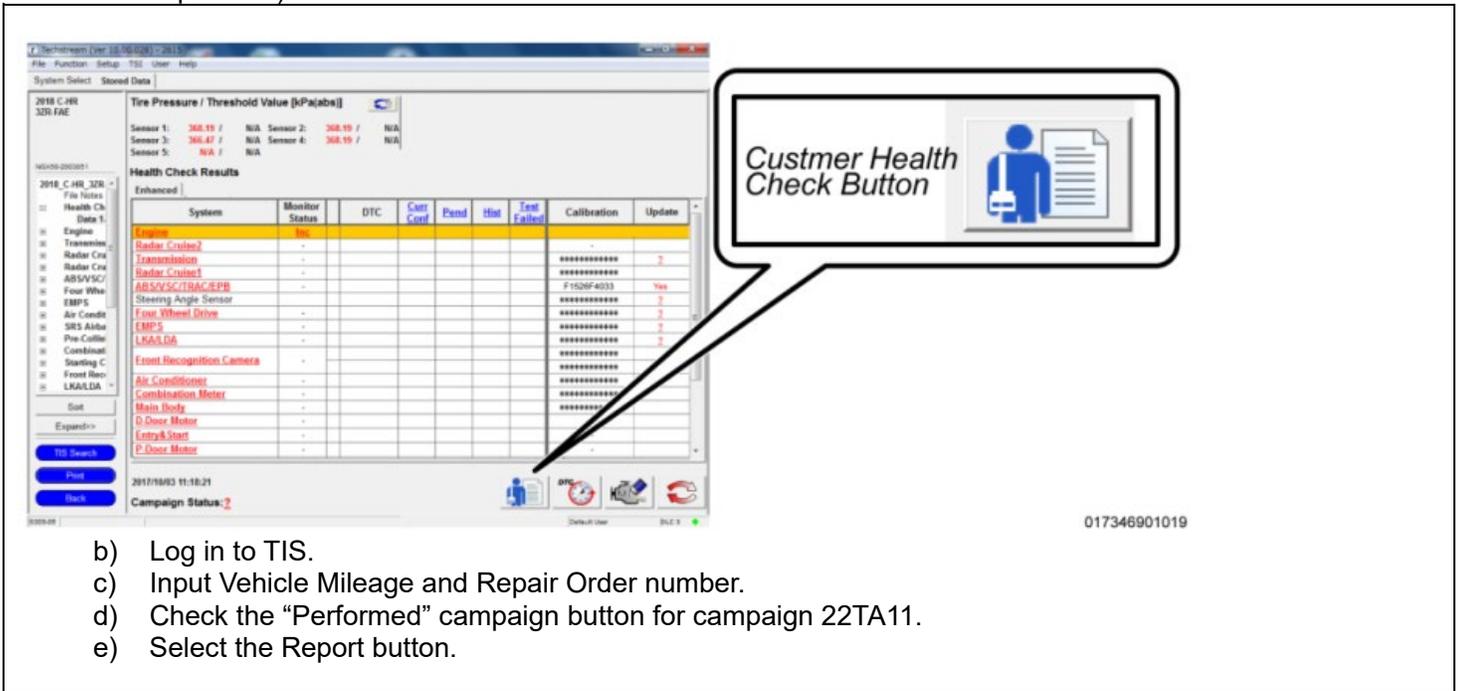
- a) From the Stored Data tab, select the Customer Health Check Report button (TIS will launch when button is pressed).

The screenshot shows the Techstream software interface. The 'Health Check Results' window is open, displaying a table of system health checks. A callout box highlights a button labeled 'Customer Health Check Button' with an icon of a person holding a clipboard. Below the screenshot, the following steps are listed:

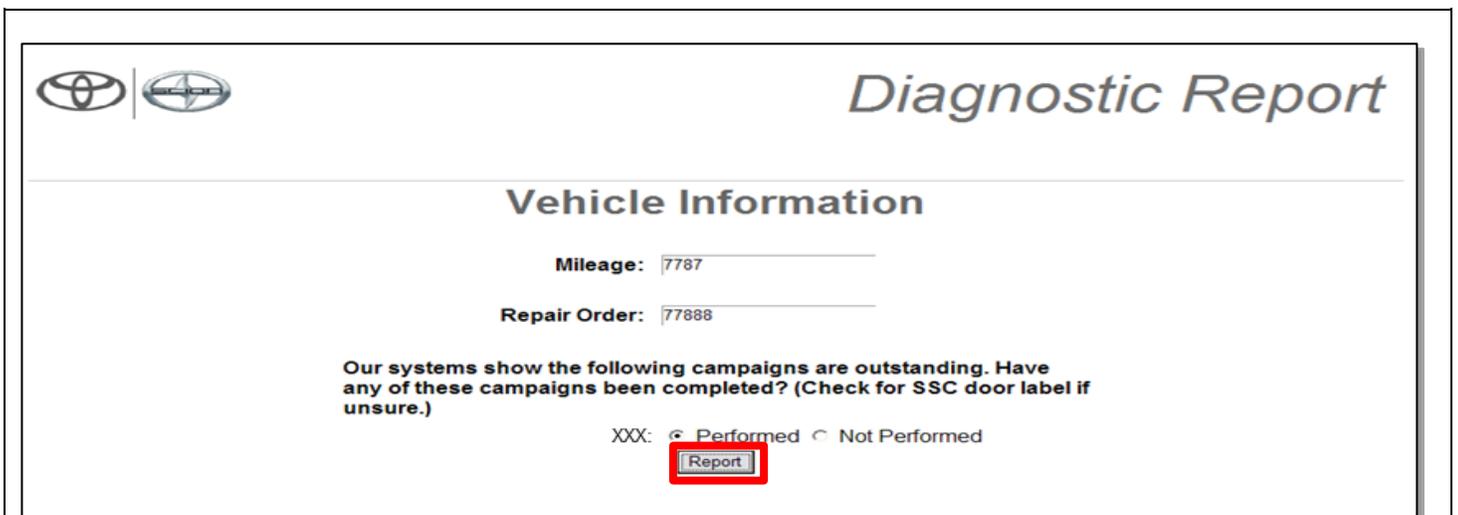
- b) Log in to TIS.
- c) Input Vehicle Mileage and Repair Order number.
- d) Check the "Performed" campaign button for campaign 22TA11.
- e) Select the Report button.

The screenshot shows the Diagnostic Report form. It includes the Toyota logo and the title 'Diagnostic Report'. Under the 'Vehicle Information' section, the Mileage is 7767 and the Repair Order is 77888. Below this, there is a question: 'Our systems show the following campaigns are outstanding. Have any of these campaigns been completed? (Check for SSC door label if unsure.)' with radio buttons for 'Performed' (selected) and 'Not Performed'. A 'Report' button is highlighted with a red box.
