VOLUNTARY RECALL CAMPAIGN

VOLUNTARY SAFETY RECALL CAMPAIGN 2023 Z; TCM REPROGRAM

CAMPAIGN ID #: R22B2
APPLIED VEHICLES: 2023 Z (Z34)

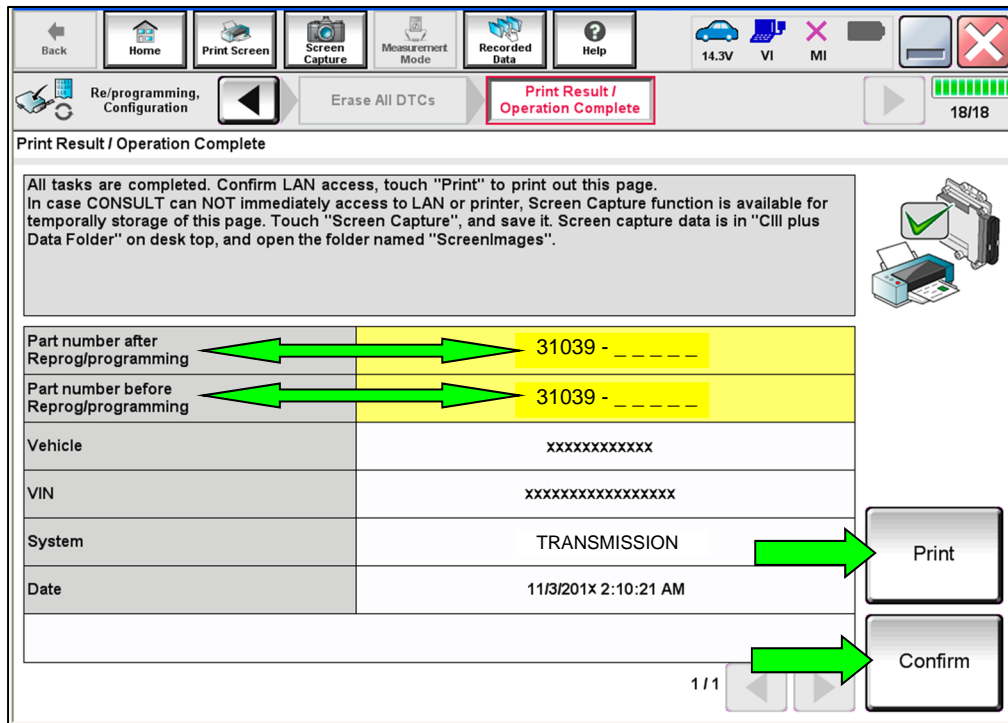
18. Follow the on-screen instructions to **Erase All DTCs**.
 - When the entire reprogramming process is complete, the screen in Figure 15 will display.
19. Verify the before and after part numbers are different.
20. Print a copy of this screen (Figure 15) and attach it to the repair order for warranty documentation.
21. Select **Confirm**.
