VOLUNTARY RECALL CAMPAIGN

VOLUNTARY SAFETY RECALL CAMPAIGN 2020-2022 FRONTIER; TCM REPROGRAM

CAMPAIGN ID #: R22A9, R22B1
APPLIED VEHICLES: 2020-2021 Frontier (D40)
2022 Frontier (D41)

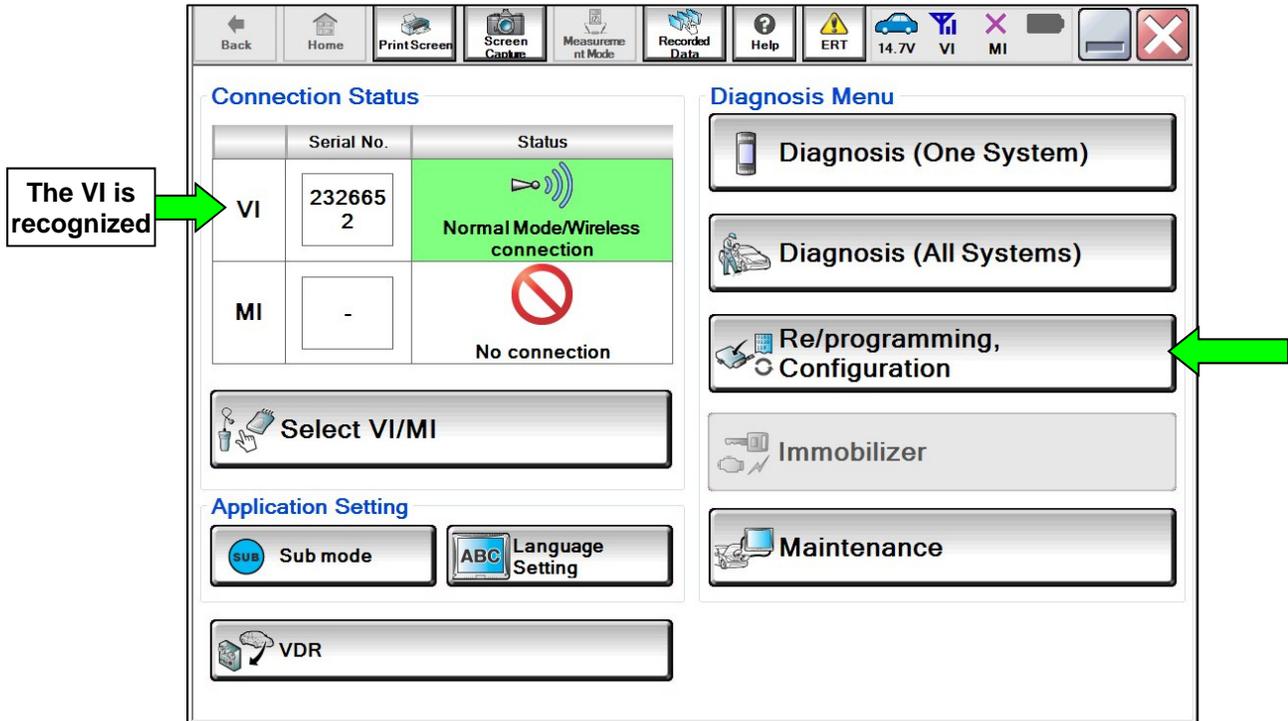
Figure 1

1. Connect the VI to the vehicle.
 2. Start C-III plus.
 3. Wait for the VI to be recognized (Figure 1 on page 4).
 - The serial number will display when the VI is recognized.

4. Select Re/programming, Configuration.

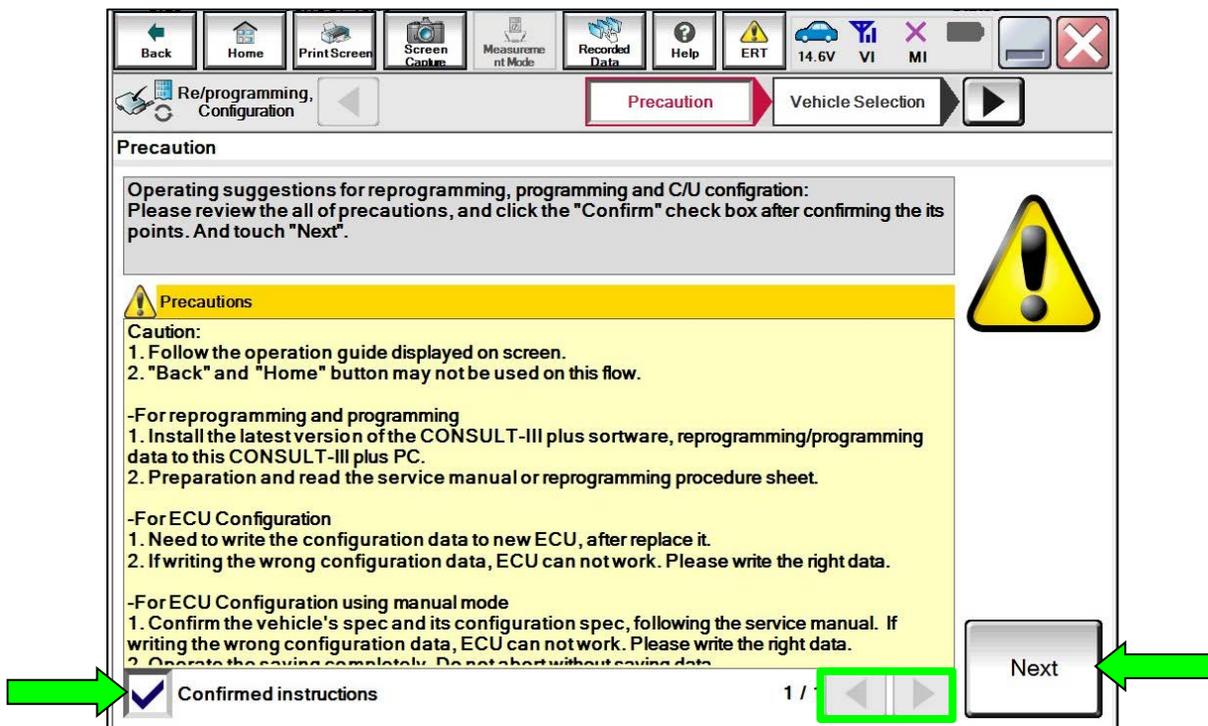
Figure 2

5. Check the box to confirm the precaution instructions have been read, and then select **Next**.

NOTE: Use the arrows (if needed) to view and read all the precautions.

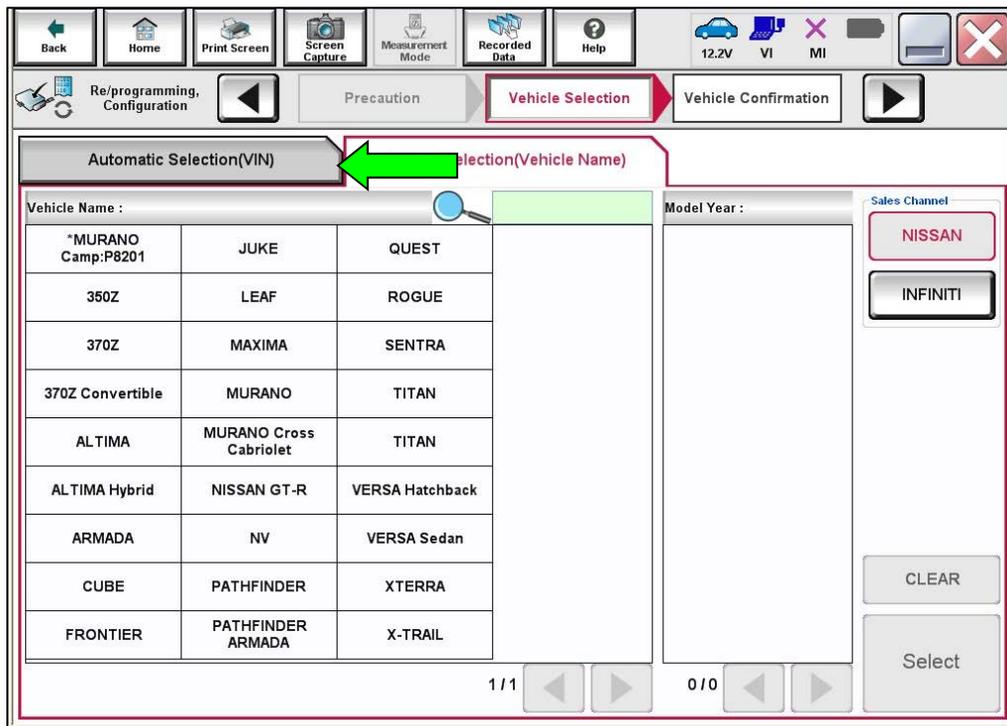
Figure 3

6. Select Automatic Selection(VIN).

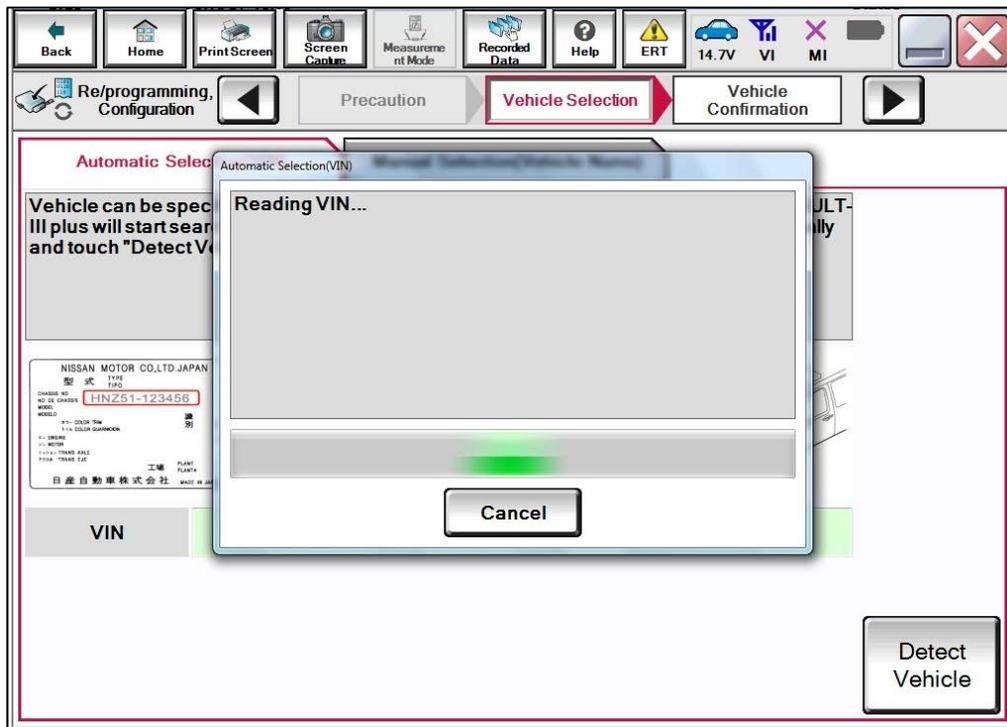
Figure 4

7. Allow C-III plus to perform automatic VIN selection.

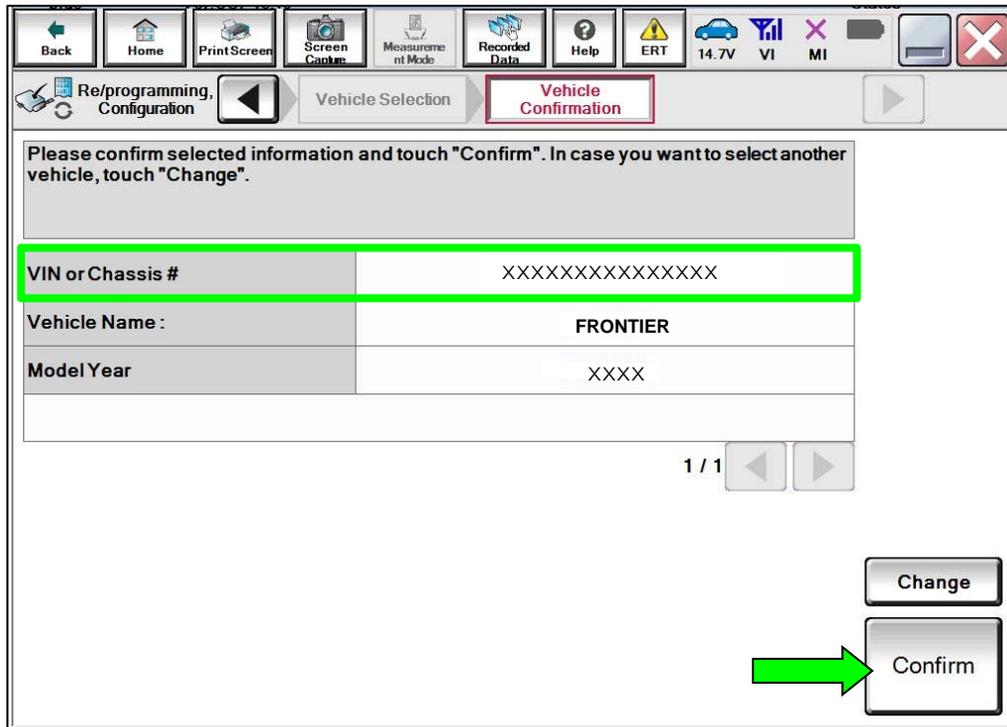
Figure 5

8. Confirm the **VIN or Chassis #** is correct, and then select **Confirm**.

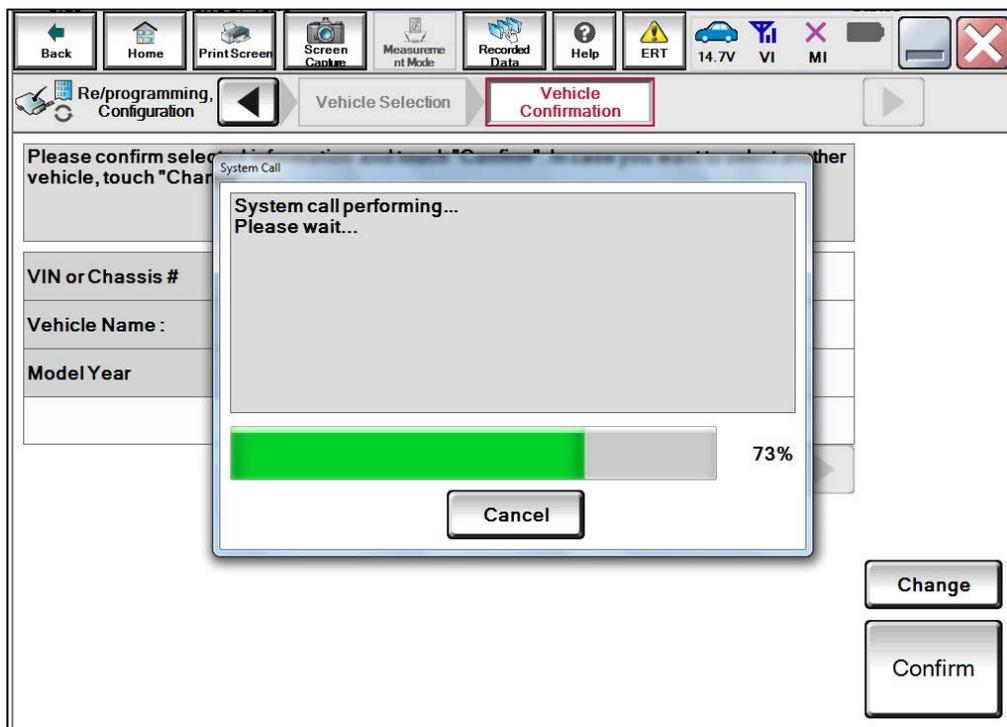
Figure 6

9. Allow the System call to be performed.

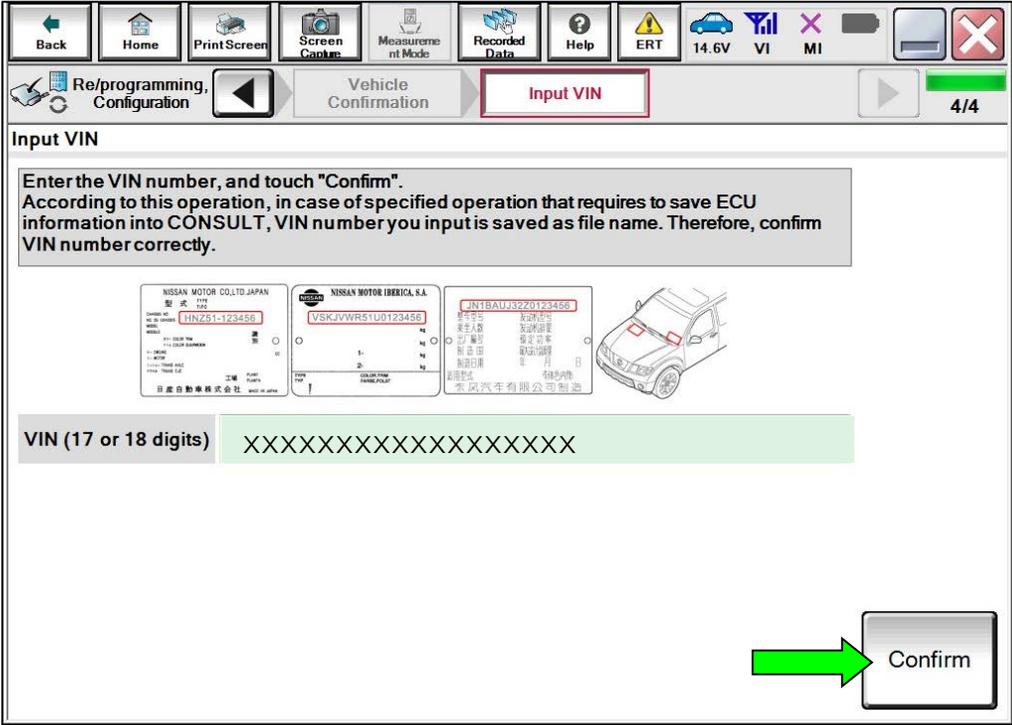
Figure 7

10. Confirm the VIN is correct for the vehicle, and then select **Confirm**.

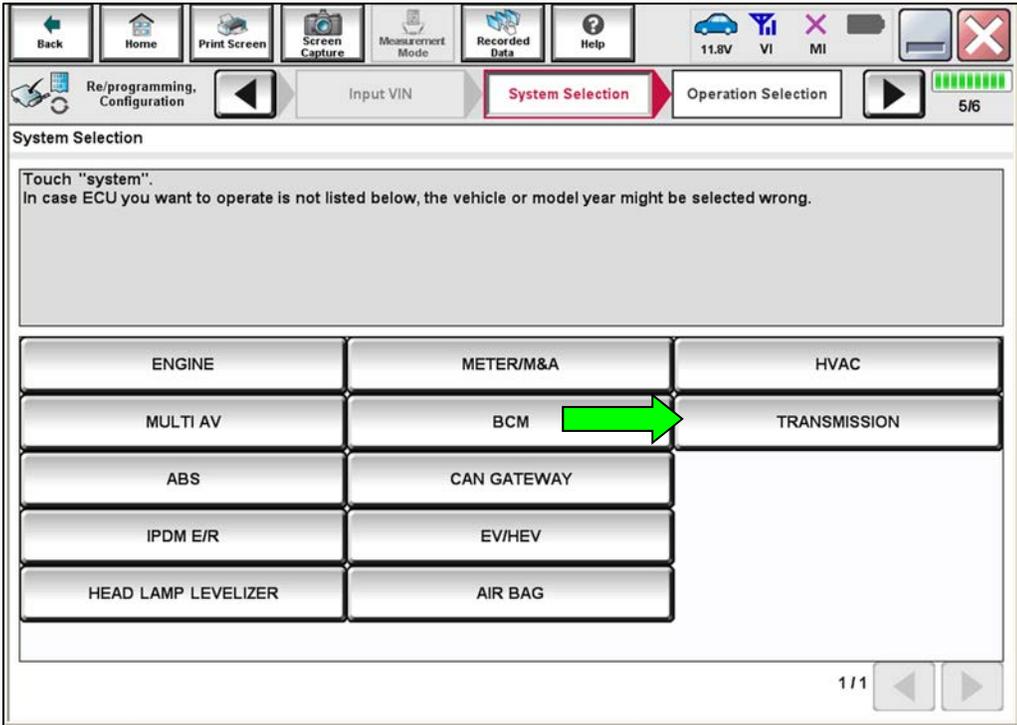
Figure 8

11. Select **TRANSMISSION**.

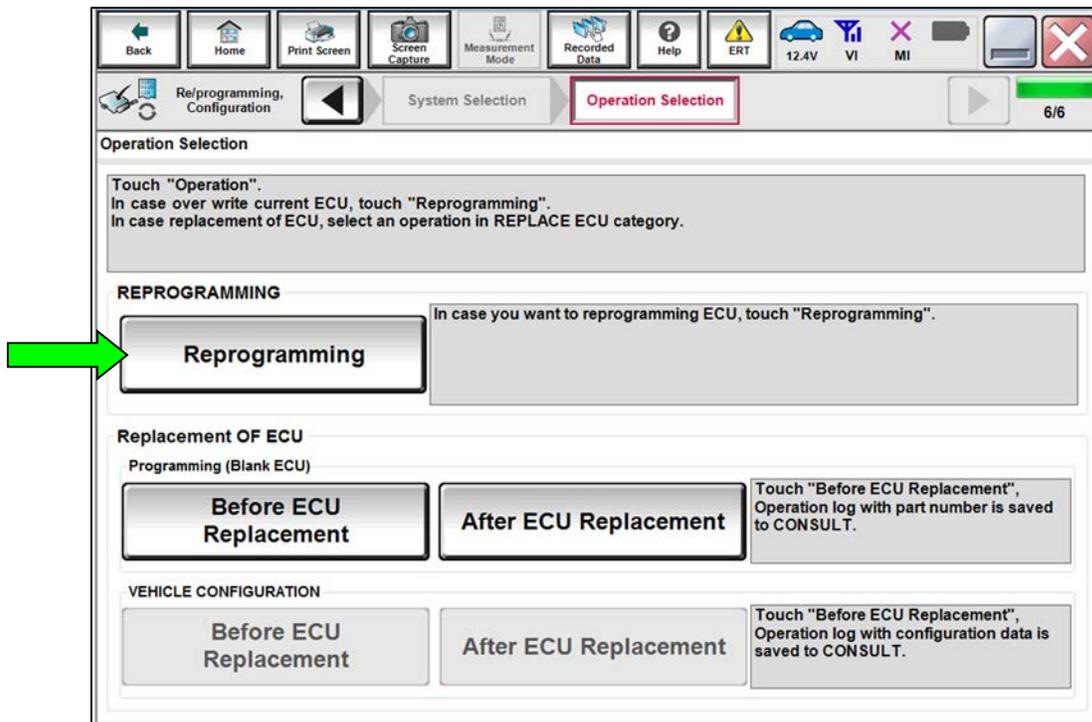
Figure 9

12. Select **Reprogramming**.

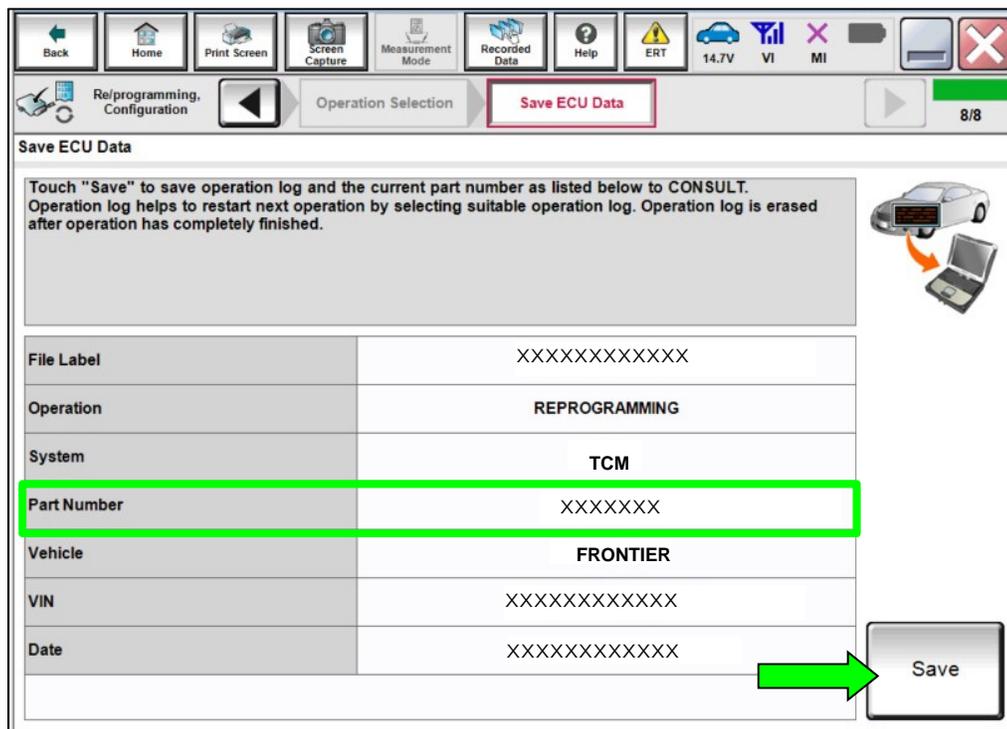
Figure 10

13. Find the TCM **Part Number** and write it on the repair order, and then select **Save**.

NOTE: This is the current Part Number (P/N).

14. Compare the Part Number you wrote down in step 13 on page 8 to the numbers in the **Current TCM Part Number** column in **Table A** below.
 - If there is a match, proceed to step 15, below, to continue the reprogramming procedure.
 - If there is not a match, this bulletin does not apply. Proceed to **CLAIMS INFORMATION** on the last page.

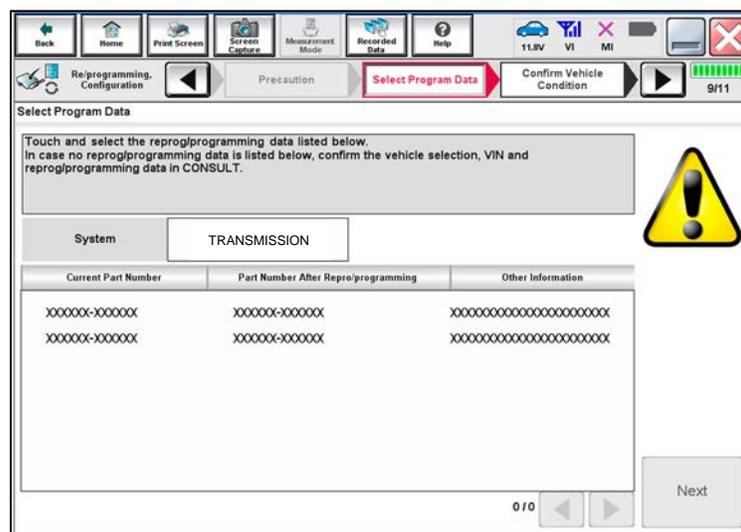
Figure 11

15. Follow the on-screen instructions to navigate C-III plus and reprogram the TCM.
 - If you get this screen and it is blank (no reprogramming listed), it means there is no reprogramming available for this vehicle.

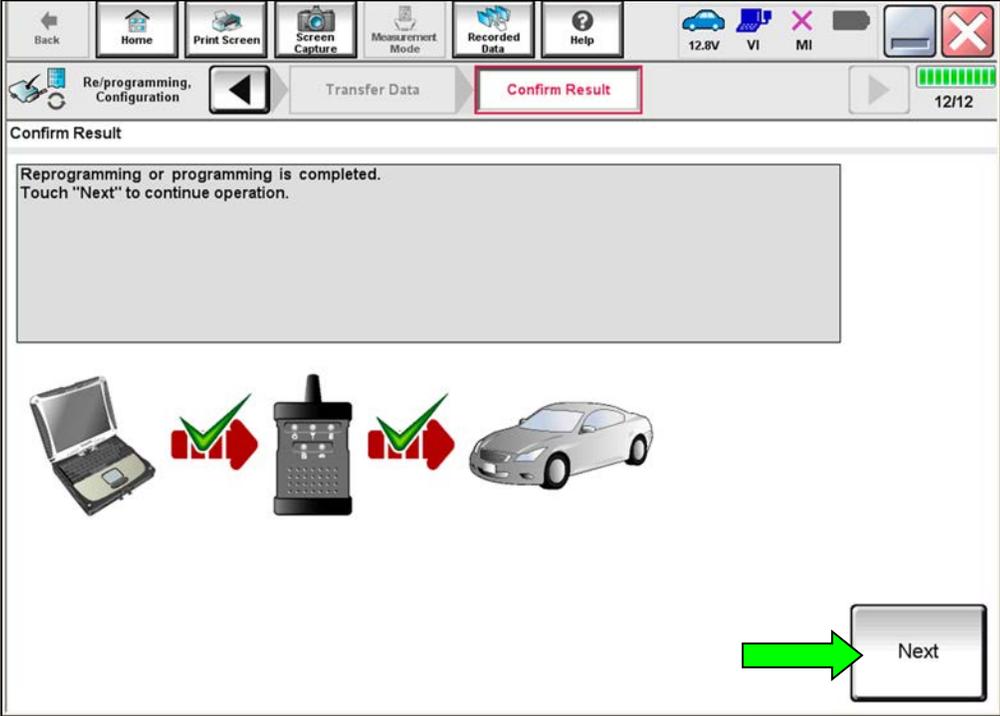
16. Select **Next**, and then proceed to step 17 on page 12.

NOTE: When the screen in Figure 12 displays, TCM reprogramming is complete. If the screen in Figure 12 does not display (indicating that reprogramming did not complete), refer to the information on the next page.

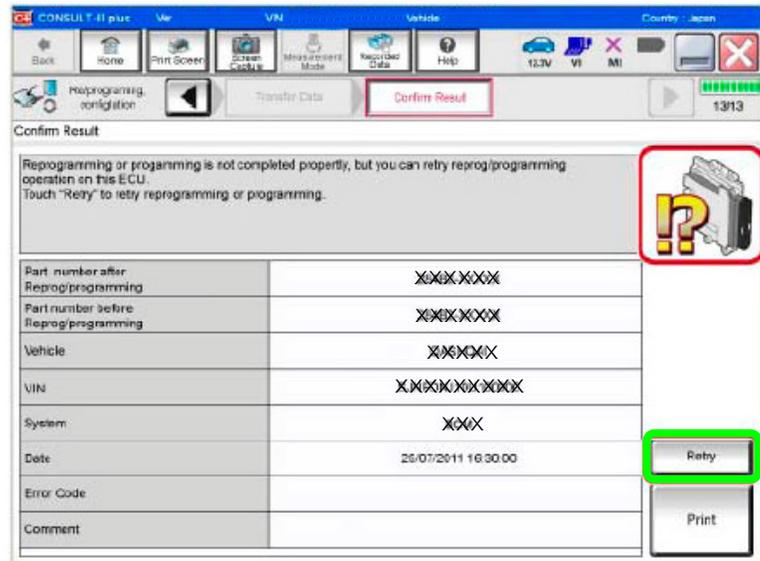
Figure 13

If reprogramming does not complete and the “!” icon displays, as shown in Figure 13:

- Check battery voltage (12.0 V – 15.5 V).
- Ignition is ON, engine is OFF.
- External Bluetooth® devices are OFF.
- All electrical loads are OFF.
- Select **Retry** and follow the on screen instructions.
- **Retry** may not go through on first attempt and can be selected more than once.

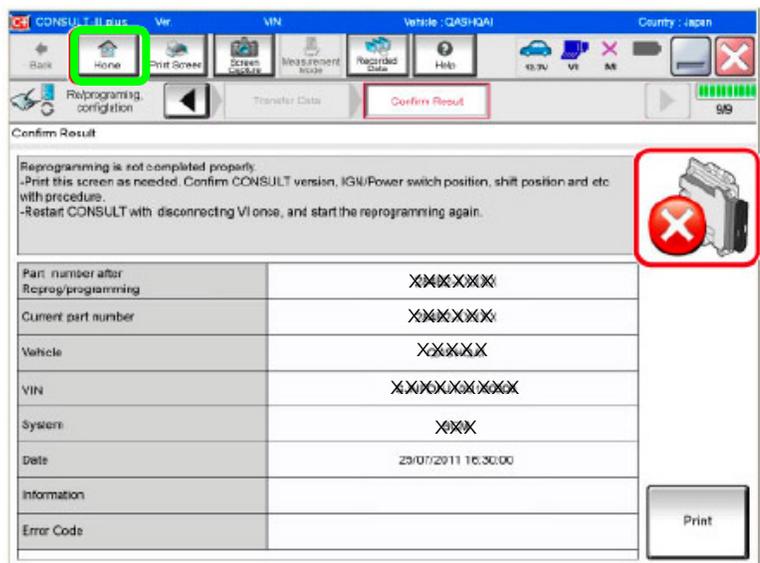
Figure 14

If reprogramming does not complete and the “X” icon displays, as shown in Figure 14:

- Check battery voltage (12.0 V – 15.5 V).
- CONSULT A/C adapter is plugged in.
- Ignition is ON, engine is OFF.
- Transmission is in Park.
- All C-III plus / VI cables are securely connected.
- All C-III plus updates are installed.
- Select **Home**, and restart the reprogram procedure from the beginning.

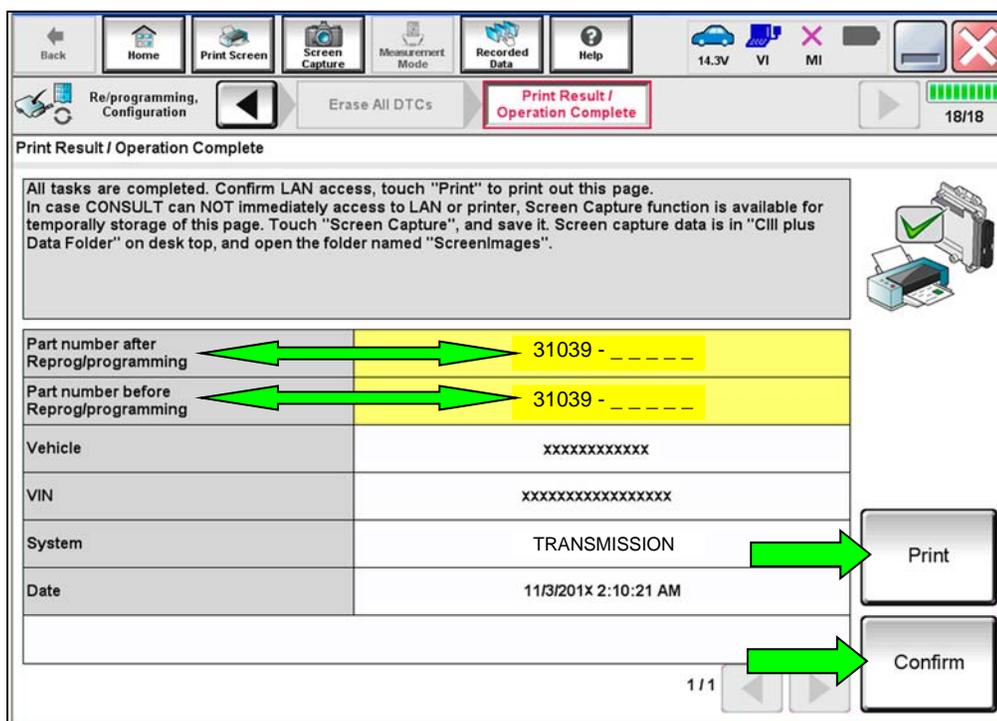
17. Follow the on-screen instructions to **Erase All DTCs**.
 - When the entire reprogramming process is complete, the screen in Figure 15 will display.
18. Verify the before and after part numbers are different.
19. Print a copy of this screen (Figure 15) and attach it to the repair order for warranty documentation.
20. Select **Confirm**.
