VOLUNTARY RECALL CAMPAIGN

VOLUNTARY SAFETY RECALL CAMPAIGN 2020-2022 TITAN/TITAN XD; TCM AND ECM REPROGRAM

CAMPAIGN ID #: R22B1, R22A9
APPLIED VEHICLES: 2020-2022 Titan and Titan XD (A61)

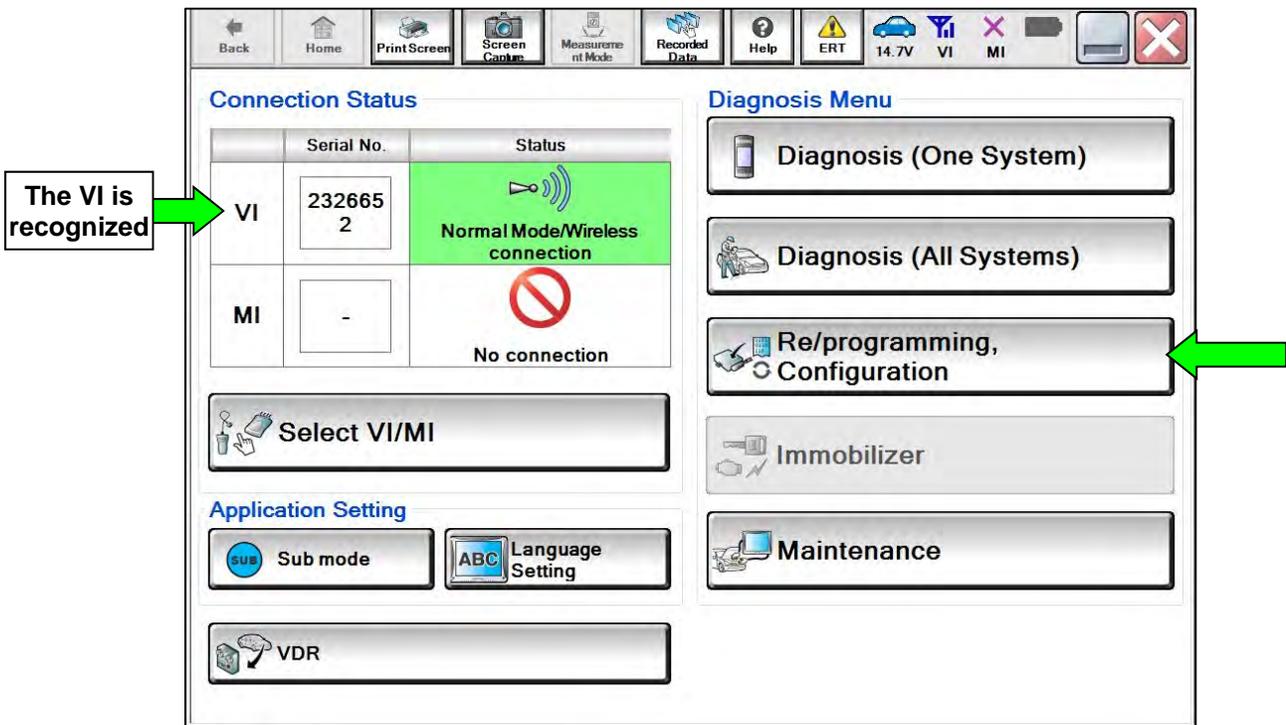
Figure 1

1. Connect the VI to the vehicle.
2. Start C-III plus.
3. Wait for the VI to be recognized (Figure 1 on page 3).
 - The serial number will display when the VI is recognized.

4. Select **Re/programming, Configuration**.

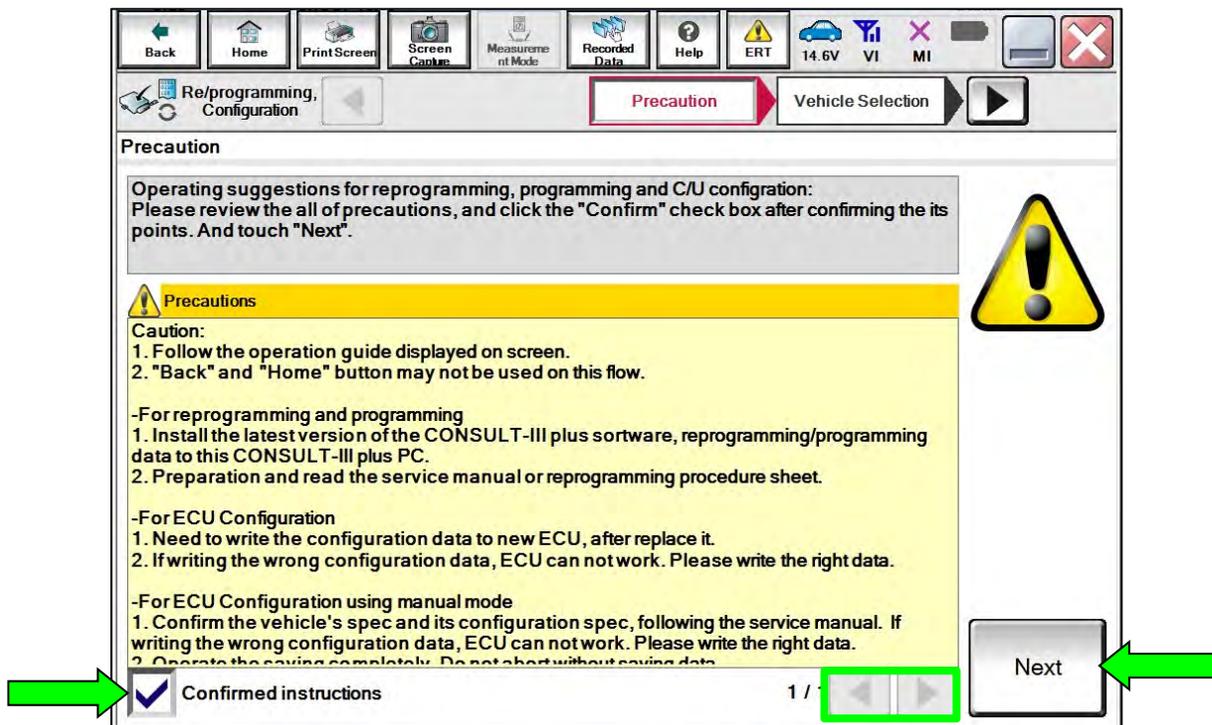
Figure 2

5. Check the box to confirm the precaution instructions have been read, and then select **Next**.

NOTE: Use the arrows (if needed) to view and read all the precautions.

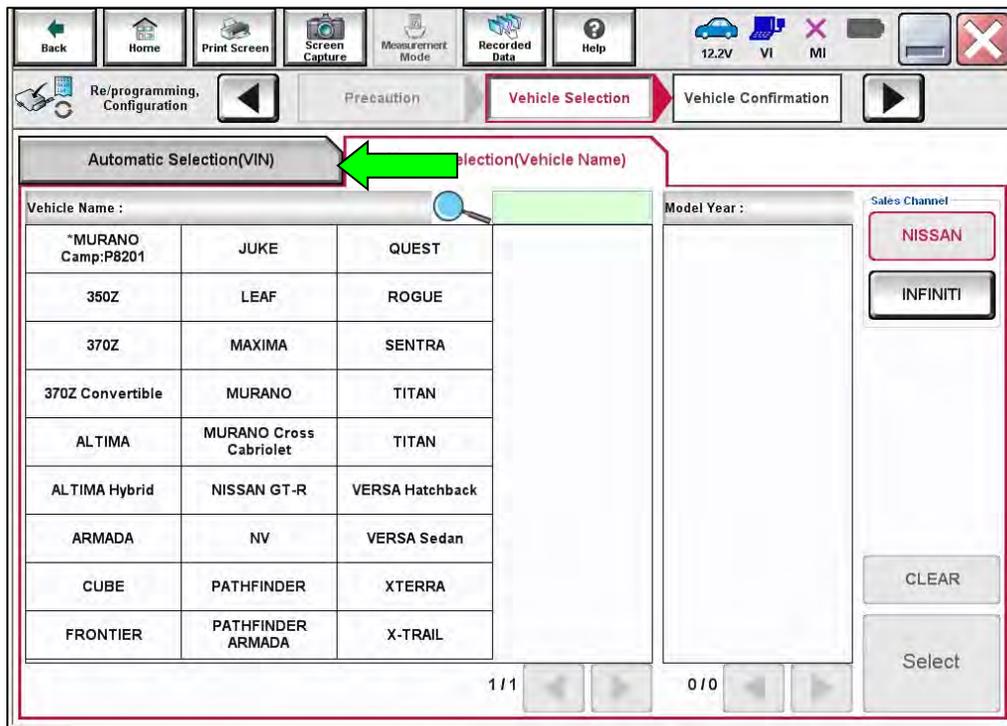
Figure 3

6. Select Automatic Selection(VIN).

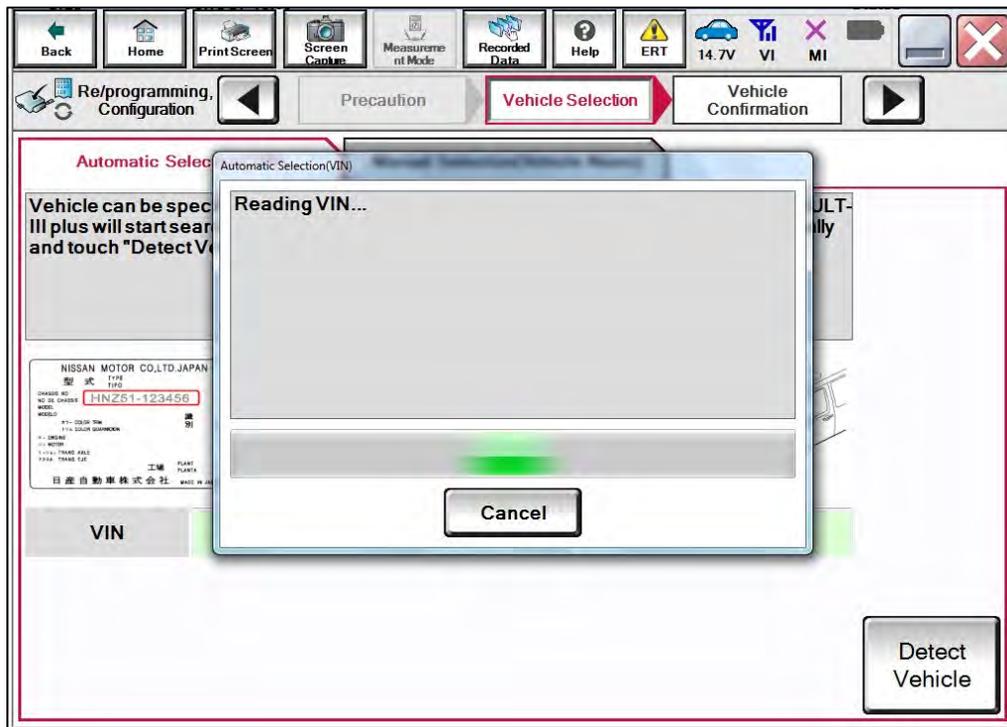
Figure 4

7. Allow C-III plus to perform automatic VIN selection.

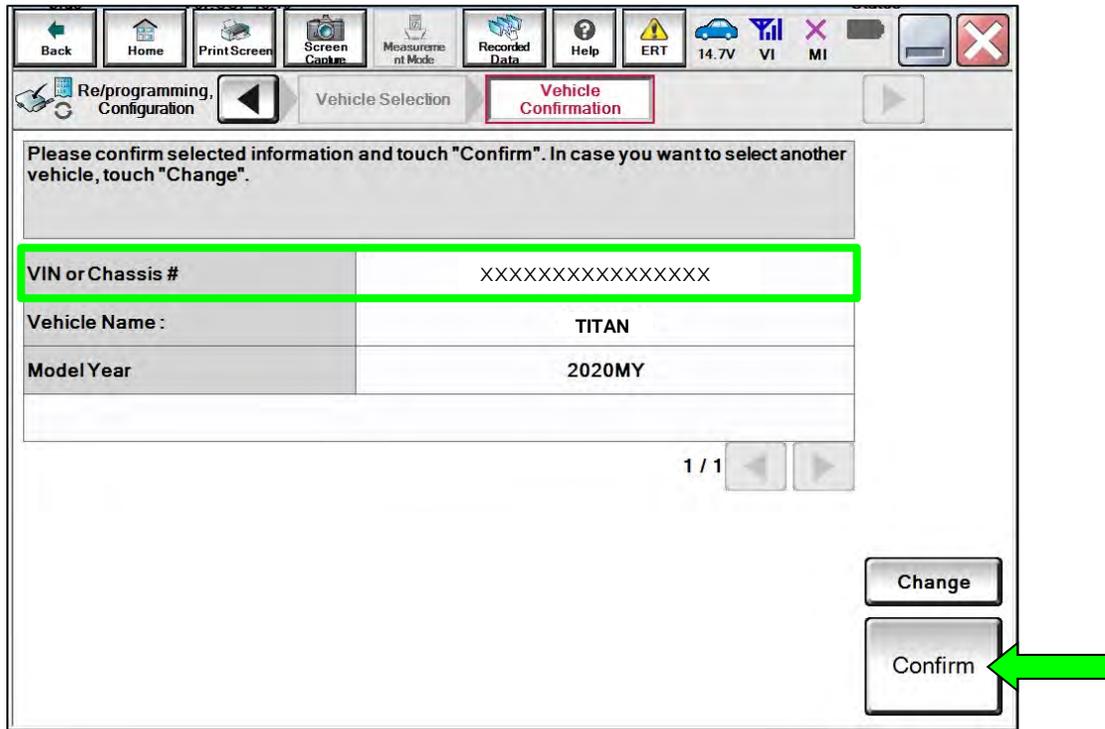
Figure 5

8. Confirm the **VIN or Chassis #** is correct, and then select **Confirm**.

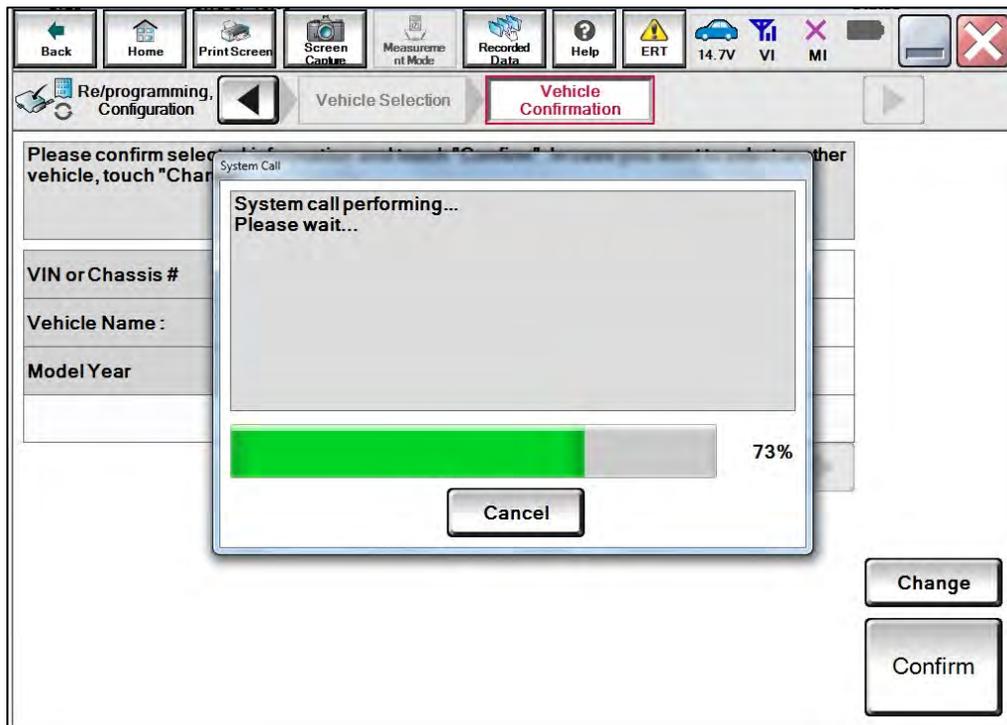
Figure 6

9. Allow the System call to be performed.

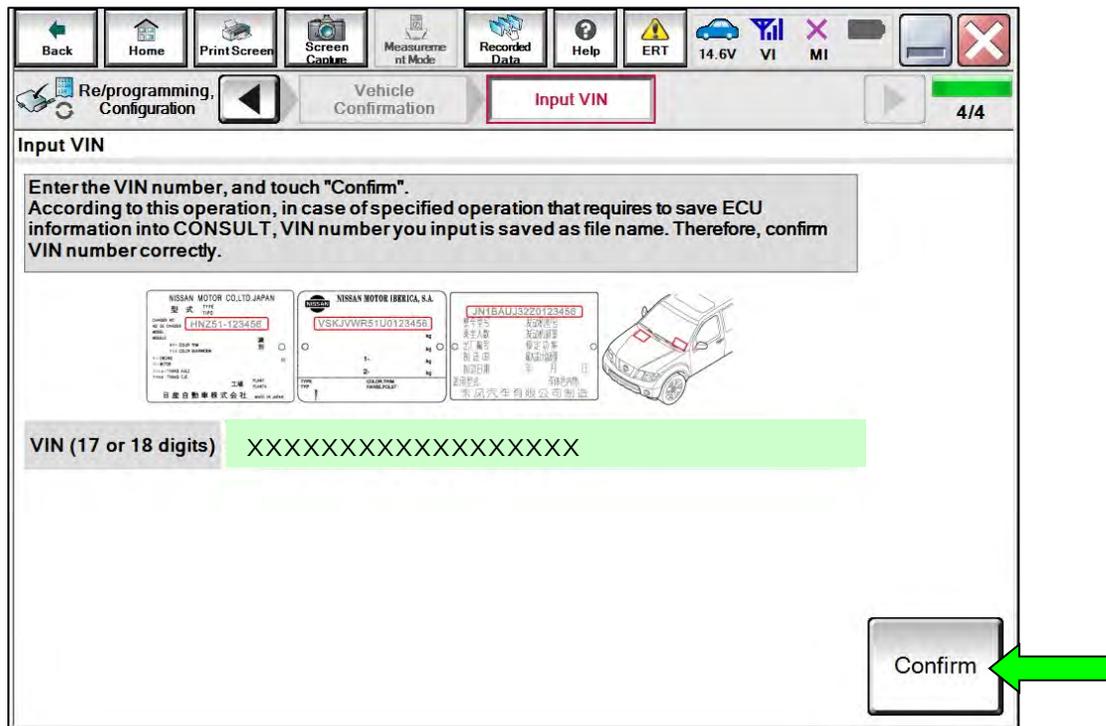
Figure 7

10. Confirm the VIN is correct for the vehicle, and then select **Confirm**.

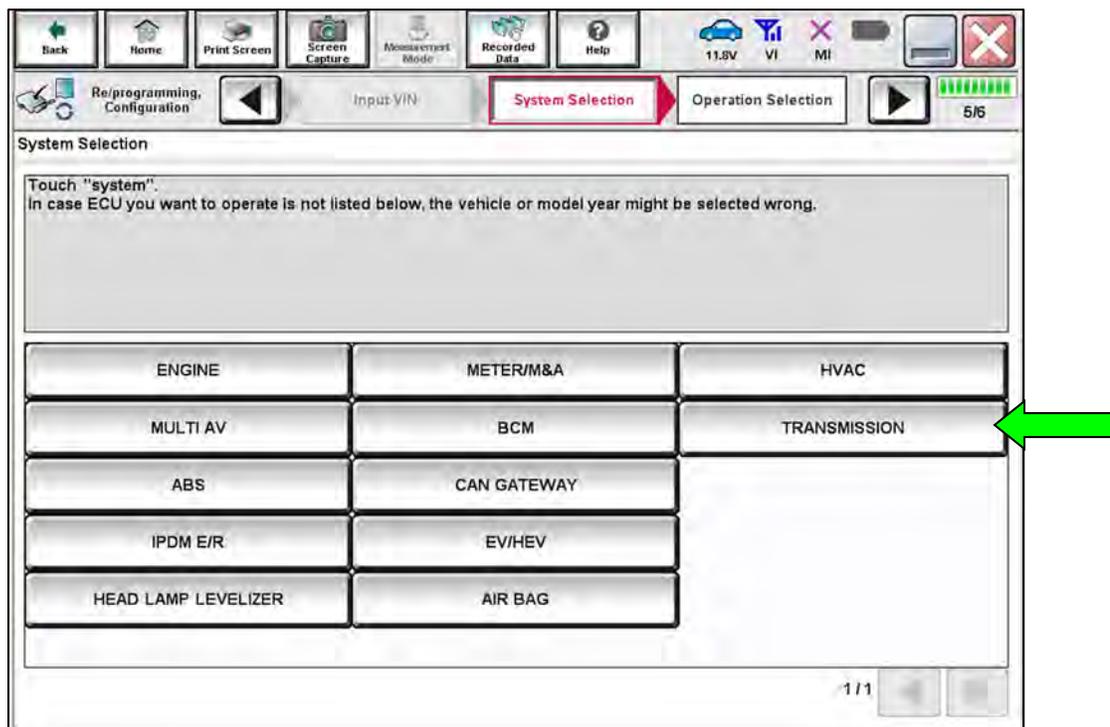
Figure 8

11. Select **TRANSMISSION**.

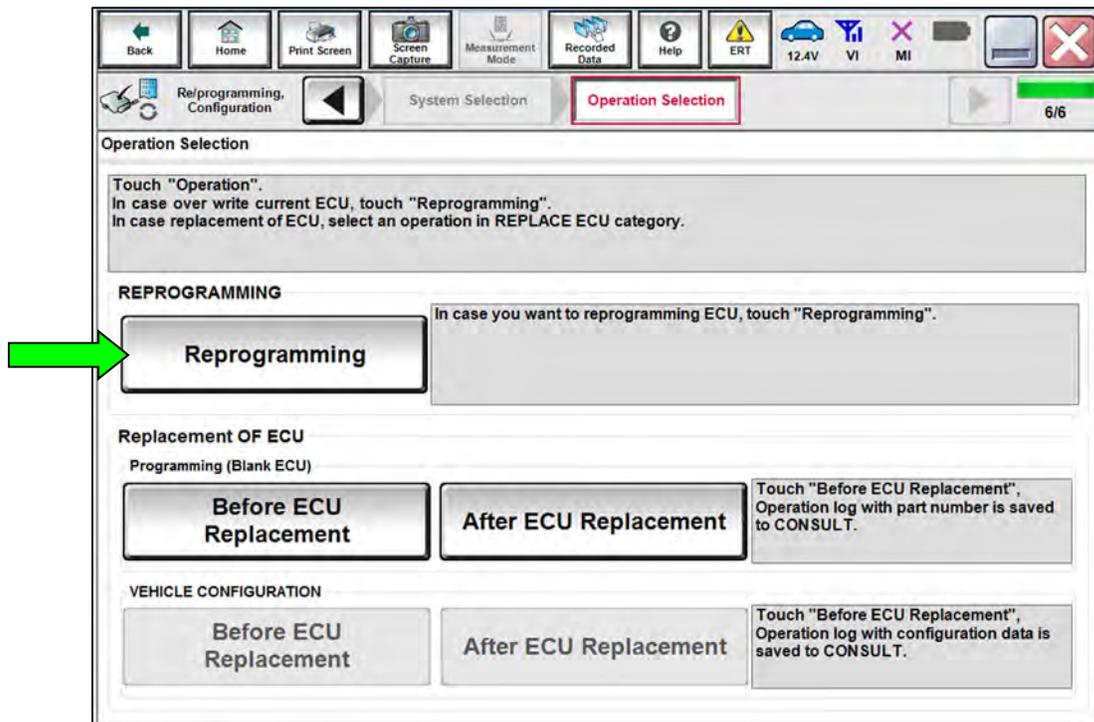
Figure 9

12. Select **Reprogramming**.

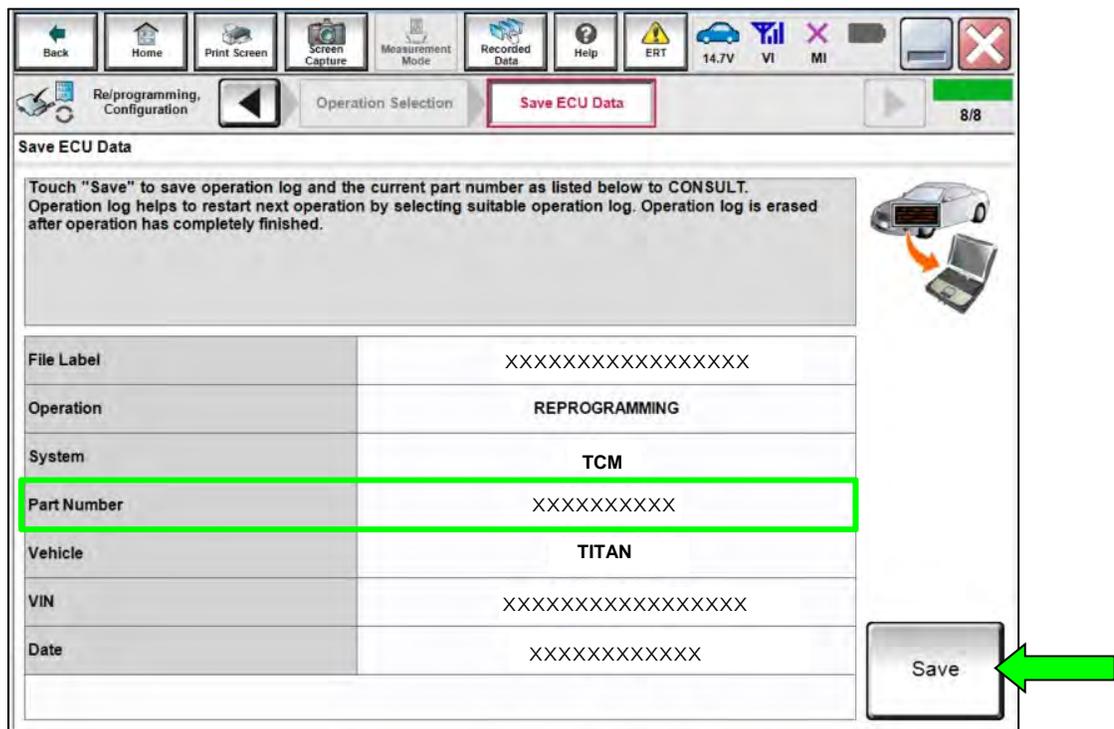
Figure 10

13. Find the TCM **Part Number** and write it on the repair order, and then select **Save**.

NOTE: This is the current Part Number (P/N).

14. Compare the Part Number you wrote down in step 13 on page 7 to the numbers in the **CURRENT TCM PART NUMBER** column in **Table A** below.

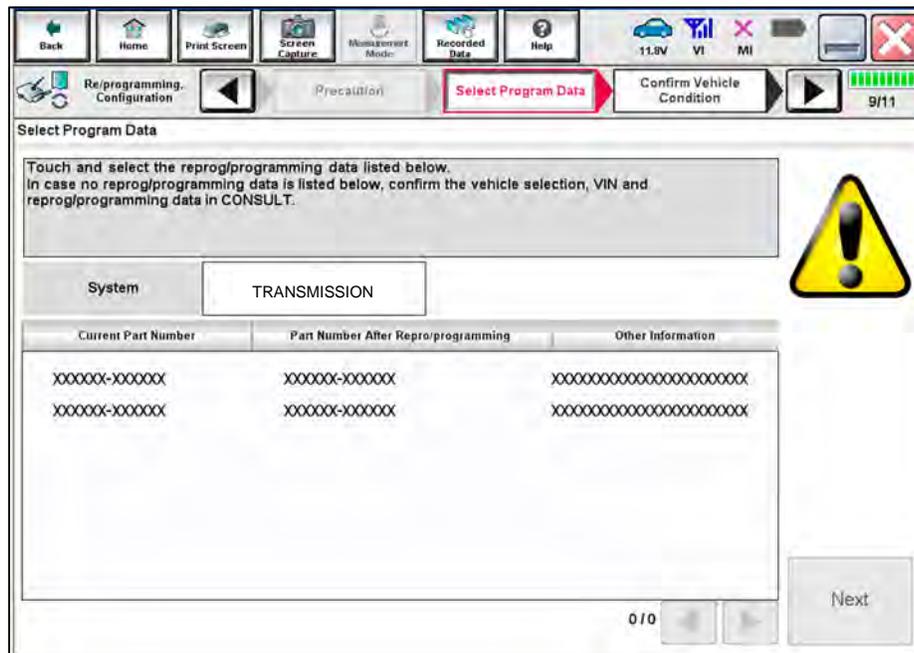
Figure 11

15. Follow the on-screen instructions to navigate C-III plus and reprogram the TCM.
 - If you get this screen and it is blank (no reprogramming listed), it means there is no reprogramming available for this vehicle.

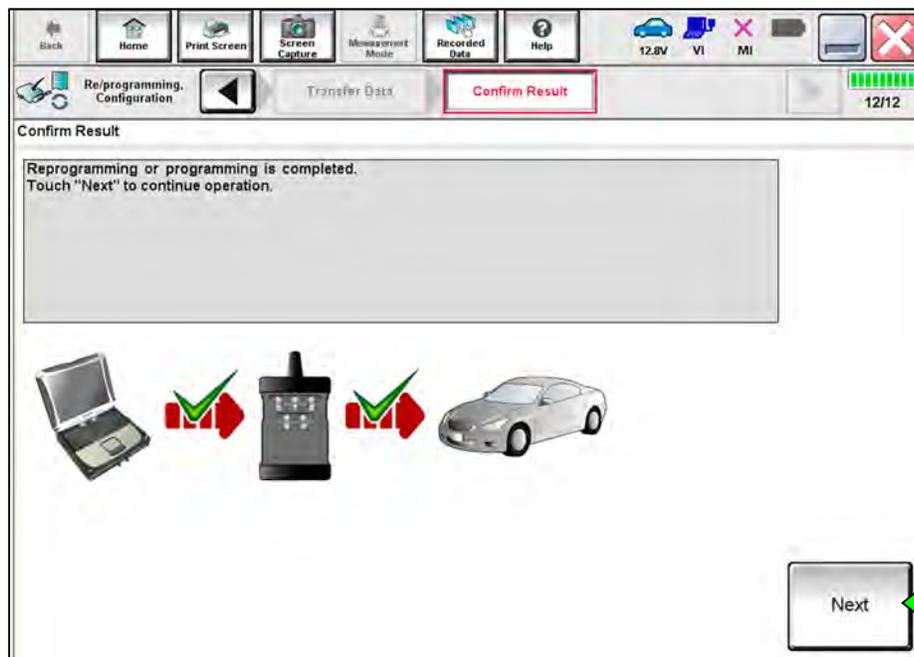
16. Select **Next**, and then proceed to step 17 on page 11.

NOTE: When the screen in Figure 12 displays, TCM reprogramming is complete. If the screen in Figure 12 does not display (indicating that reprogramming did not complete), refer to the information on the next page.

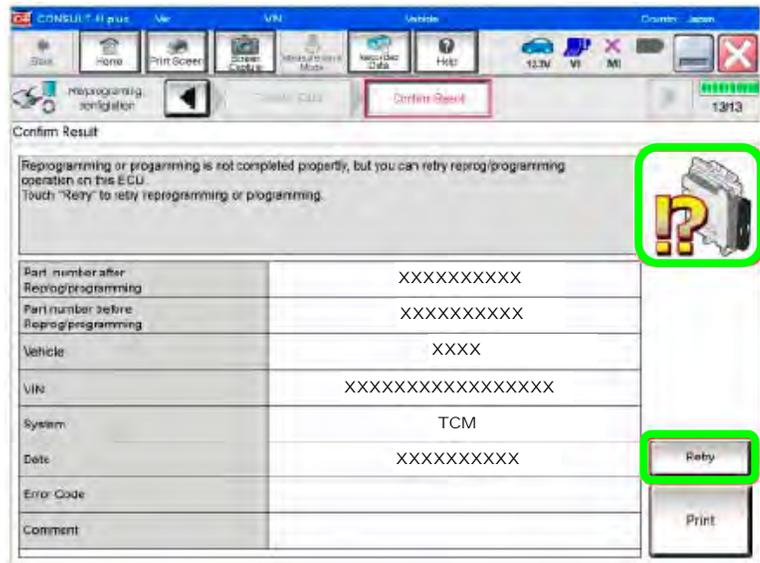
Figure 13

If reprogramming does not complete and the “!?” icon displays, as shown in Figure 13:

- Check battery voltage (12.0 V – 15.5 V).
- Ignition is ON, engine is OFF.
- External Bluetooth® devices are OFF.
- All electrical loads are OFF.
- Select **Retry** and follow the on screen instructions.
- **Retry** may not go through on first attempt and can be selected more than once.

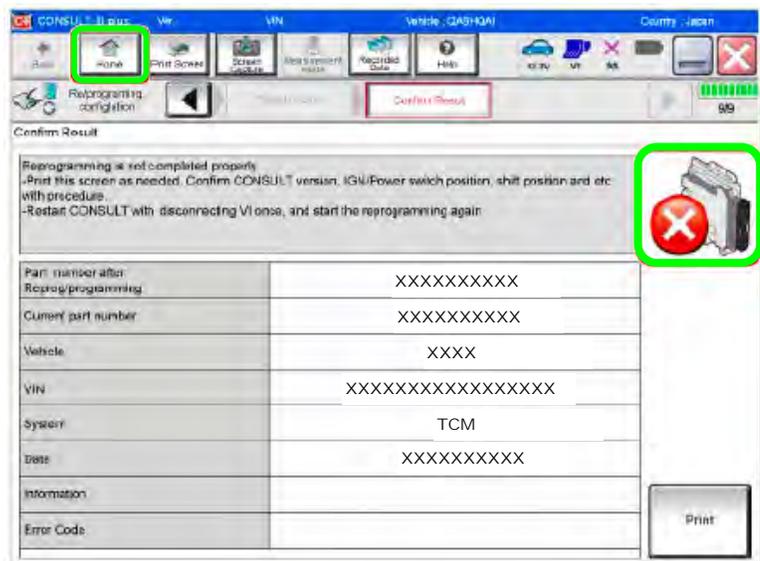
Figure 14

If reprogramming does not complete and the “X” icon displays, as shown in Figure 14:

- Check battery voltage (12.0 V – 15.5 V).
- CONSULT A/C adapter is plugged in.
- Ignition is ON, engine is OFF.
- Transmission is in Park.
- All C-III plus / VI cables are securely connected.
- All C-III plus updates are installed.
- Select **Home**, and restart the reprogram procedure from the beginning.

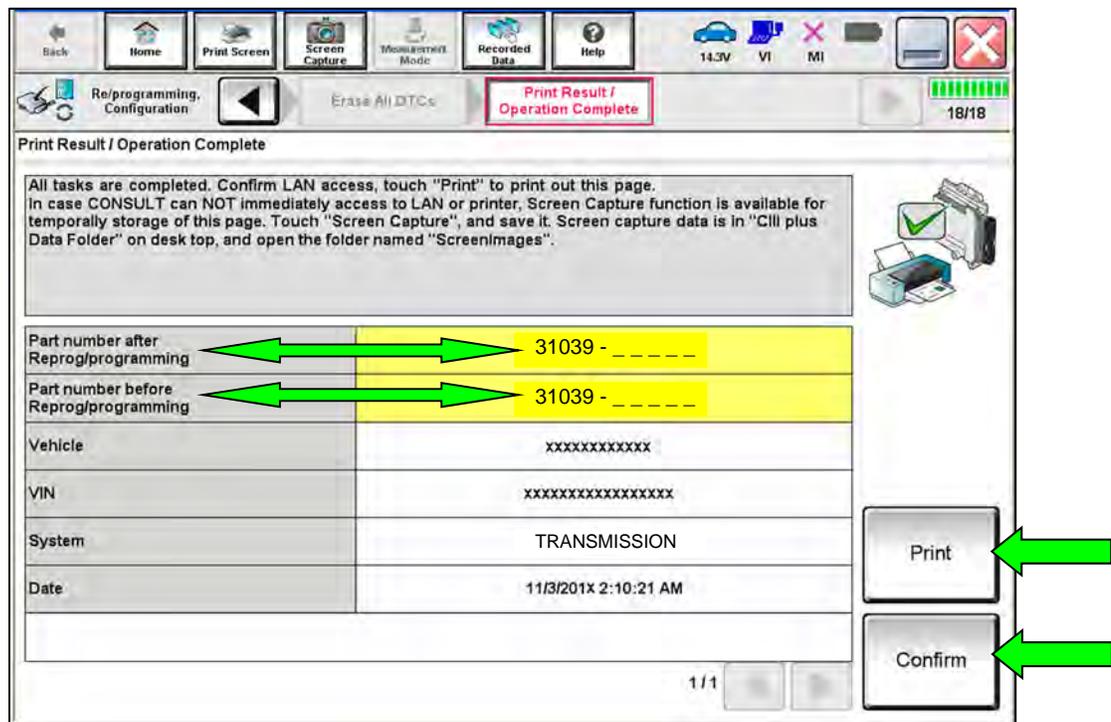
17. Follow the on-screen instructions to **Erase All DTCs**.
 - When the entire TCM reprogramming process is complete, the screen in Figure 15 will display.
18. Verify the before and after part numbers are different.
19. Print a copy of this screen (Figure 15) and attach it to the repair order for warranty documentation.
20. Select **Confirm**, and then proceed to step 21 on page 12 to confirm the ECM part number.

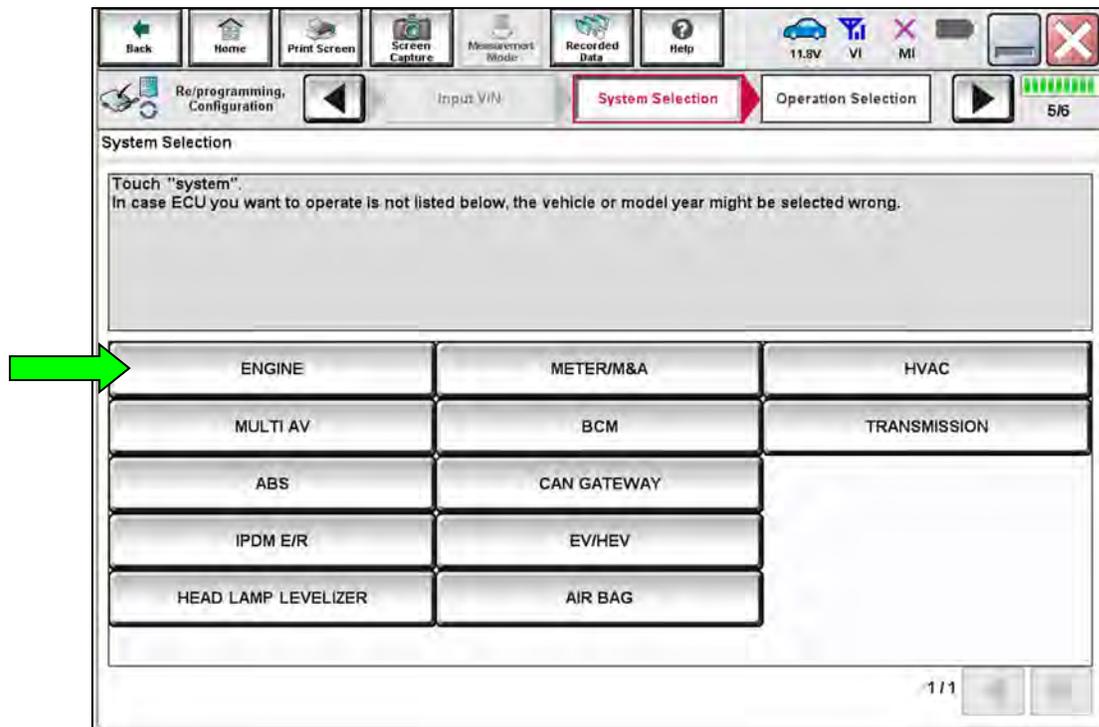
Figure 16

21. Return to the home screen and perform steps 4 - 10 on pages 3 - 6.
22. Select **ENGINE**.

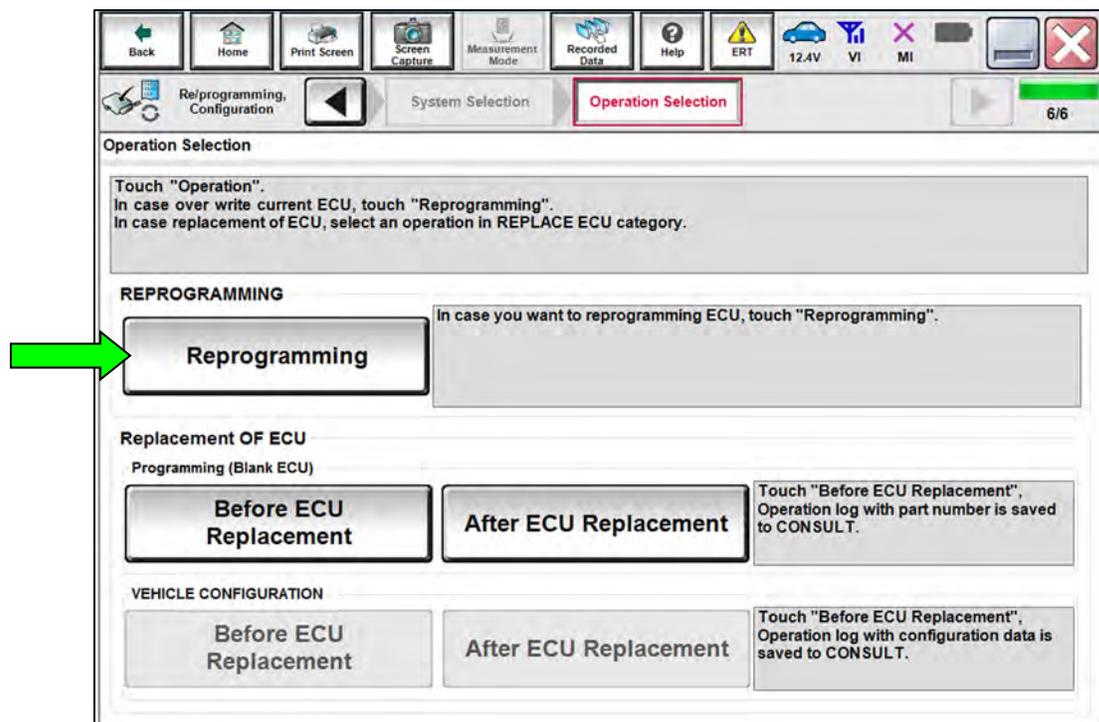
Figure 17

23. Select **Reprogramming**.

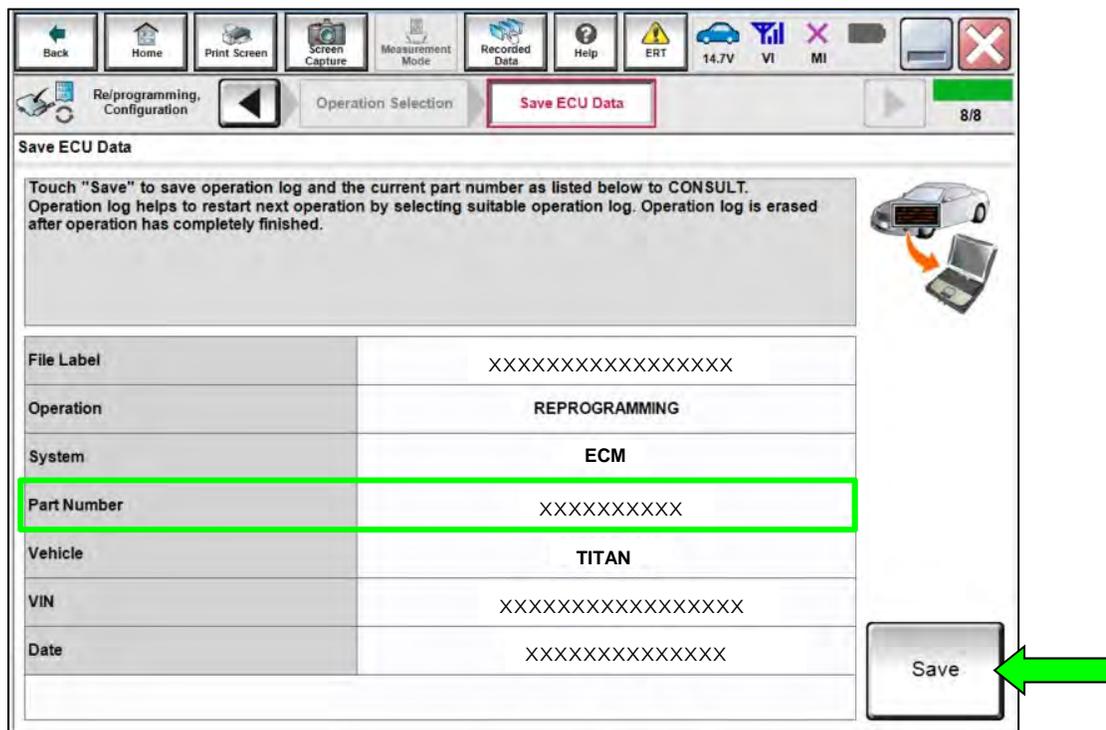
Figure 18

24. Find the ECM **Part Number** and write it on the repair order, and then select **Save**.

NOTE: This is the current Part Number (P/N).

25. Compare the Part Number you wrote down in step 24 to the numbers in the **CURRENT ECM PART NUMBER** column in **Table B** below.

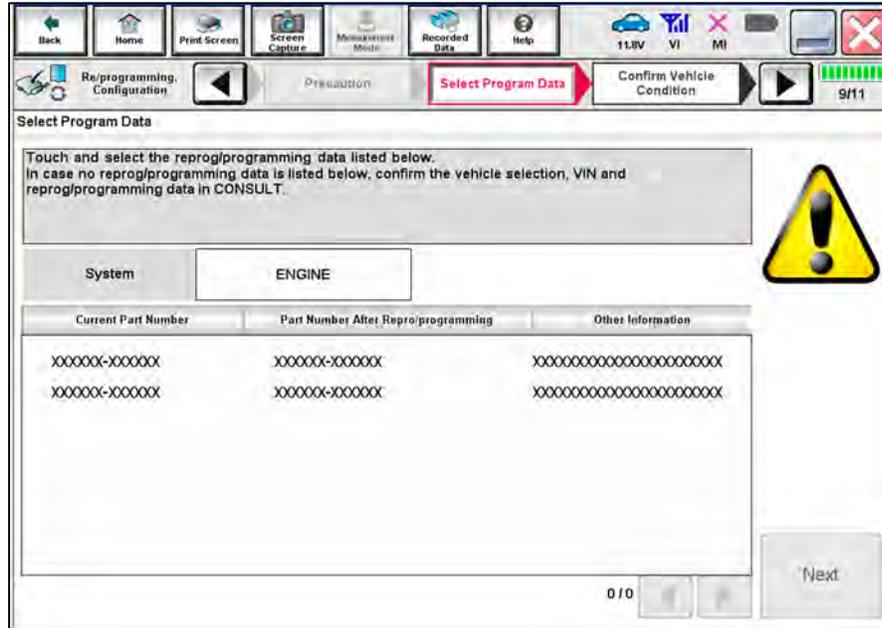
Figure 19

26. Follow the on-screen instructions to navigate C-III plus and reprogram the ECM.

NOTE: In some cases, more than one new P/N for reprogramming is available.

- If you get this screen and it is blank (no reprogramming listed), it means there is no reprogramming available for this vehicle.

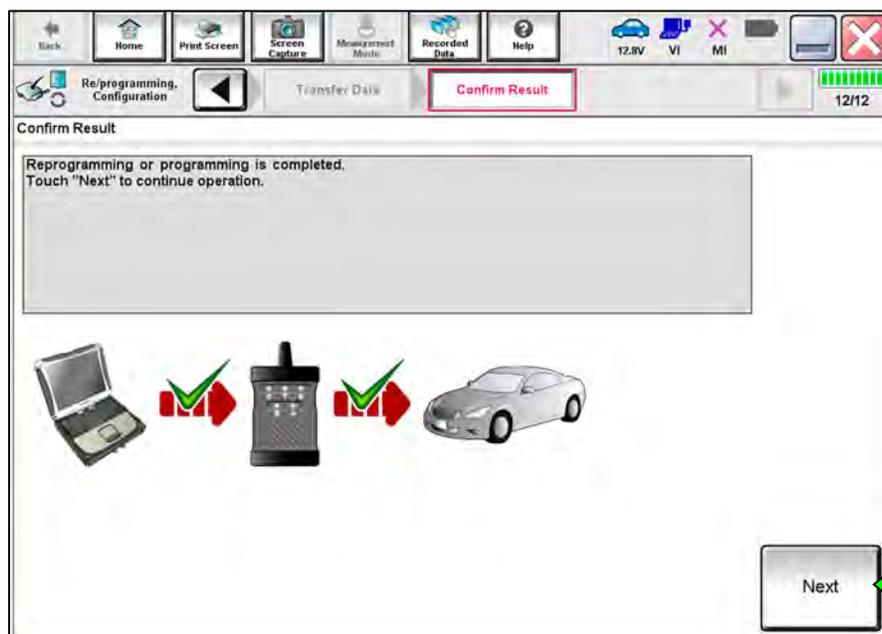
27. Select **Next**, and then proceed to step 28 on page 16.

NOTE: When the screen in Figure 20 displays, ECM reprogramming is complete. If the screen in Figure 20 does not display (indicating that reprogramming did not complete), refer to the information on the next page.

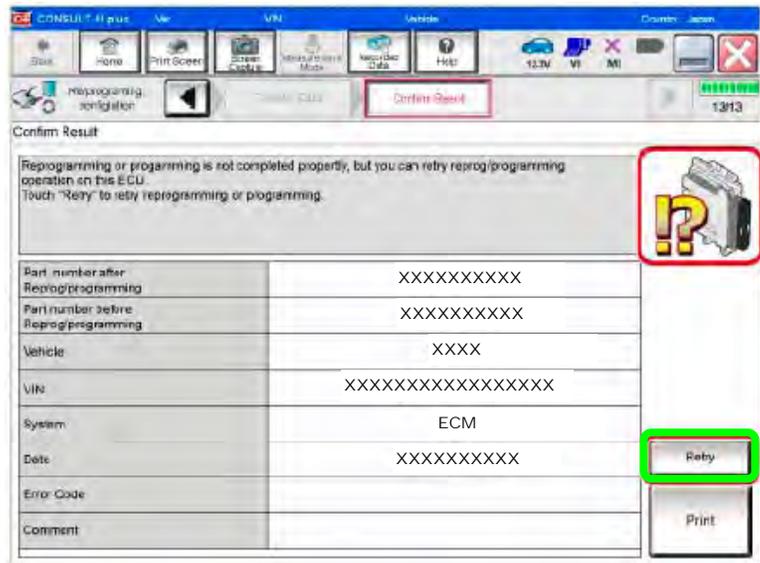
Figure 21

If reprogramming does not complete and the “!?” icon displays as shown in Figure 21:

- Check battery voltage (12.0 V – 15.5 V).
- Ignition is ON, engine is OFF.
- External Bluetooth® devices are OFF.
- All electrical loads are OFF.
- Select **Retry** and follow the on screen instructions.
- **Retry** may not go through on first attempt and can be selected more than once.

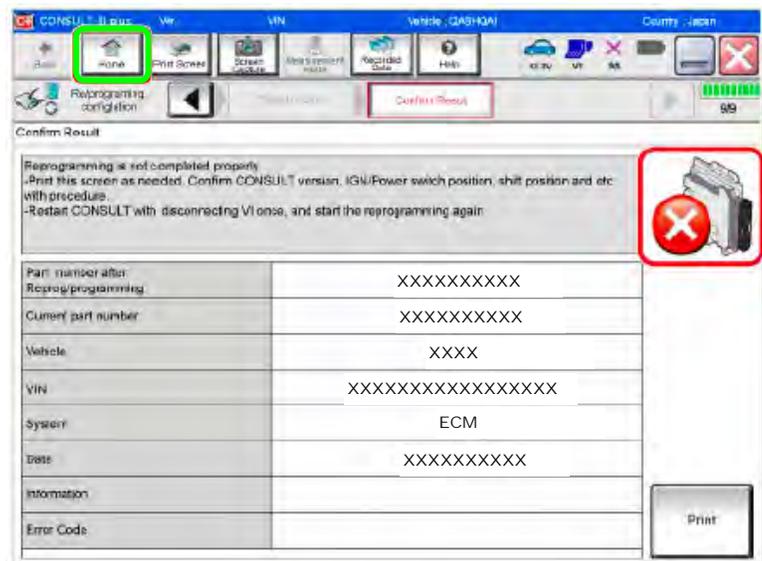
Figure 22

If reprogramming does not complete and the “X” icon displays as shown in Figure 22:

- Check battery voltage (12.0 V – 15.5 V).
- CONSULT A/C adapter is plugged in.
- Ignition is ON, engine is OFF.
- Transmission is in Park.
- All C-III plus / VI cables are securely connected.
- All C-III plus updates are installed.
- Select **Home**, and restart the reprogram procedure from the beginning.

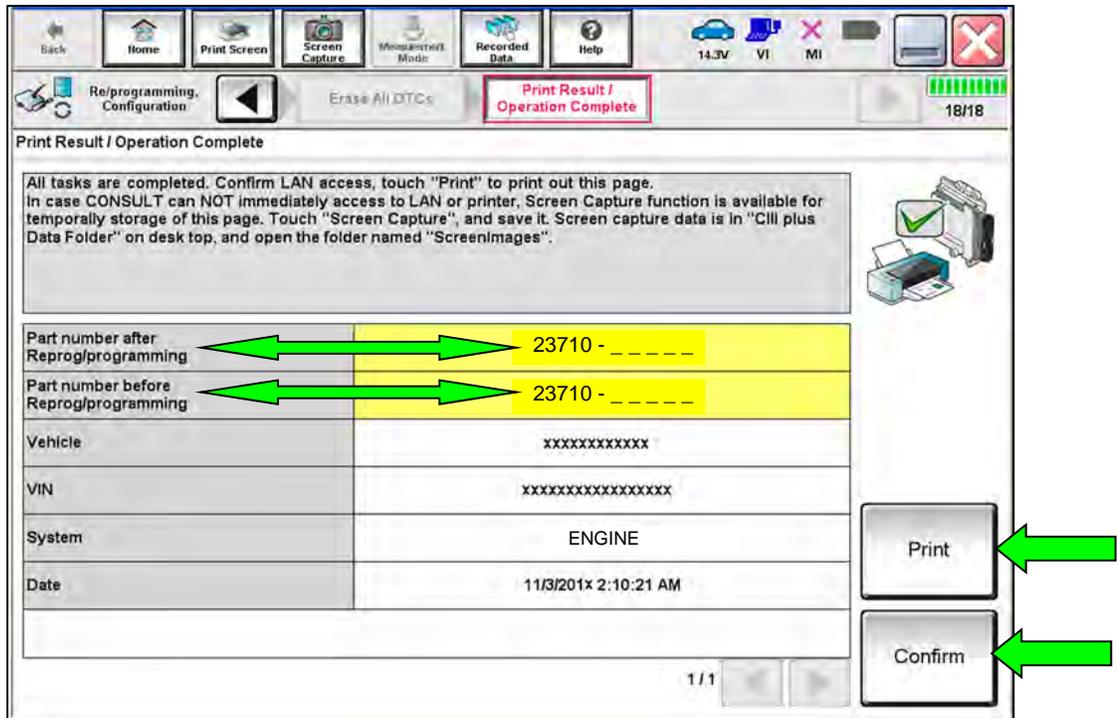
28. Follow the on-screen instructions to **Erase All DTCs**.
 - When the entire reprogramming process is complete, the screen in Figure 23 will display.
29. Verify the before and after part numbers are different.
30. Print a copy of this screen (Figure 23) and attach it to the repair order for warranty documentation.
31. Select **Confirm**.
