Safety Recall

Code: 24IL

| Subject | Engine Control Unit (ECU) Software | | | | | | | | | | | | | | | |
|---|---|---|---|---|---|---|---|---|---|---|---|---|---|---|---|---|
| Release Date | September 23, 2022 | | | | | | | | | | | | | | | |
| Affected Vehicles |

Repair Instruction

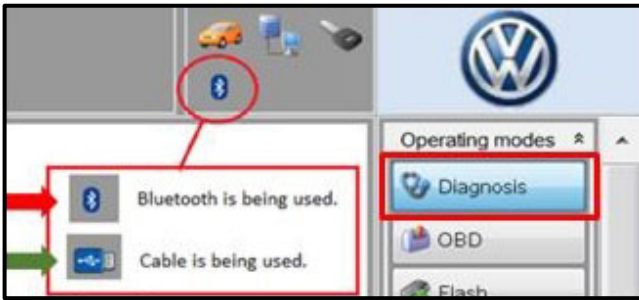
- Confirm that scan tool is communicating with the diagnostic head by USB <Green Arrow>.
 - If the Bluetooth symbol is shown <Red Arrow> then disconnect the diagnostic head from the vehicle and reconnect the USB cable to the diagnostic head and then reattach to the vehicle.
- Upon ODIS startup, verify the “Diagnosis” operating mode is selected <as shown>.

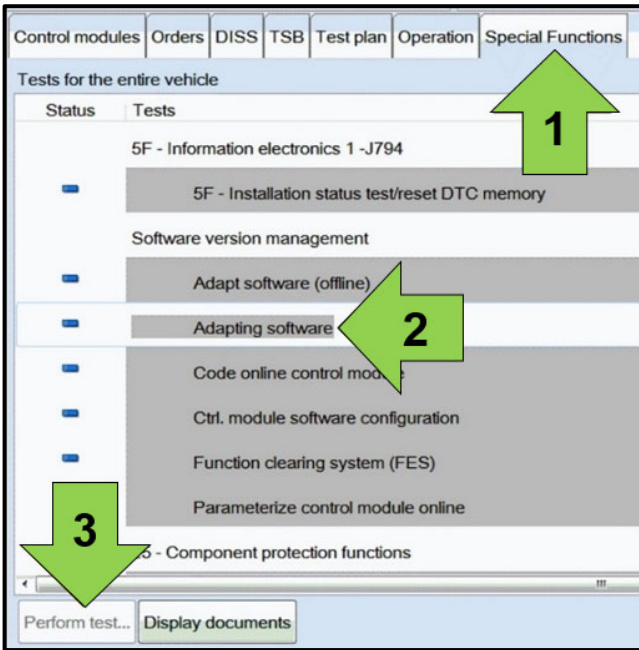
- Once the GFF scan is complete, select “Special functions” <arrow 1>, then “Adapting software” <arrow 2>, then select “Perform test” <arrow 3>.

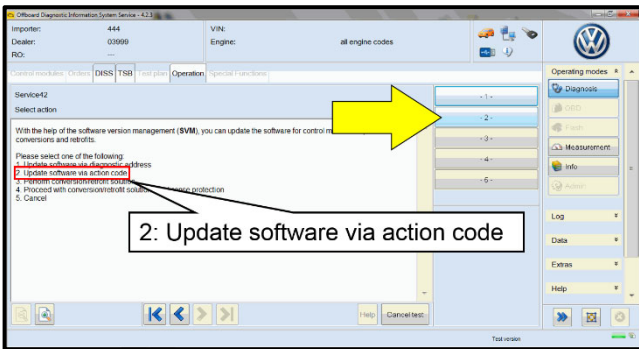
- Select the correct option to “Update software via action code” OR “Software update via measured code”.

NOTE
The different options to perform the SVM operation may vary based on model.

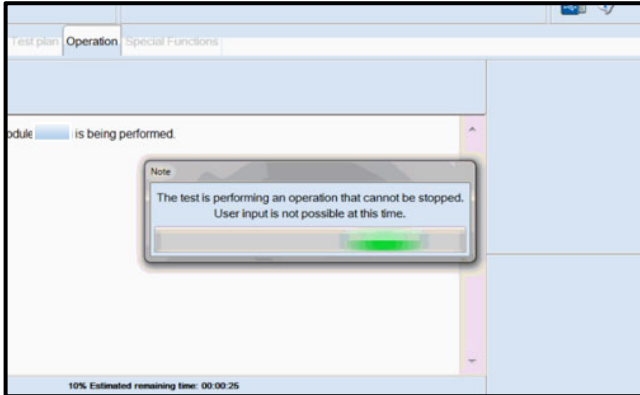
- Select "Accept" <arrow> and follow the on screen prompts.
- During the flash, this screen appears when each operation is performed:

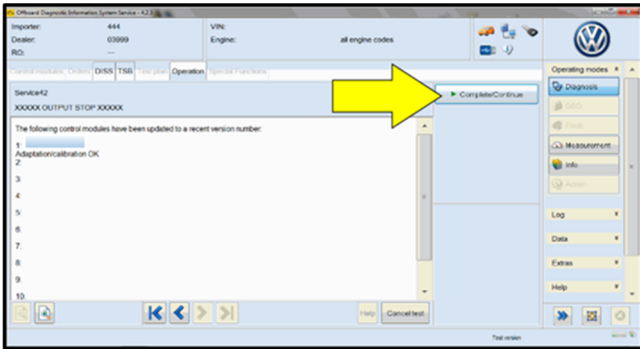
- Select Complete/Continue <arrow> after each operation is completed.

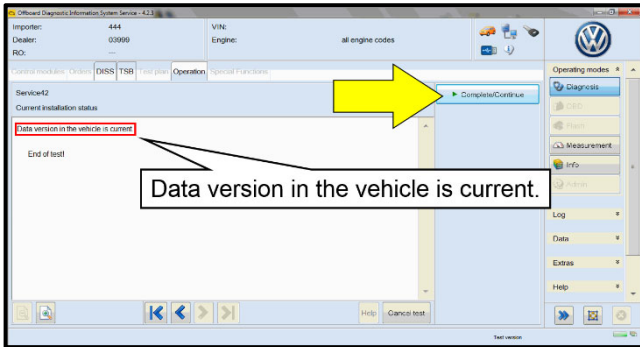
- When the SVM update is complete a confirmation message is displayed <as shown>.
- Select "Complete/Continue" <arrow>.
