# Product Safety Recall

## N222379510 Instrument Panel Display May Go Blank

<b>Condition</b>	General Motors has decided that a defect which relates to motor vehicle safety exists in certain 2023 model year Cadillac LYRIQ vehicles. The driver video display control module in these vehicles occasionally performs a boot-up/shut-down cycle when the vehicle is parked and powered off that can be interrupted if a door is opened. If the cycle is interrupted during a specific five-second window, the driver video display can go blank. This blank-screen condition will normally reset if the vehicle is turned off and turned back on. If this condition occurs and the driver operates the vehicle with the video display blank, the vehicle's instrument panel and other FMVSS-regulated features will not be available, increasing the risk of a crash.
<b>Correction</b>	GM will update the vehicles' video display control module software. Owners who have accepted applicable terms and conditions will have the opportunity to accept these software changes using wireless over-the-air (OTA) technology without having to bring their vehicle to a dealership. Alternatively, owners may schedule to have the updates pe

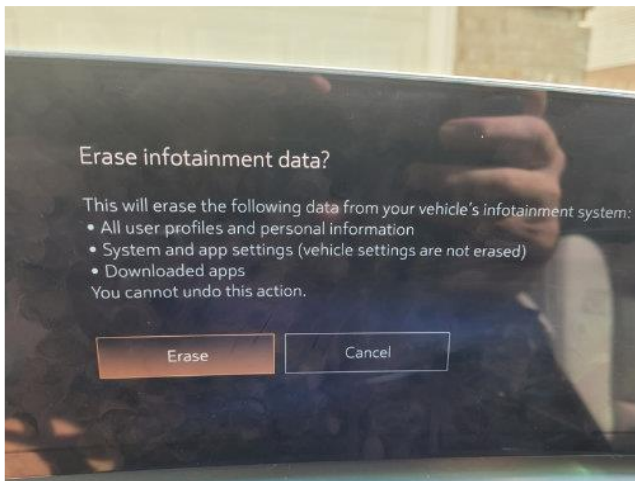
6162024

4. Record the currently saved radio presets and customer downloaded Apps from the radio.

**Important:** Erasing the Infotainment data will delete all of the radio presets. Any currently paired devices will need to be re-paired for both Bluetooth and Wi-Fi. The customer will need to log back into their Google account on the radio and re-download any Apps they previously downloaded.
