Compliance Recall

Code: 91DZ

Subject Rearview Camera Software

Release Date October 14, 2022

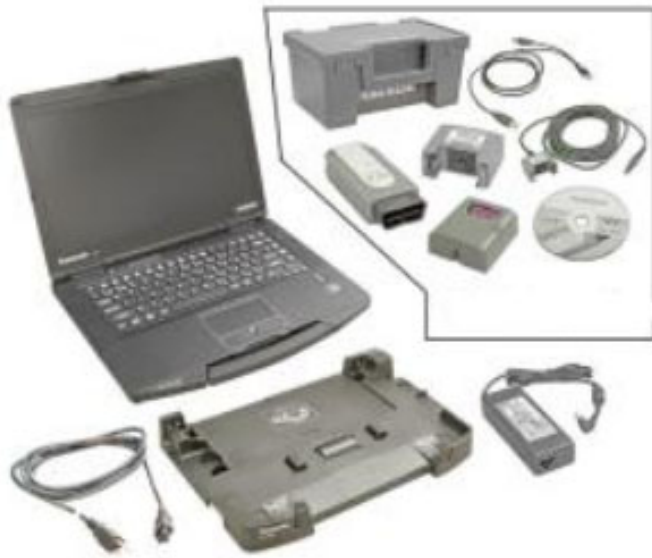
Repair Overview

- Activate flight mode.
- Update MIB3 infotainment system via SVM + USB drive.
- Perform bus sleep.
- Change communication path to DoIP.
- Update -J949- via SVM.
- Deactivate flight mode.
- Perform bus sleep.
- Clear repair related faults.

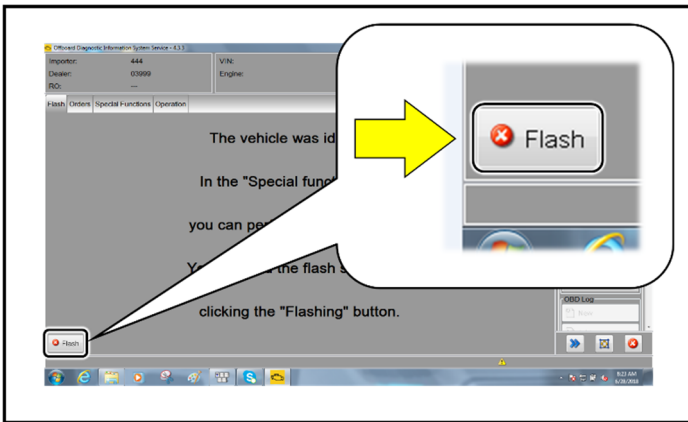
- Click "Flash" to exit the flash session.
