Compliance Recall

Code: 91DZ

Audi

Subject Rearview Camera Software

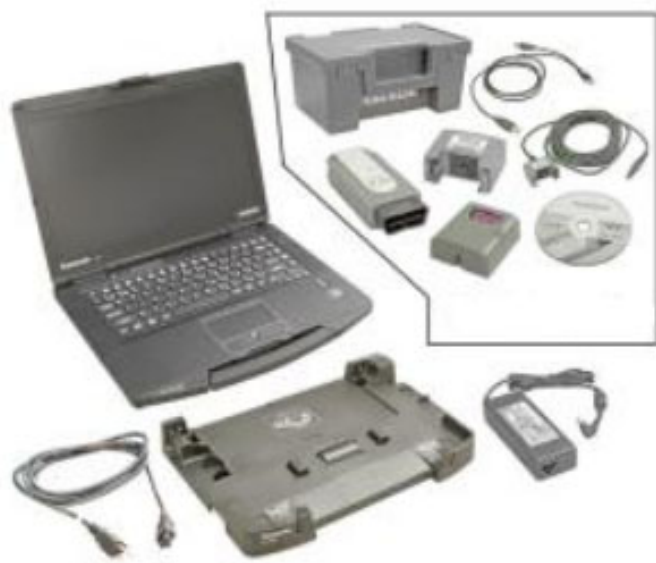
- Activate flight mode.
- Update MIB3 infotainment system via SVM + USB drive.
- Perform bus sleep.
- Change communication path to DoIP.
- Update -J949- via SVM.
- Deactivate flight mode.
- Perform bus sleep.
- Clear repair related faults.

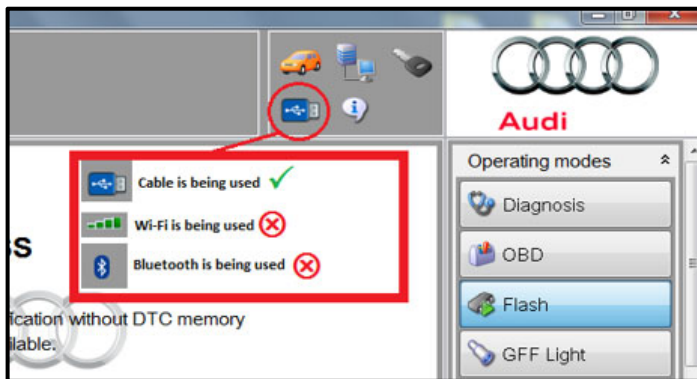
- Confirm that scan tool is communicating with the diagnostic head by USB cable.
 - If the Bluetooth or WiFi symbol is shown, then disconnect the diagnostic head from the vehicle and reconnect the USB cable to the diagnostic head and then reattach to the vehicle.

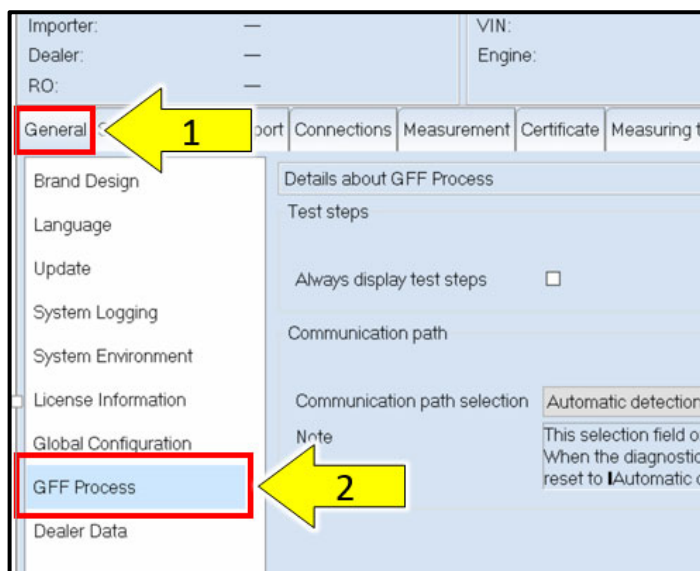
- From the “General” tab <arrow 1>, select “GFF Process” <arrow 2>.
