HYUNDAI
Technical Service Bulletin

GROUP RECALL	NUMBER 22-01-093H
DATE DECEMBER 2022	MODEL(S) SANTA FE (TMa) SONATA (DN8a/DN8) SANTA CRUZ (NXT) VELOSTER N (JSN) KONA N (OSN) ELANTRA N (CN7N)

SUBJECT: 8-SPEED WET DCT TCU UPDATE (RECALL 236)

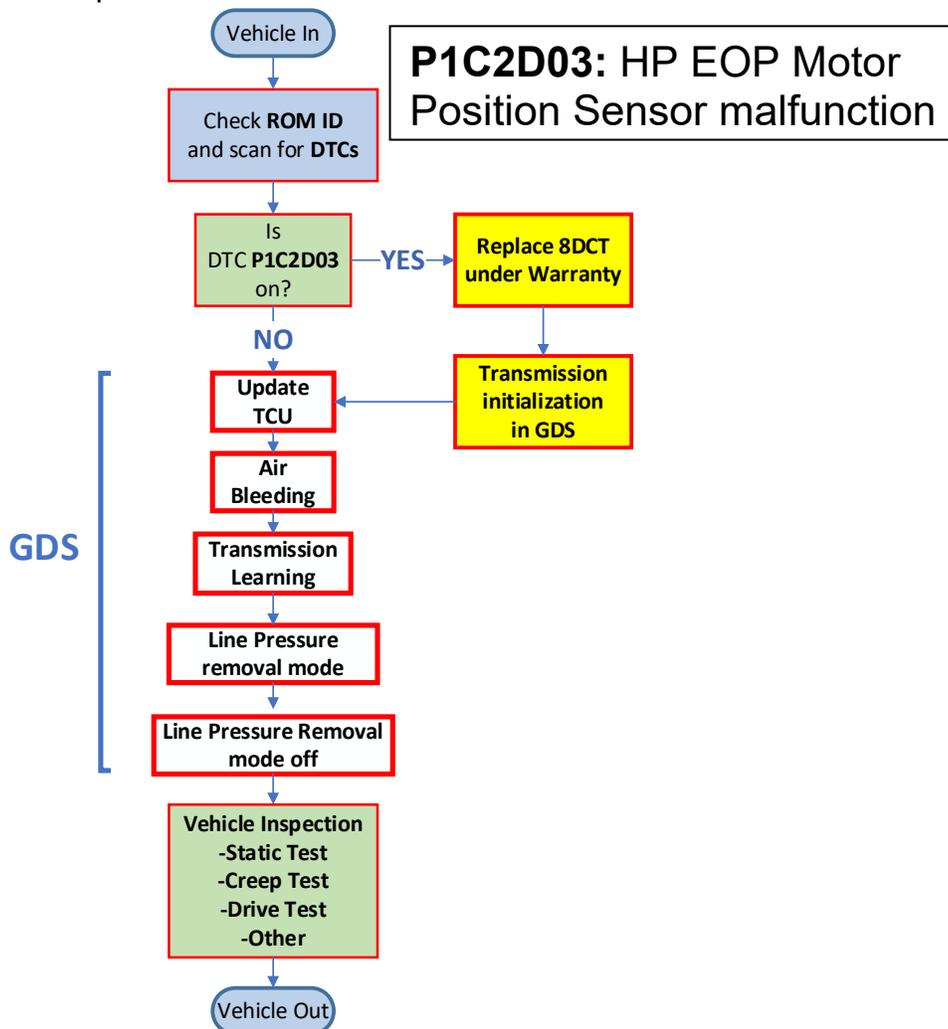
1. Refer to the flowchart below for overall procedure.

1. Check the ROM ID of the TCU of the vehicle.
2. Scan the vehicle for any DTCs.
3. If DTC P1C2D03 is **not** found, then proceed to Section B.
4. If the DTC **P1C2D03** is found, replace the DCT according to the shop manual. Then proceed to Section B.

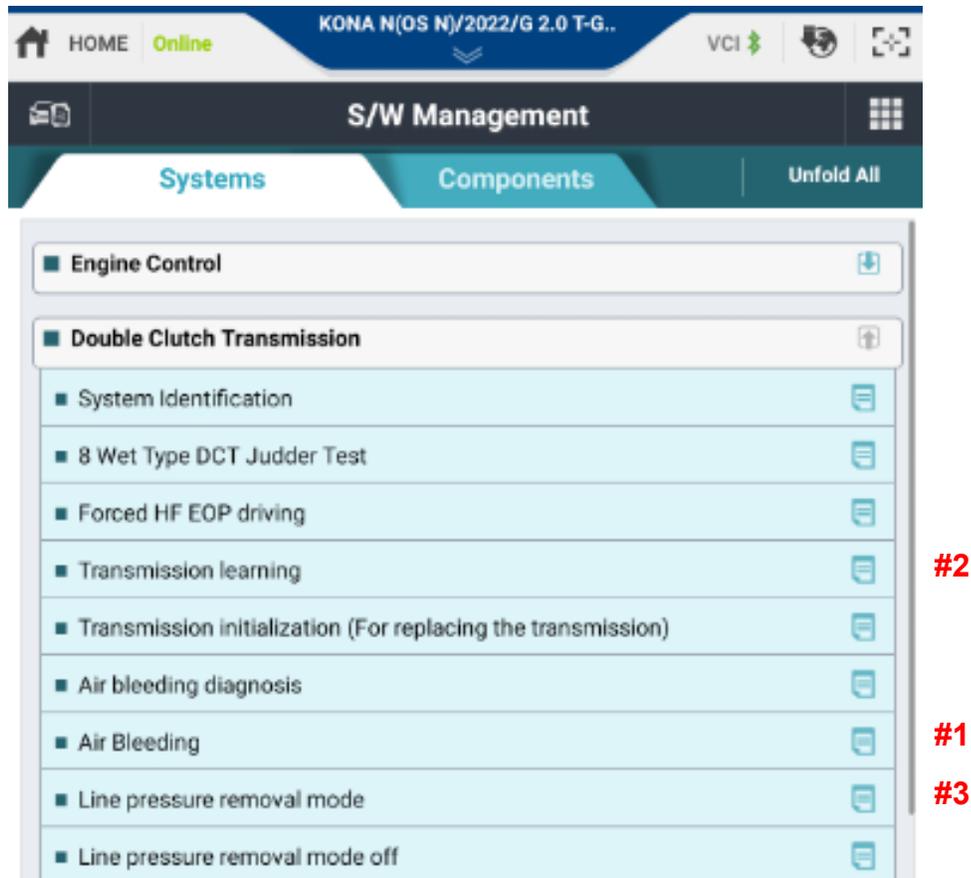
2. After performing the TCU Upgrade, select **S/W Management** and **Double Clutch Transmission** within the GDS. Perform the following procedures in the order shown.

3. After performing “Line pressure removal mode,” leave IG on and wait for **1 minute**.
4. Turn the **engine on** and let the engine idle for **1 minute**.
5. Turn the engine **off**. After 3 seconds, turn the **engine on again**.
6. With the engine running, scan the vehicle for DTCs.
- 6a. If DTC P086800 **is detected** – check and replace the control fluid according to the shop manual.
- 6b. If DTC P086800 **is not detected** – proceed to the next step.

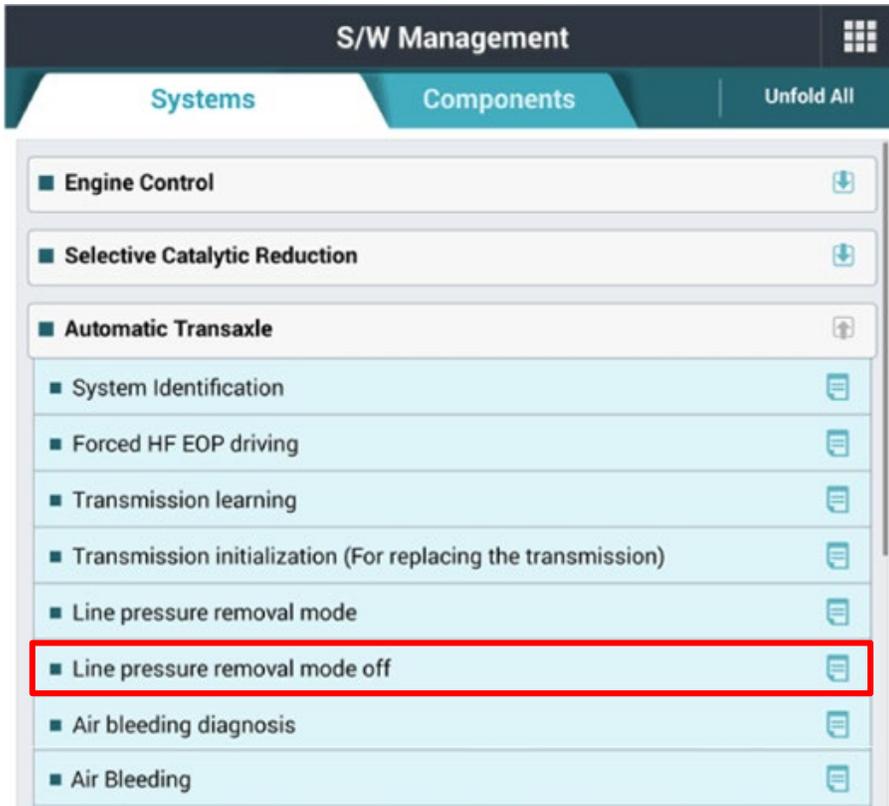
7. Perform the “Line pressure removal mode off” within the GDS.

If the “Line pressure removal mode off” is not performed, drivability concerns can occur (shift shock).
