VOLUNTARY RECALL CAMPAIGN

Classification: AN22-025	Reference: NTB22-090	Date: October 13, 2022
-----------------------------	-------------------------	---------------------------

VOLUNTARY SAFETY RECALL CAMPAIGN 2021-2022 ROGUE; INFOTAINMENT SYSTEM REPROGRAM

CAMPAIGN ID #: R22C1 and PC925
APPLIED VEHICLES: 2021-2022 Rogue (T33)
APPLIED GRADES: SL, SV And Platinum

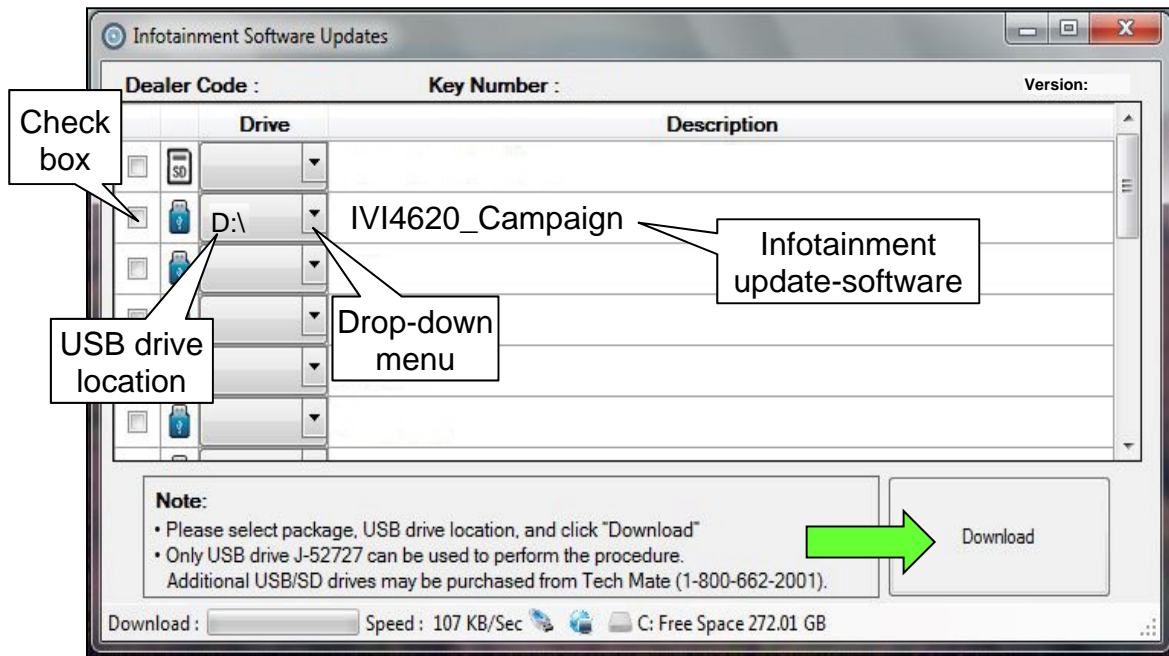
Figure 3

- Select the **Infotainment Update-Software** related to the model on the Repair Order (refer to **Table A** below).

6. Select **Download** (Figure 3 on page 4), and then wait for the download to complete.

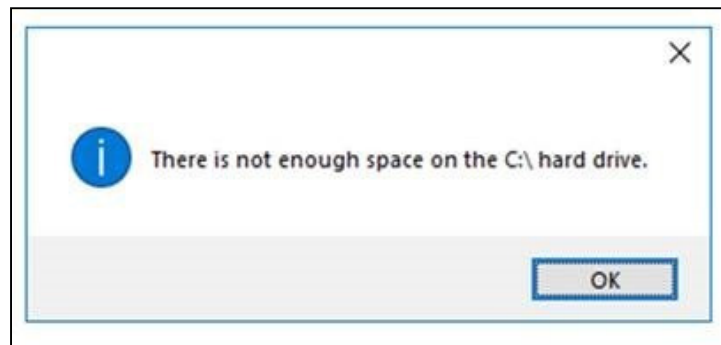
Figure 4

- The update-software is estimated to take **4 hours** to download to the USB drive.
- If, while attempting to download the software to the CONSULT PC, you receive the message shown in Figure 4:
 - a. First attempt to clear space on the CONSULT PC hard drive.
 - b. If space cannot be cleared and a second CONSULT PC is available with space, use it and start over from step 1 on page 3.

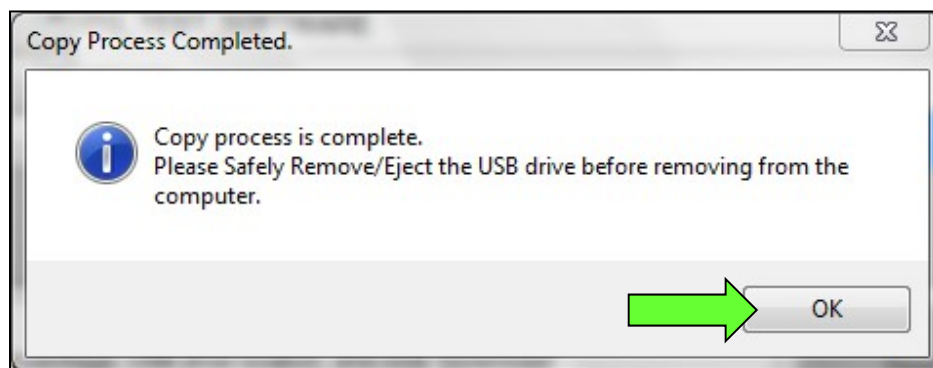
Figure 5

7. Select **OK**.

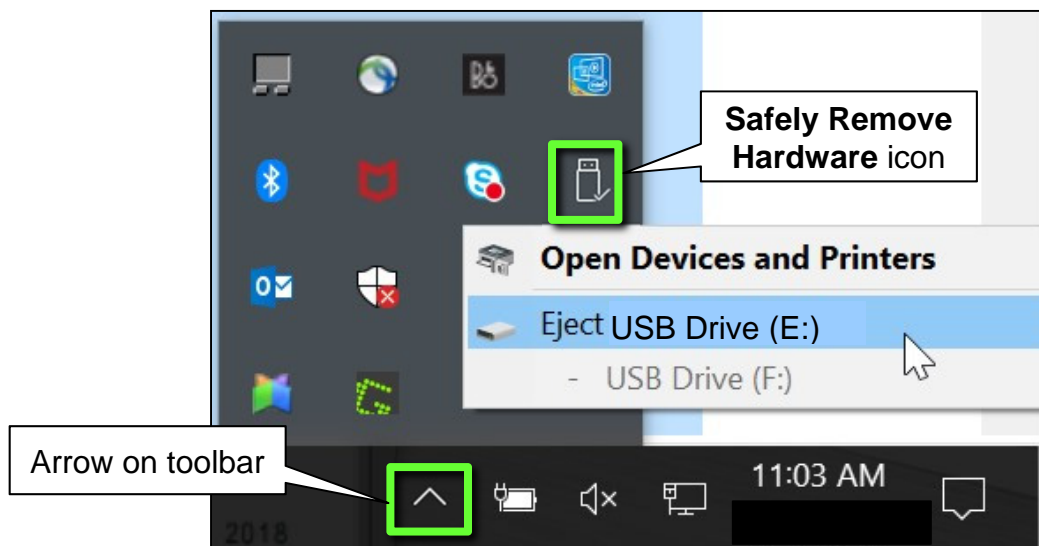
Figure 6

8. Once the transfer is complete, safely remove the USB drive from the CONSULT PC.
 - a. From the PC toolbar, select the **Safely Remove Hardware** icon.
 - o The icon is on the toolbar, or can be found after selecting the arrow.
 - b. Select the USB drive to be removed, and then remove the USB drive from the CONSULT PC.

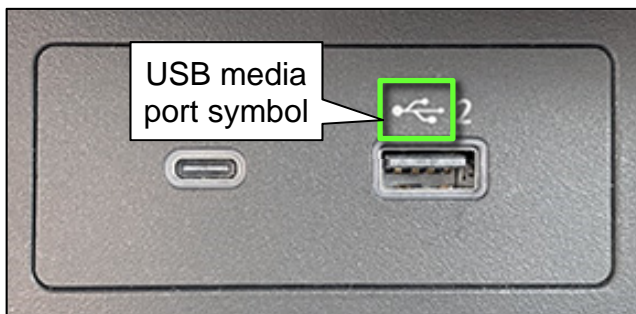
Figure 7

11. Insert the USB drive with the infotainment update-software into the vehicle's USB media port (Figure 7).

HINT: Charging ports are marked in the vehicle with a “lightning bolt” symbol.

Do not insert the USB drive into a charging port. If used, the update-software and/or USB drive may become damaged. Only insert the USB drive in a USB media port.

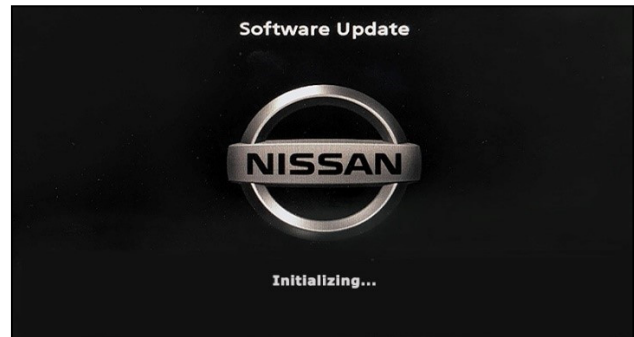
12. Wait approximately 10-30 seconds for the screen in Figure 9 to appear.

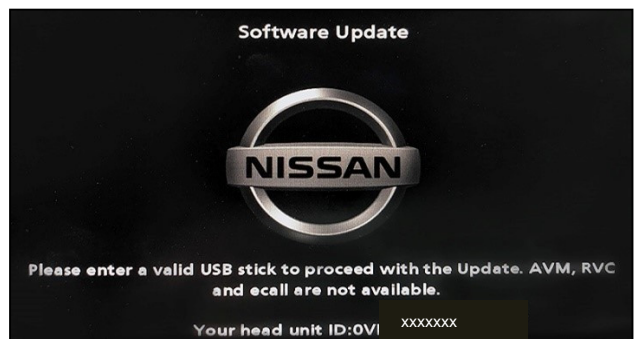
- The screen in Figure 10 may briefly appear. **Do not remove the USB drive.** The audio system will detect the USB drive and continue the update.

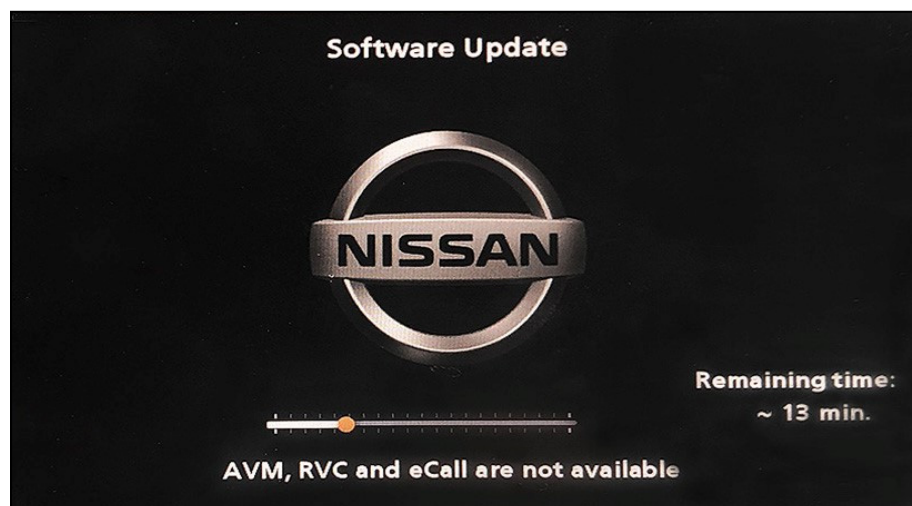
Figure 11

13. Wait for the update to complete.
 - Follow the on-screen instructions while waiting.

HINT: The update may take 15-25 minutes.

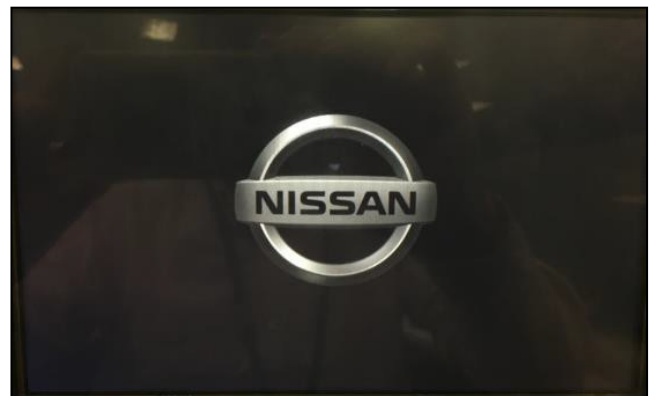
Figure 13

15. Allow the reboot to complete (approximately 30 seconds).
 - The Nissan logo will be displayed during the reboot.
16. Turn the ignition OFF.

21. Turn the ignition ON (engine OFF) and wait for the Nissan logo to appear (Figure 13 on page 9).
 - If the Nissan logo does not appear (this might take up to 30 seconds), start over from step 16 on page 9.

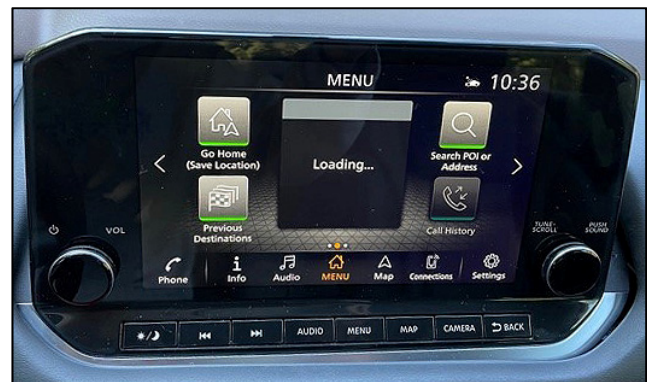
22. After the Nissan logo appears, wait about 1 minute.
 - The **MENU** (Home) screen in Figure 14 will be displayed.
