Compliance Recall

Code: 45J7

Subject	TPMS Software																				
Release Date	November 09, 2022																				
Affected Vehicles

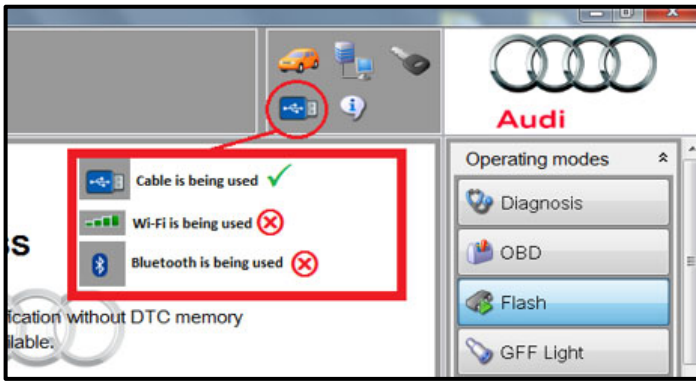
- Confirm that scan tool is communicating with the diagnostic head by USB cable.
 - If the Bluetooth or WiFi symbol is shown, then disconnect the diagnostic head from the vehicle and reconnect the USB cable to the diagnostic head and then reattach to the vehicle.

- ✓ **The VAS Diagnostics Interface MUST ONLY be connected to the tester with a USB cable.**
 - Performing a software update using a Bluetooth or WiFi connection increases the risk of losing connection during the update, which could result in damage to the control module. It also greatly increases the time required to perform the update. Requests for additional time or parts will be denied if the GFF log shows the update was performed using Bluetooth or WiFi.

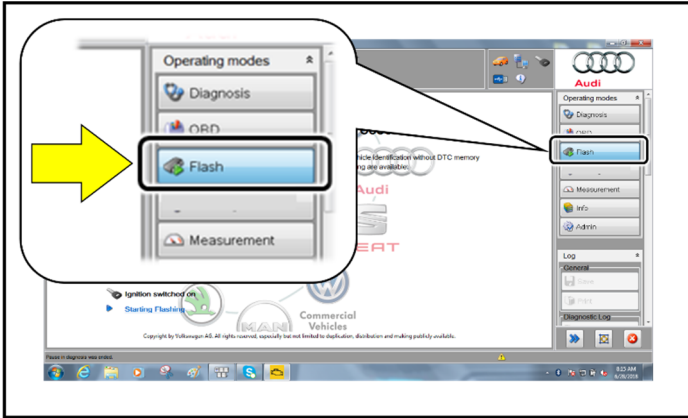
- From the home screen of the scan tool highlight “Flash” <1>.
- Follow the on-screen prompts.

NOTE
 Operating mode “Flash” must be used. Performing this update using “Diagnosis” (Guided Fault Finding) could result in non-payment of the claim.

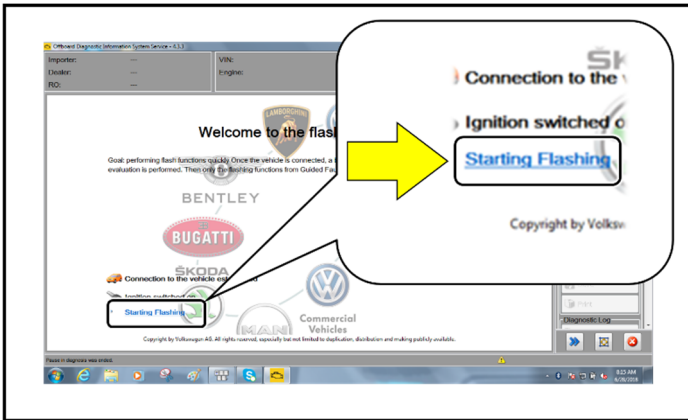
- Select “Starting Flashing” and follow the on-screen prompts.

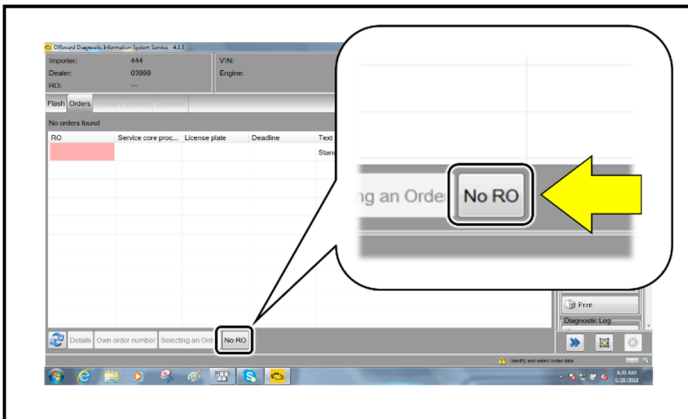
- Select “No RO”.

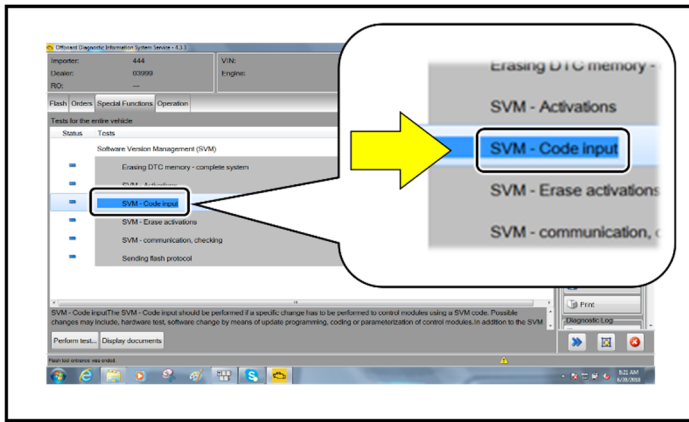
- Highlight “SVM – Code Input”.

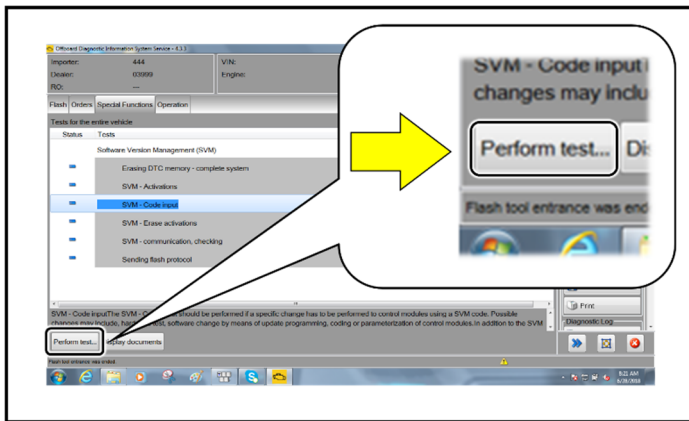
- Select “Perform test”.

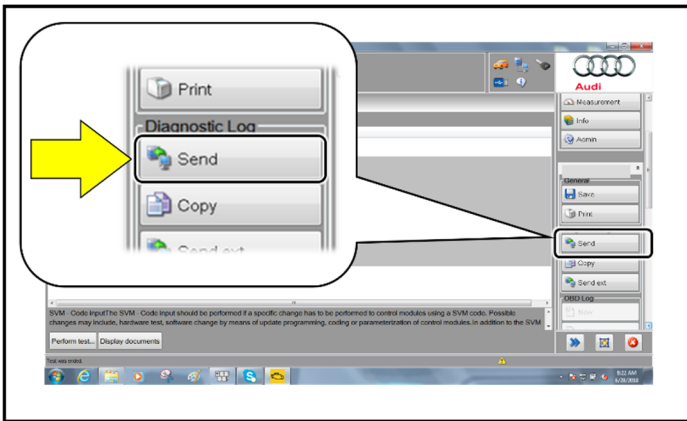
- After receiving confirmation that the flash completed successfully, select "Send" to send the diagnostic protocol online.
- Follow the on-screen prompts.

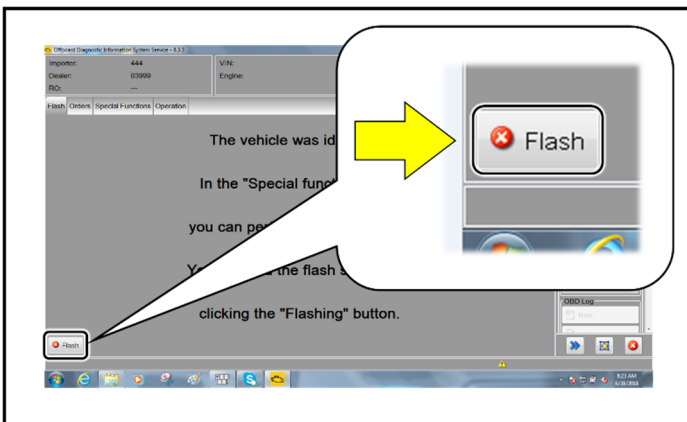
- Click "Flash" to exit the flash session.
- **Proceed to Section C.**
