N222382220 Daytime Running Lights (DRL) May Not Deactivate When Headlamps Are On

Release Date: November 2022 Revision: 00

Condition	General Motors has decided that certain 2021 model year GMC Yukon and Yukon XL vehicles, Chevrolet Tahoe and Suburban vehicles, and Cadillac Escalade and Escalade ESV vehicles fail to conform, in part, to Federal/Canada Motor Vehicle Safety Standard (F/CMVSS) No. 108, "Lamps, reflective devices, and associated equipment." The daytime running lamps (DRLs) may not deactivate when the headlamps are on. If the DRLs do not deactivate when the headlamps are on, the resulting glare could increase the risk of a crash.			
Correction	General Motors will update the software in the vehicles' Body Control Module (BCM) to correct the			
	condition.

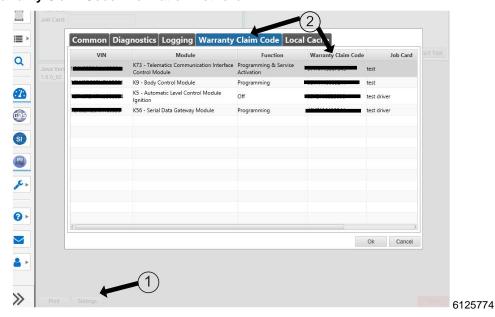
Warranty Claim Code Information Retrieval

If the Warranty Claim Code was not recorded on the Job Card, the code can be retrieved in the SPS2 system as follows:

- 1. Open TLC on the computer used to program the vehicle.
- 2. Select and start SPS2.
- Select Settings (1).
- 4. Select the Warranty Claim Code tab (2).

The VIN, Warranty Claim Code and Date/Time will be listed on a roster of recent programming events. If the code is retrievable, dealers should resubmit the transaction making sure to include the code in the SPS Warranty Claim Code field.

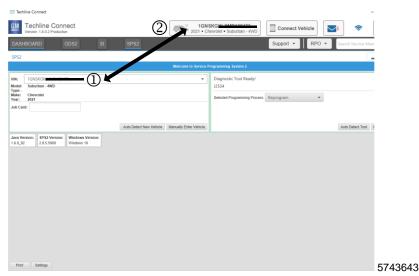
Caution: Be sure the VIN selected in the drop down menu (1) is the same as the vehicle connected (2) before beginning programming.

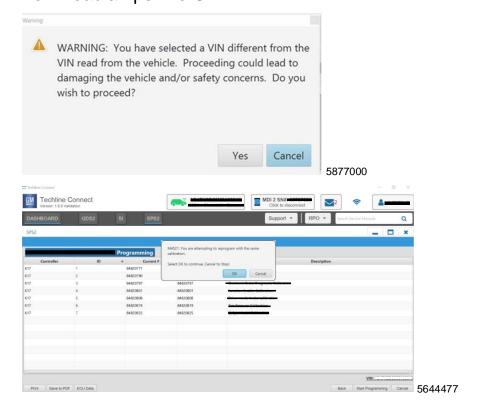
Important: If the vehicle VIN DOES NOT match, the message below will be shown.

Important: Techline Connect screens shown above.
