Compliance Recall Code: 91EN

Subject	Windshield	Wiper Softw	are		
Release Date	December 08	3, 2022			
Affected Vehicles	Country	Beginning Model Year	Ending Model Year	Vehicle	Vehicle Count
	USA	2016	2016	GOLF R	5
	CAN	2016	2016	GOLF R	3
	 Check Campaigns/Actions screen in ELSA on the day of repair to verify that a VIN qualifies for repair under the action. ELSA is the <u>only</u> valid campaign inquiry & verification source. ✓ Campaign status must show "open." ✓ If ELSA shows other open action(s), inform your customer so that the work can also be completed a the same time the vehicle is in the workshop for this campaign. 				
Problem Description	Incorrect windshield wiper (front) software was installed during vehicle production and, in rar cases, the wipers may not be activated due to a software fault. This is noncompliant wit regulatory requirements. If the windshield wipers cannot be activated, it may lead to reduce visibility for the driver and may increase the risk of a crash.

Repair Instruction

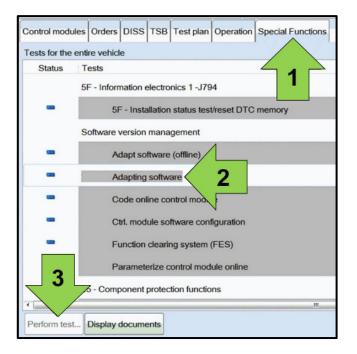
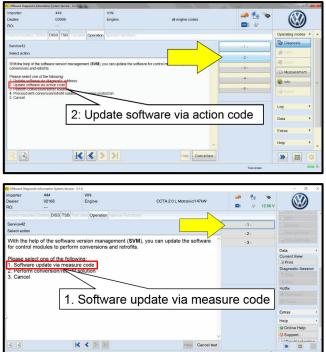
- Confirm that scan tool is communicating with the diagnostic head by USB <Green Arrow>.
 - If the Bluetooth symbol is shown <Red Arrow> then disconnect the diagnostic head from the vehicle and reconnect the USB cable to the diagnostic head and then reattach to the vehicle.
- Upon ODIS startup, verify the "Diagnosis" operating mode is selected <as shown>.
- Once the GFF scan is complete, select "Special functions" <arrow 1>, then "Adapting software" <arrow 2>, then select "Perform test" <arrow 3>.
