F/CMVSS Noncompliance Recall

N222370090 Increased Stopping Distance During Certain Brake Vacuum Loss Events

Release Date: September 2022

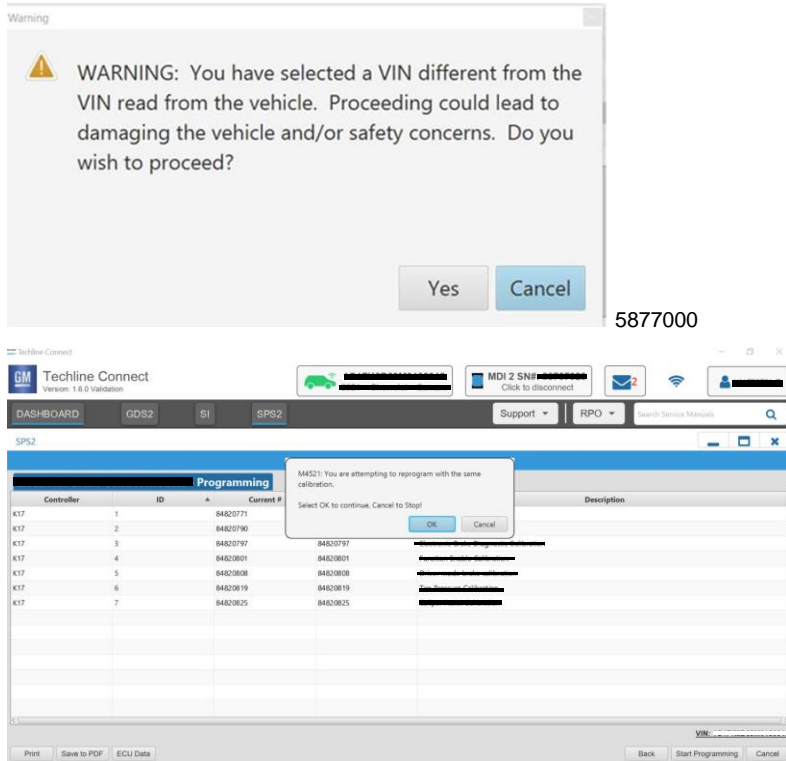
Important: If the vehicle VIN DOES NOT match, the message below will be shown.

Important: Techline Connect screens shown above.
