PREVOST

**SAFETY
RECALL**

SR23-02

DATE :	January 2023	SECTION :	06 ELECTRICAL
SUBJECT:	ENGINE REAR STOP BUTTON

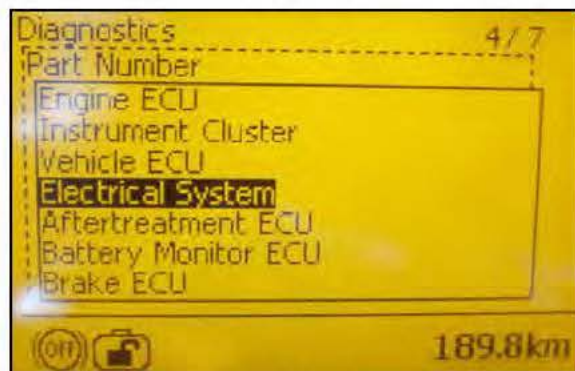
Figure 3

4. Select Electrical System menu.

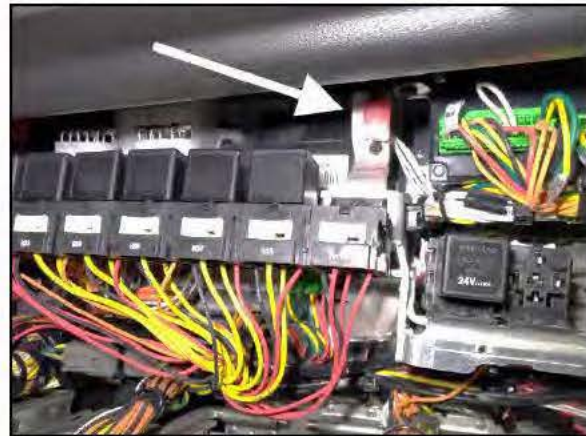
Figure 5

1. Connect the 110 power line on the vehicle.
2. Turn the ignition to "ON" position.
3. Activate the Hazard flashers.
4. Locate the RS232 serial port into the front service compartment at the right top corner.

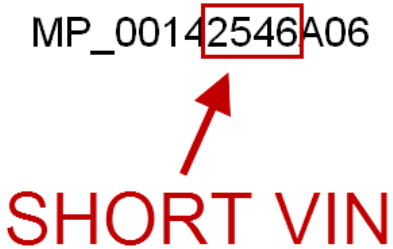
SHORT VIN

The name of the file that you received should match with the VIN of the vehicle you are about to update. It should look like this example: MP_00142546A06.exe.txt. The four numbers before the last letter are the last 4 numbers of the VIN (short VIN).

MP_00142546A06
