FL966 A-G

Creation Date:	October 2023
Revised Date:	July 2025
NHTSA #	23V-073
Transport Canada #	2023-051

Subject: Brake Modulator Valves

Models Affected: Specific model years 2017-2022 Freightliner 114SD, and Cascadia; and Western Star 47X, and 49X vehicles manufactured June 28, 2016, through April 8, 2022.

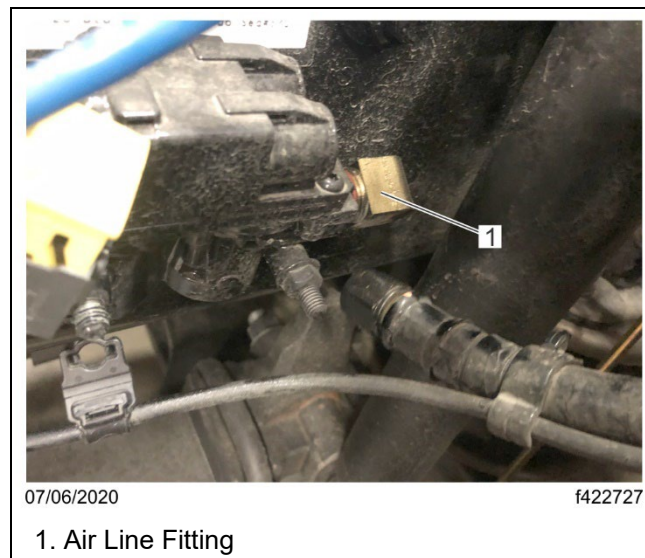
Fig. 9, Loosening the Brake Chamber Air Line Fitting

7. Use a 23-mm wrench to loosen the brake chamber air line fitting on the modulator valve. See [Fig. 9](#).

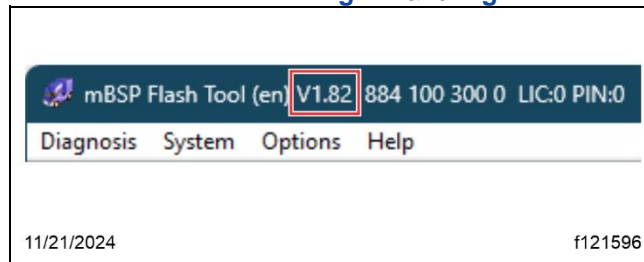
Fig. 20, mBSP Flash Tool Software Version

- An mBSP flash tool software version v1.90 (or later), as shown in **Fig. 20**, is required to perform this ABS ECU software update procedure.

NOTE: The latest version of mBSP flash tool must be obtained to correctly update the ABS ECU software (v1.90 at time of publication). The version shown in Images below are for reference only and DOES NOT depict the latest version.

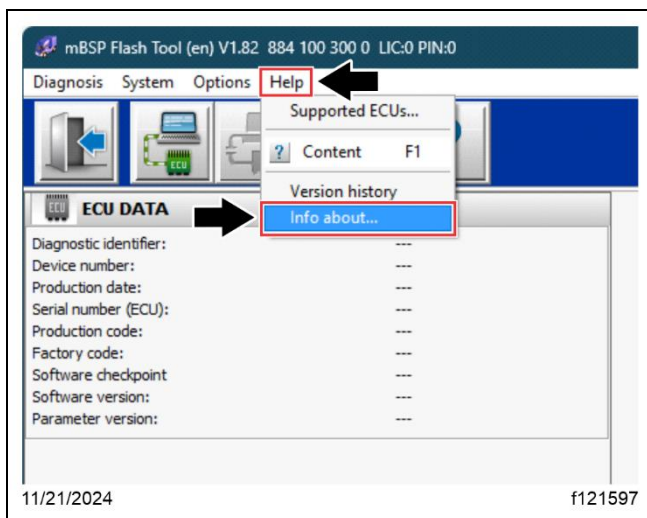
Fig. 21, Opening the Info About Diagnostic Software Window

If the mBSP flash tool software is already installed, check the software version of the mBSP Flash Tool. From the menu bar, select 'Help,' then select 'Info about...'. See **Fig. 21** and **Fig. 22**.

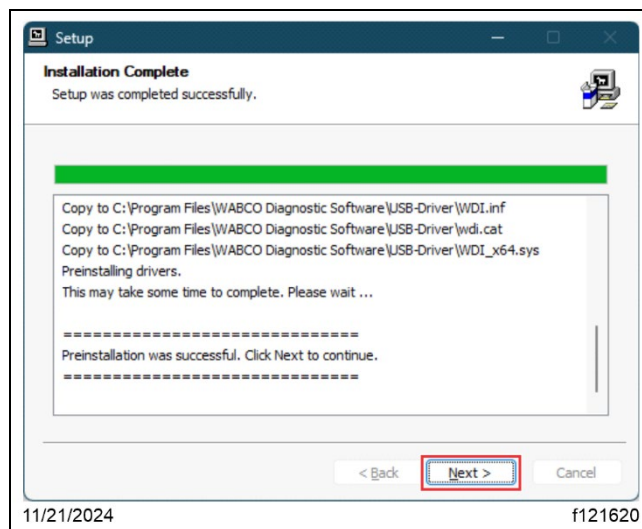
Fig. 42, Installation Complete

7.15. The 'Installation Complete' screen appears once the setup is completed successfully. Select 'Next' to continue. See [Fig. 42](#).

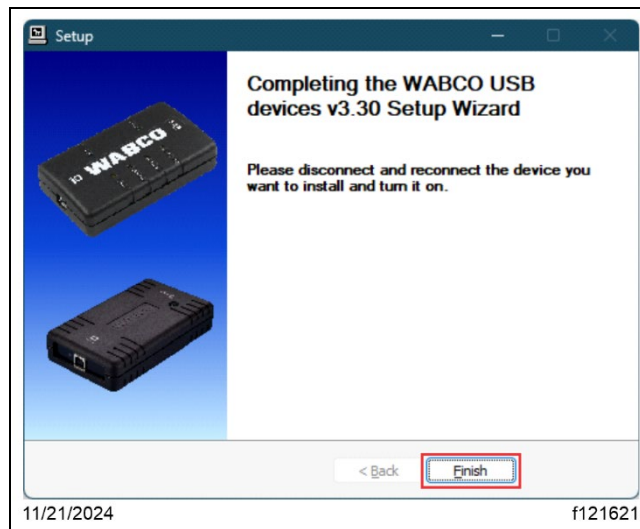
Fig. 43, Completing the WABCO USB Devices Setup Wizard

7.16. Select 'Finish' to complete the WABCO USB v3.30 setup wizard. See [Fig. 43](#).

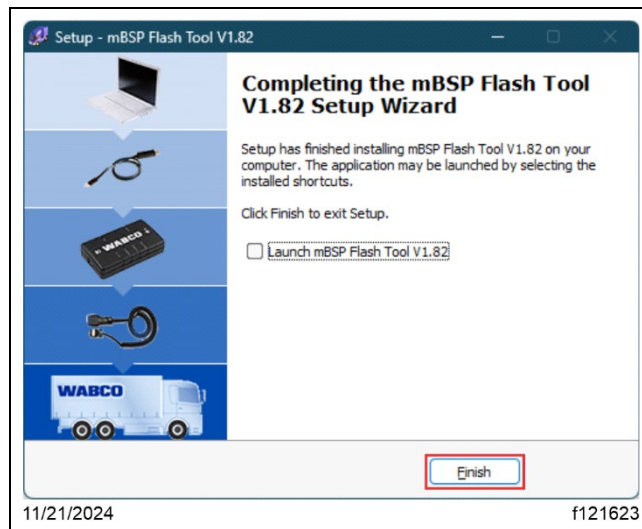
Fig. 45, Completing the mBSP Flash Tool Setup Wizard

7.18. Select 'Finish' to complete the mBSP Flash Tool V1.82 setup wizard. See [Fig. 45](#).

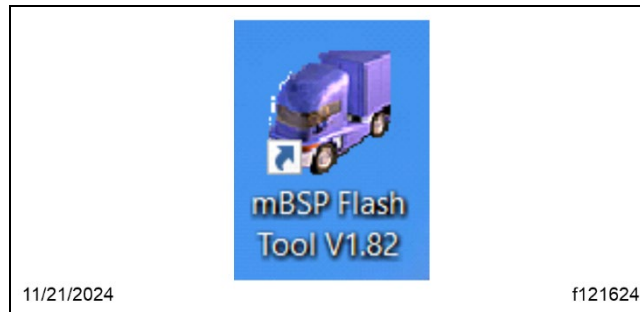
Fig. 46, mBSP Flash Tool Desktop Shortcut

10. Double-click the 'mBSP Flash Tool V1.85' shortcut on the desktop to launch the application. See [Fig. 46](#).

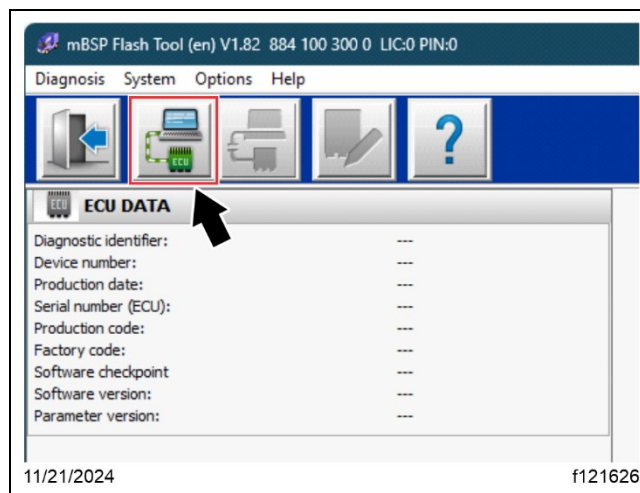
Fig. 48, Initializing the ECU and Switching to Diagnostic Mode

12. If the ECU does not automatically connect, select the button, shown in **Fig. 48**, to initialize the ECU and switch to diagnostic mode.

IMPORTANT: The ECU may not connect automatically due to wrong adaptor settings. To make sure the correct adaptor settings are selected, go to 'Options,' 'Settings,' then 'Change port.'

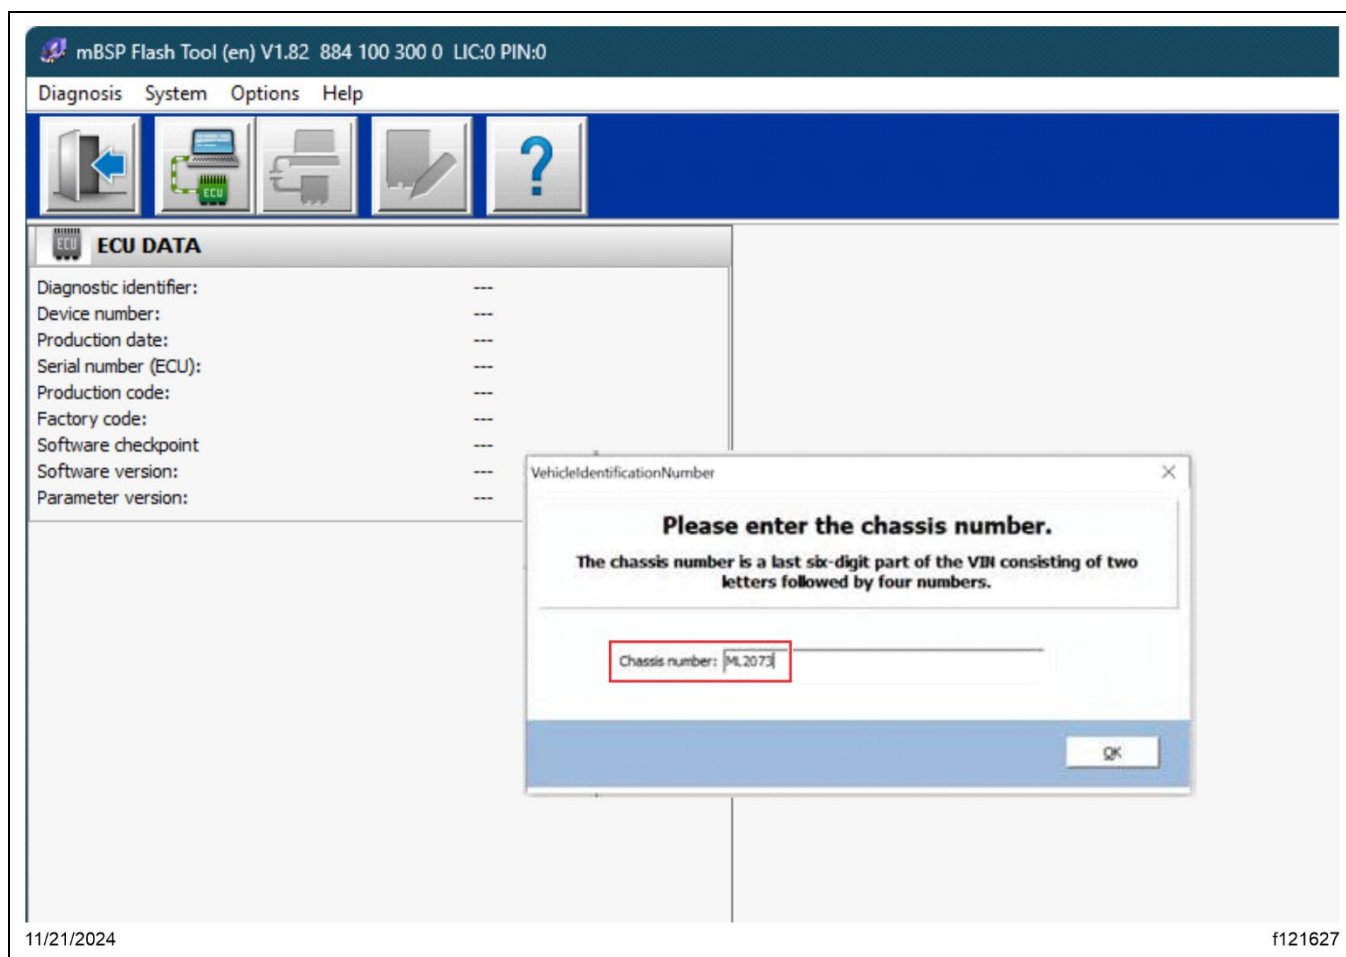
Fig. 49, Entering the Chassis Number

13. A window will now open, requesting the chassis number to be entered. The chassis number is the last six characters of the VIN that consists of two letters followed by four numbers (also known as serial number). Enter the vehicle chassis number. See [Fig. 49](#).

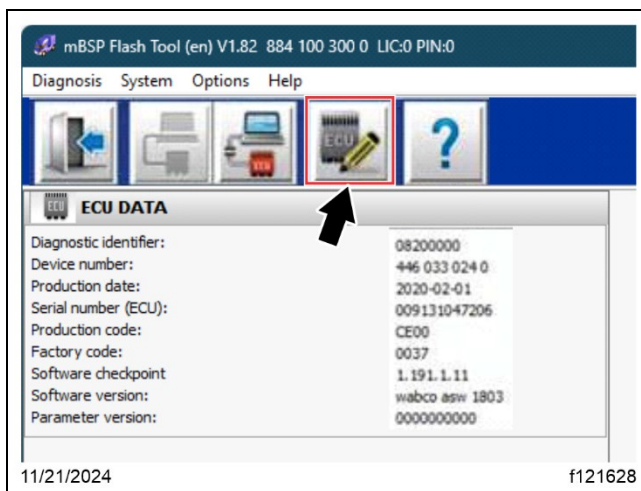
Fig. 50, Beginning the ECU Update

14. Select the 'ECU software update' button to begin the ECU update. See [Fig. 50](#).

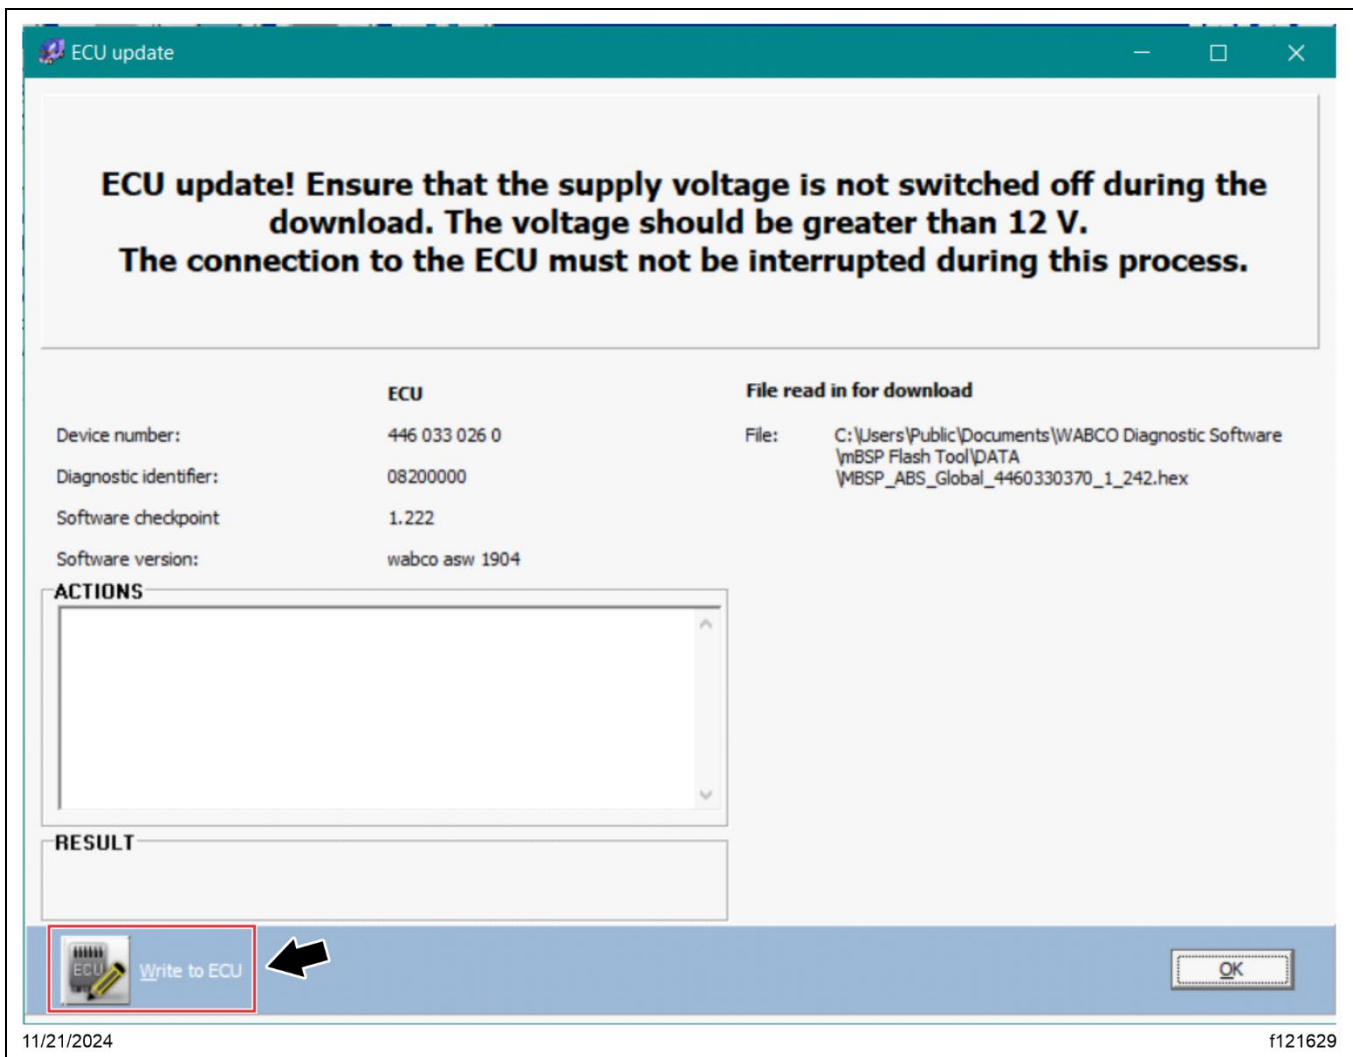
Fig. 51, Selecting the Write to ECU Button

15. In the 'ECU update' window, select the 'Write to ECU' button to begin the ECU update. Note that pressing the 'OK' button cancels the flash tool process. See [Fig. 51](#).

The update may take several minutes (approximately 30 minutes). Do not disconnect the vehicle, turn the key to the OFF position, or allow the laptop to go to sleep during this process.

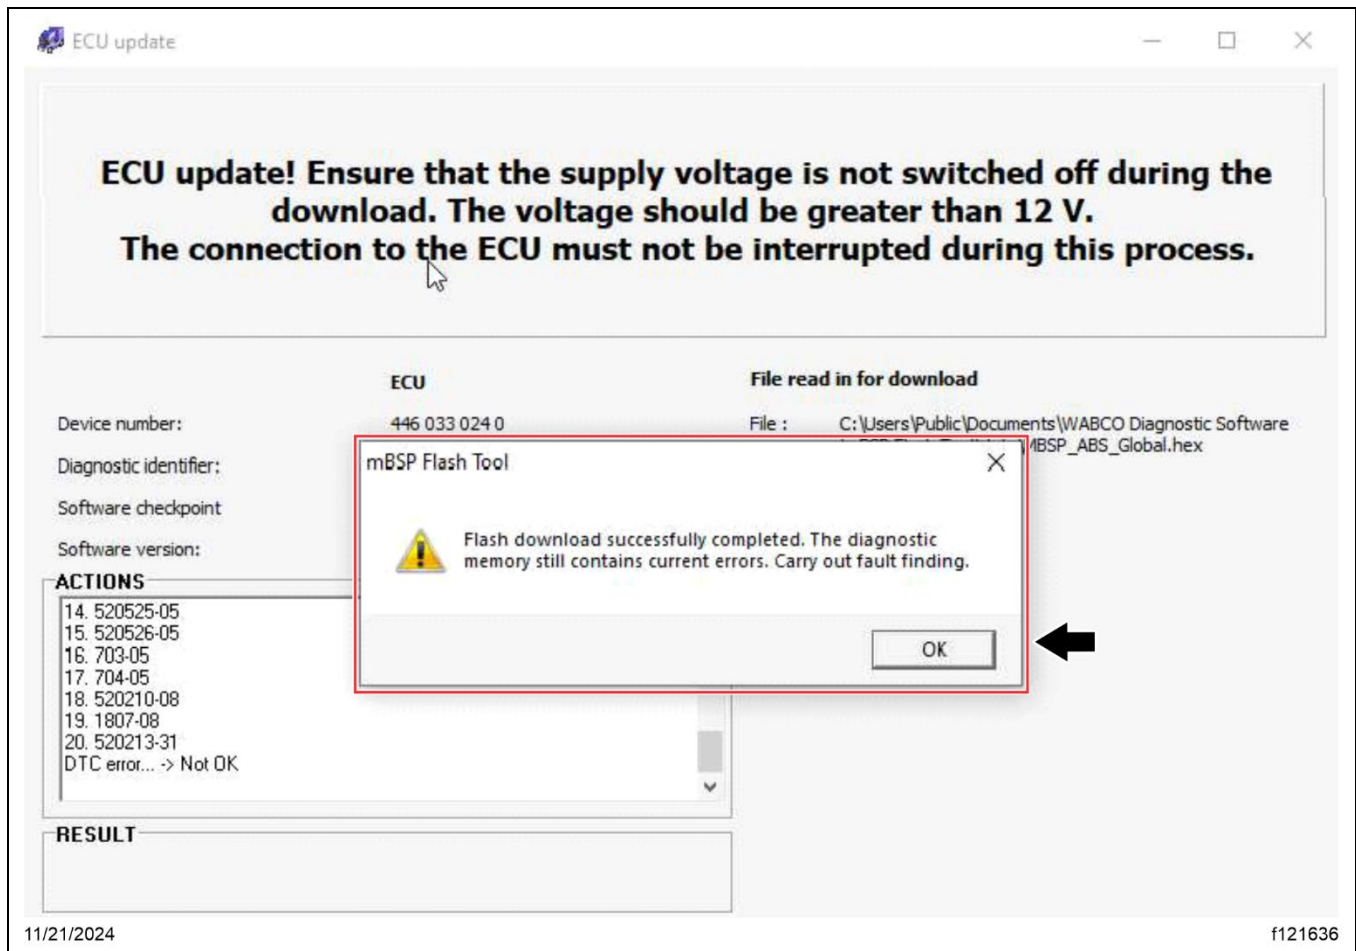
Fig. 56, ECU Update Successful

- When the flash tool completes a successful ECU update, an error message is displayed advising that ABS fault codes will be present requiring an ESC Calibration procedure. Select 'OK' and close the flash tool application. In some cases, the flash tool may show an error message, lock up, or close unexpectedly. Follow the substeps to verify the flash tool update has been successfully written to the ABS ECU. See [Fig. 56](#).

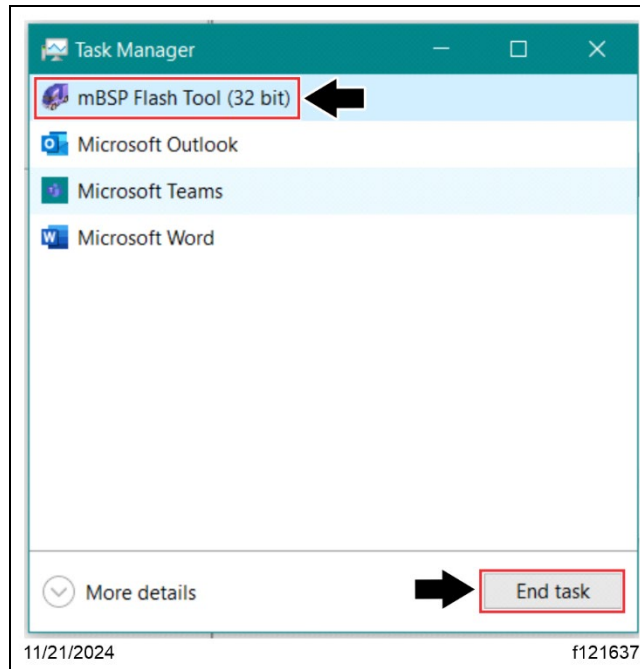
Fig. 57, Task Manager

- 17.2. Go to 'Task Manager' on the computer and make sure the flash tool application is closed. Select 'mBSP Flash Tool,' then select the 'End Task' button. See [Fig. 57](#).

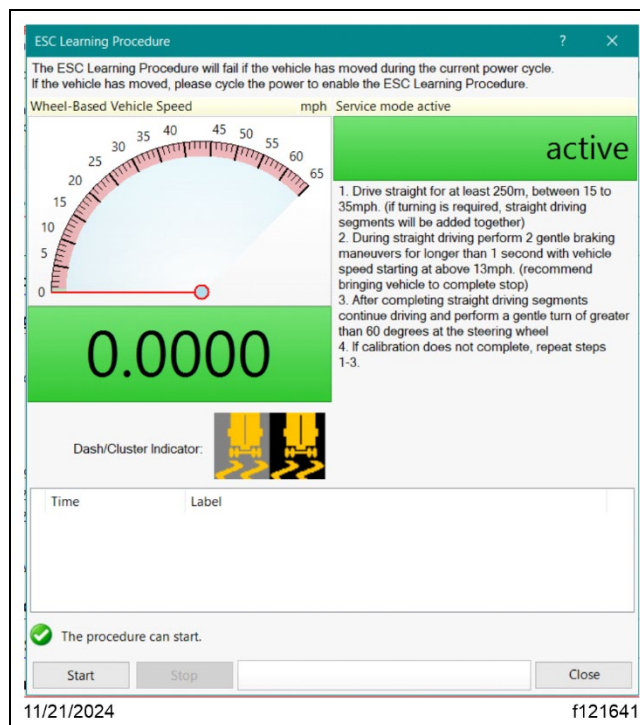
Fig. 60, ESC Calibration in DiagnosticLink

18. The ABS ECU is now in the ESC calibration mode. Use either WABCO TOOLBOX or DiagnosticLink to perform the ESC Calibration procedure. Complete the driving portion of the End of Line (EOL) procedure. After approximately 100 yards of straight-line driving and then a 90- to 180-degree turn is recorded by the ABS ECU, the stability lamp on the dash will turn off. See [Fig. 60](#).

NOTE: ESC calibration is required after the flashing process is complete.
