SUBJECT: NEW VEHICLE DEMONSTRATION / DELIVERY HOLD

Compliance Recall 23C04

Certain 2023 Model Year Maverick XL, XLT, and Lariat Trim Packages

Trailer Tow Taillamp Wiring Replacement

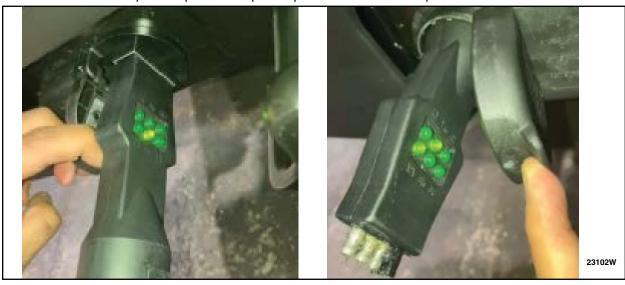
FIGURE 2

- 2. From the rear of the vehicle, test the trailer connector by using the tester in the 4-way or 7-way connector. On a 4-way connector, light number 5 will be visible. On a 7-way connector lights numbers 2 and 4 will be visible. See Figure 2. Did the correct light(s) become visible based on the connector being tested?
 - Yes Passes inspection Recall complete.
 - No Does not pass inspection repair required. Continue to Step 3.

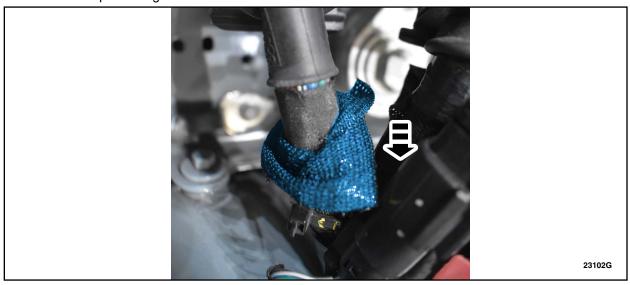
FIGURE 6

8. Remove tape from Power Distribution Box (PDB) connector C1035B, and roll down the wire covering to the tie strap. See Figure 6.

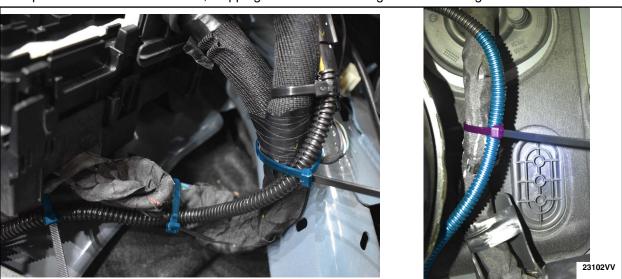
FIGURE 14

17. Zip-tie to the identified harness, stopping at the driver's side grommet. See Figure 14.

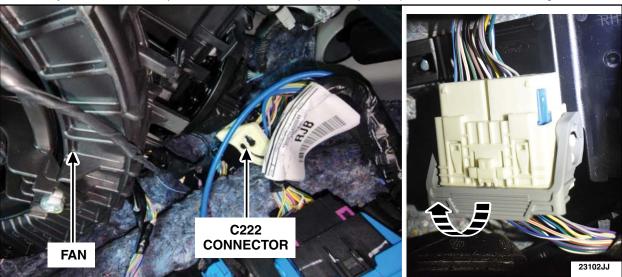
FIGURE 19

22. Identify connector C222 (black connector with white lever). Unclip and disconnect. See Figure 19.

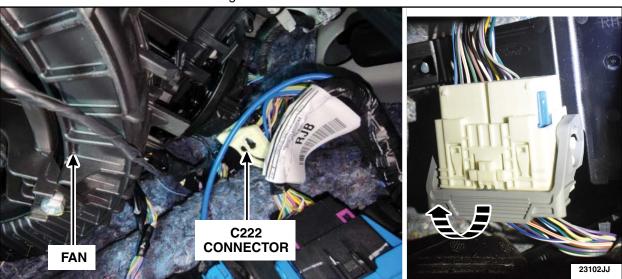
FIGURE 24

28. Reconnect connector C222. See Figure 24.

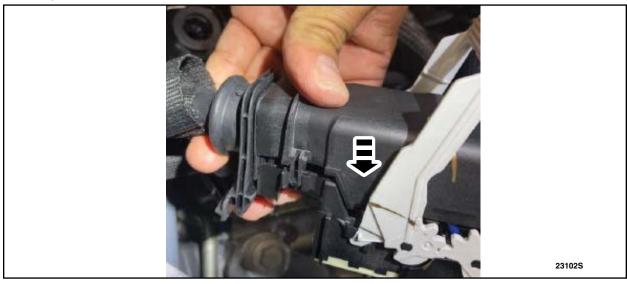
FIGURE 26

31. Clip the C1035B connector cover in place, ensuring that no wires are caught. See Figure 26.

NOTE: Ensure that the plastic eyelet is well positioned and that a click is heard when the cover is put into place.

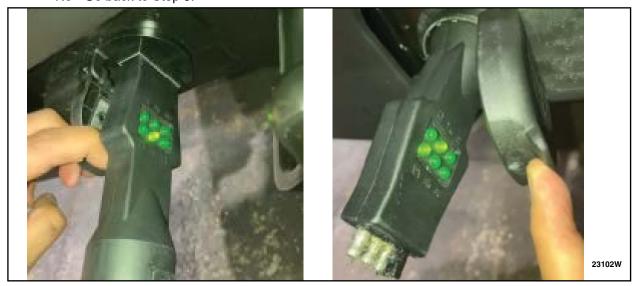
FIGURE 30

36. From the rear of the vehicle, test the trailer connector by using the tester into the 4-way or 7-way connector. On a 4-way connector, light number 5 will be visible. On a 7-way connector lights numbers 2 and 4 will be visible. See Figure 30. Did the correct light(s) become visible based on the connector being tested?

Yes - Recall complete.

No - Go back to Step 3.

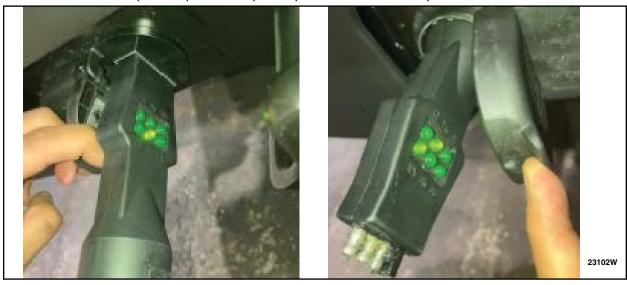
FIGURE 2

- 2. From the rear of the vehicle, test the trailer connector by using the tester into the 4-way or 7-way connector. On a 4-way connector, light number 5 will be visible. On a 7-way connector lights numbers 2 and 4 will be visible. See Figure 2. Did the correct light(s) become visible based on the connector being tested?
 - Yes Passes inspection Recall complete.
 - No Does not pass inspection repair required. Continue to Step 3.

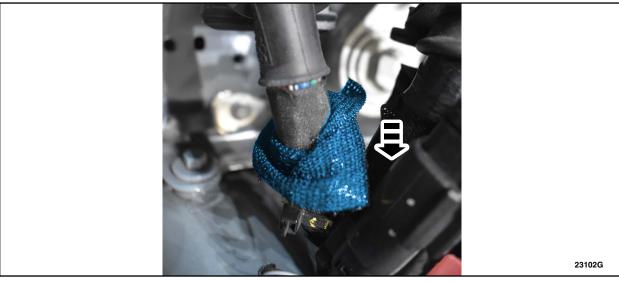
FIGURE 7

10. Remove tape from Power Distribution Box (PDB) connector C1035B, and roll down the wire covering to the tie strap. See Figure 7.

NOTE: C1035B connector is black, when plugged into the PDB it is located on the left side.

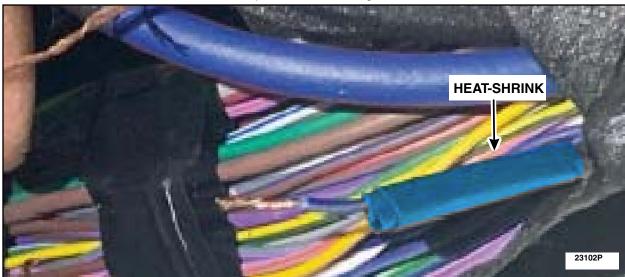
FIGURE 15

18. Place 30 mm of heat-shrink on each exposed wire. See Figure 15.

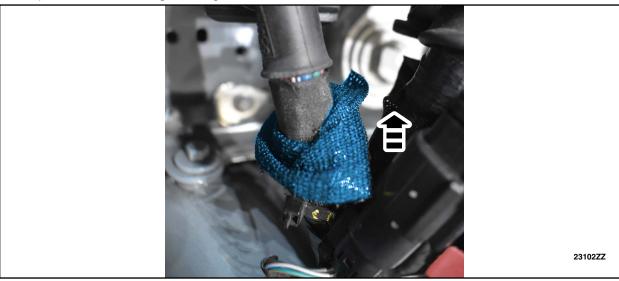
FIGURE 19

22. Reposition wire covering. See Figure 19.

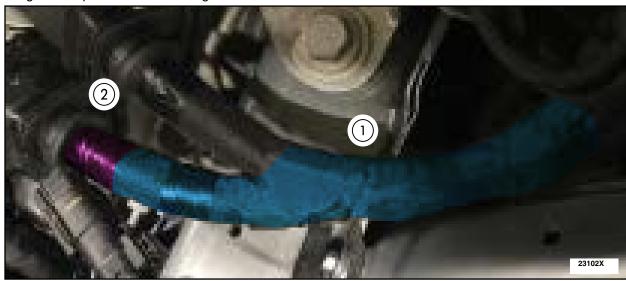
FIGURE 20

23. Apply anti-abrasive tape to the wire branch, covering all exposed wires. Apply vinyl tape to secure the grommet point as well. See Figure 20.

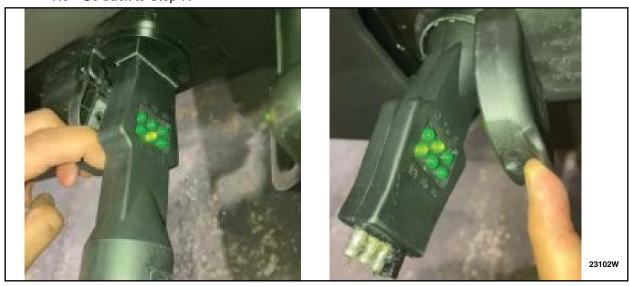
FIGURE 22

26. From the rear of the vehicle, test the trailer connector by using the tester into the 4-way or 7-way connector. On a 4-way connector, light number 5 will be visible. On a 7-way connector lights numbers 2 and 4 will be visible. See Figure 22. Did the correct light(s) become visible based on the connector being tested?
