SUBJECT: **NEW VEHICLE DEMONSTRATION / DELIVERY HOLD**
Compliance Recall 23C04 - Supplement #1
Certain 2023 Model Year Maverick XL, XLT, and Lariat Trim Packages
Trailer Tow Taillamp Wiring Replacement

NEW VEHICLE DEMONSTRATION / DELIVERY HOLD
Compliance Recall 23C04 - Supplement #1
Certain 2023 Model Year Maverick XL, XLT, and Lariat Trim Packages
Trailer Tow Taillamp Wiring Replacement

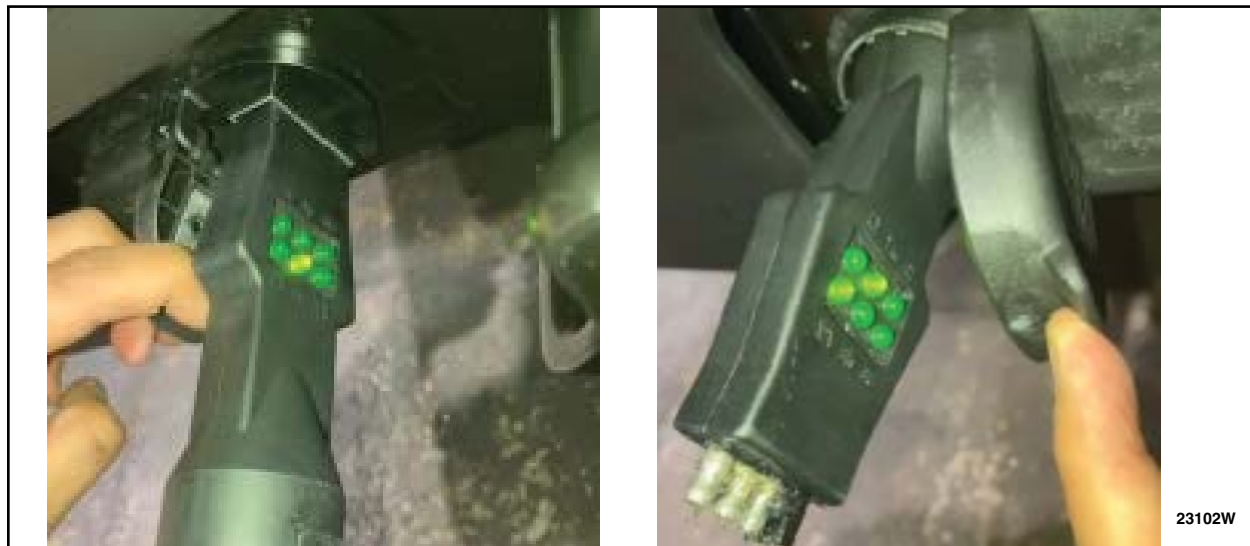
FIGURE 2

2. From the rear of the vehicle, test the trailer connector by using the tester in the 4-way or 7-way connector. On a 4-way connector, light number 5 will be visible. On a 7-way connector lights numbers 2 and 4 will be visible. See Figure 2. Did the correct light(s) become visible based on the connector being tested?

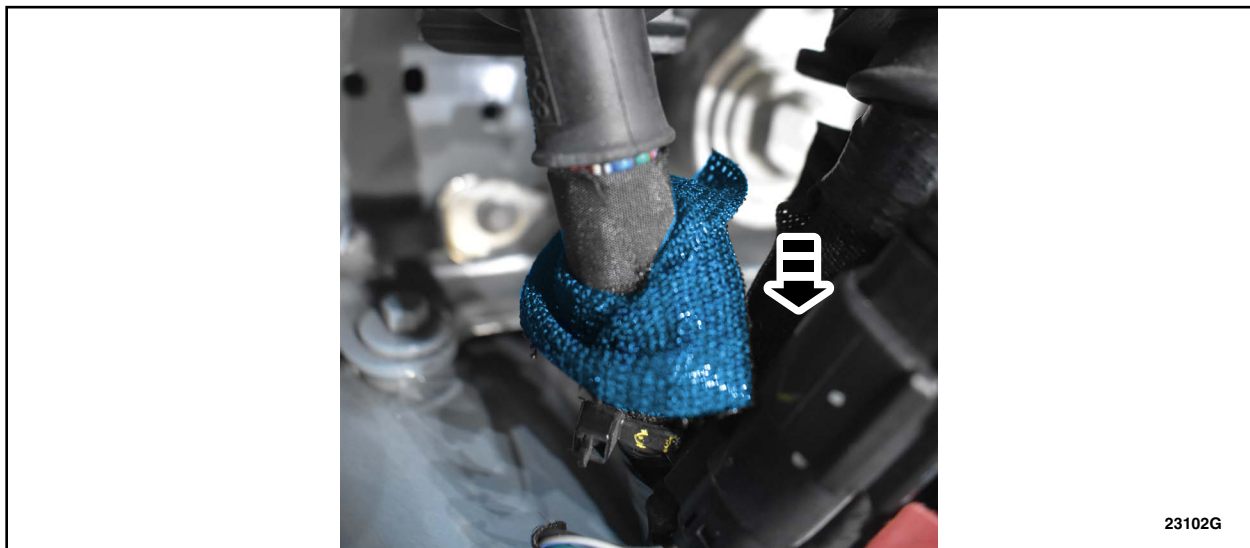
FIGURE 6

8. Remove tape from Power Distribution Box (PDB) connector C1035A, and roll down the wire covering to the tie strap. See Figure 6.

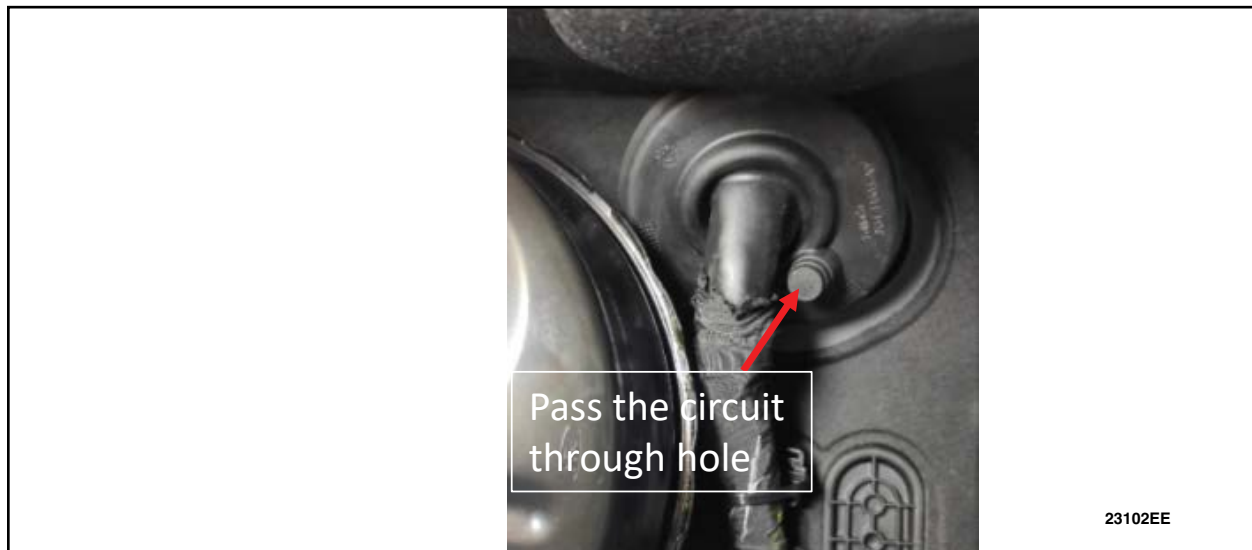
FIGURE 16

19. Pass the circuit crossing the grommet from outside to inside the vehicle. See Figure 16.

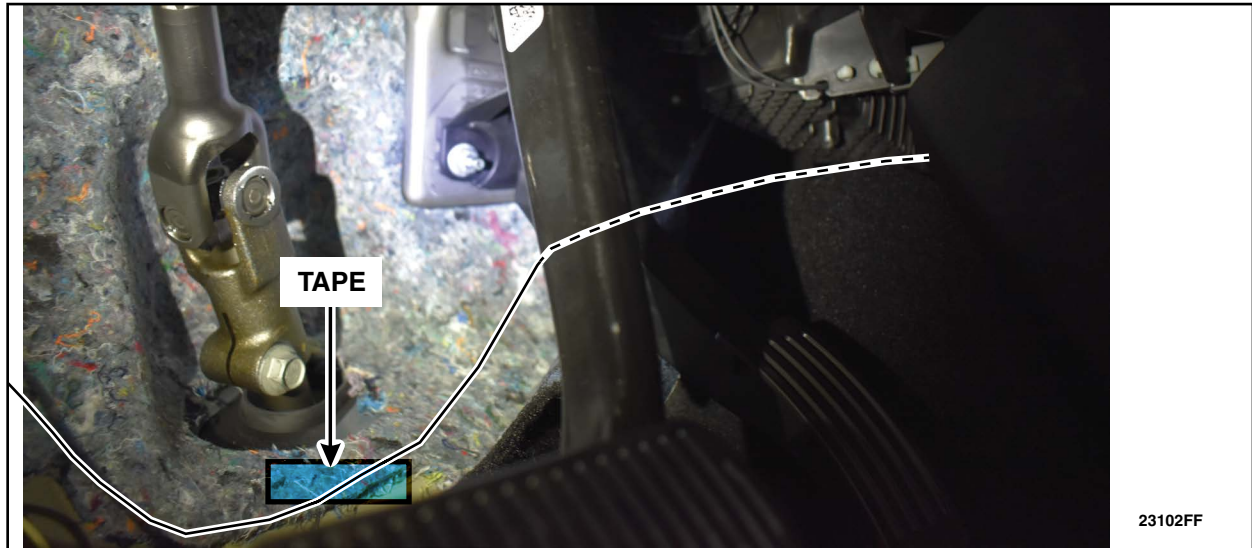
FIGURE 17

20. Once the circuit is positioned inside the vehicle, route the wire down and under the carpet behind the pedals. Secure wire with body tape. See Figure 17.

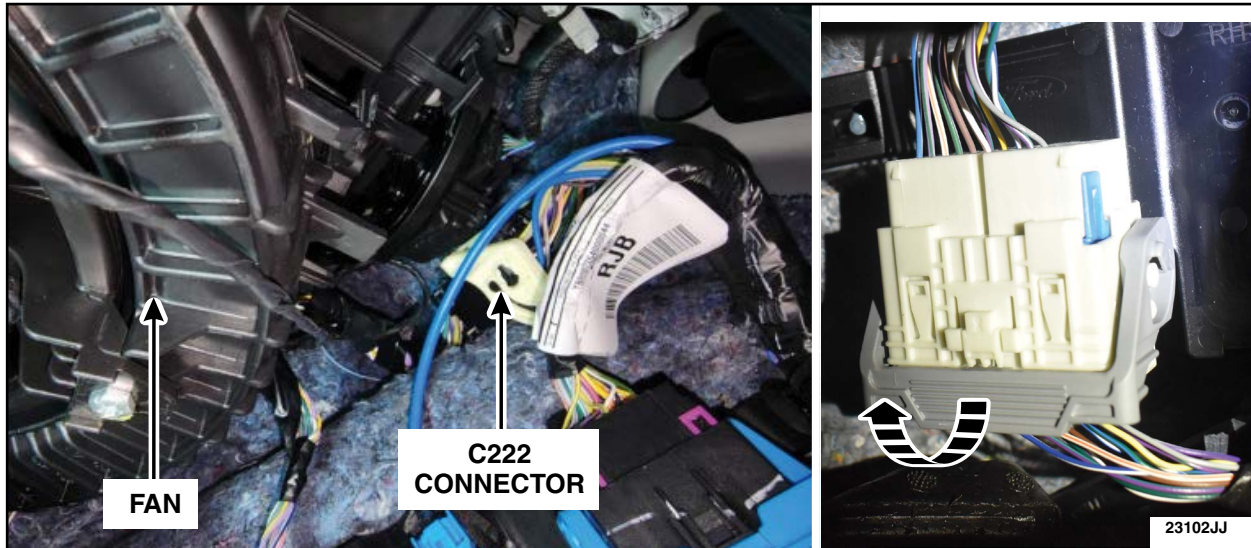
FIGURE 19

22. Identify connector C222 (black connector with white lever). Unclip and disconnect. See Figure 19.

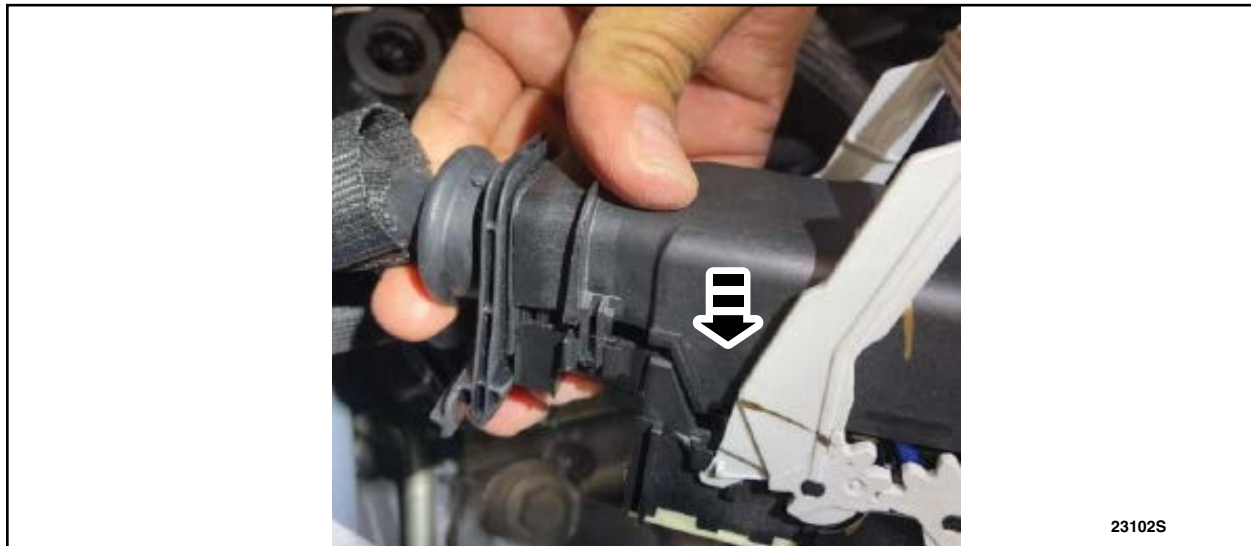
FIGURE 26

31. Clip the C1035A connector cover in place, ensuring that no wires are caught. See Figure 26.

NOTE: Ensure that the plastic eyelet is well positioned and that a click is heard when the cover is put into place.

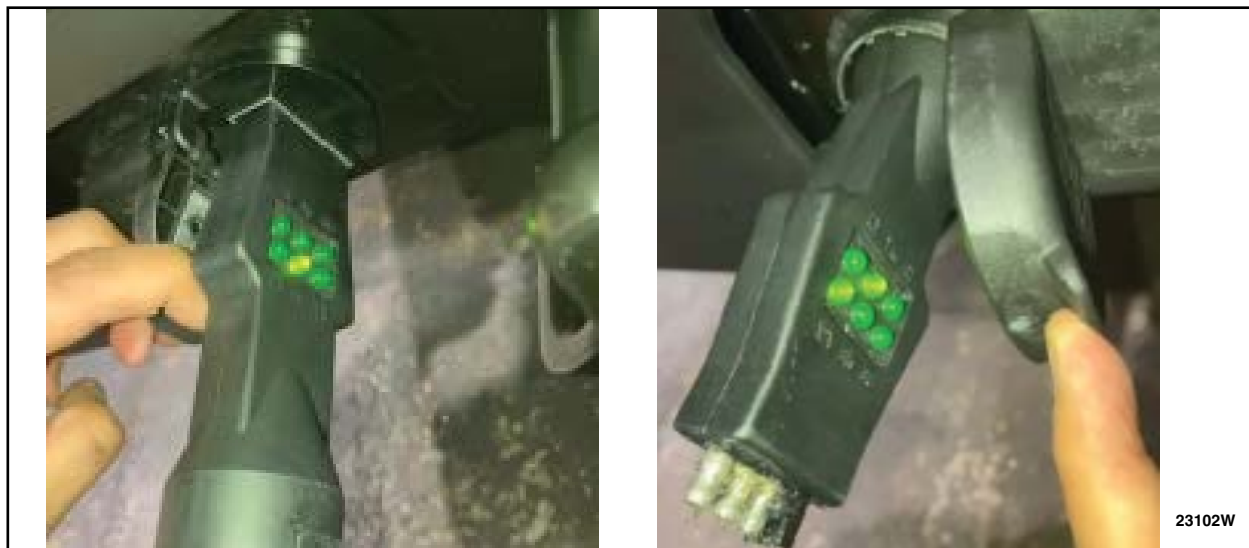
FIGURE 30

36. From the rear of the vehicle, test the trailer connector by using the tester into the 4-way or 7-way connector. On a 4-way connector, light number 5 will be visible. On a 7-way connector lights numbers 2 and 4 will be visible. See Figure 30. Did the correct light(s) become visible based on the connector being tested?

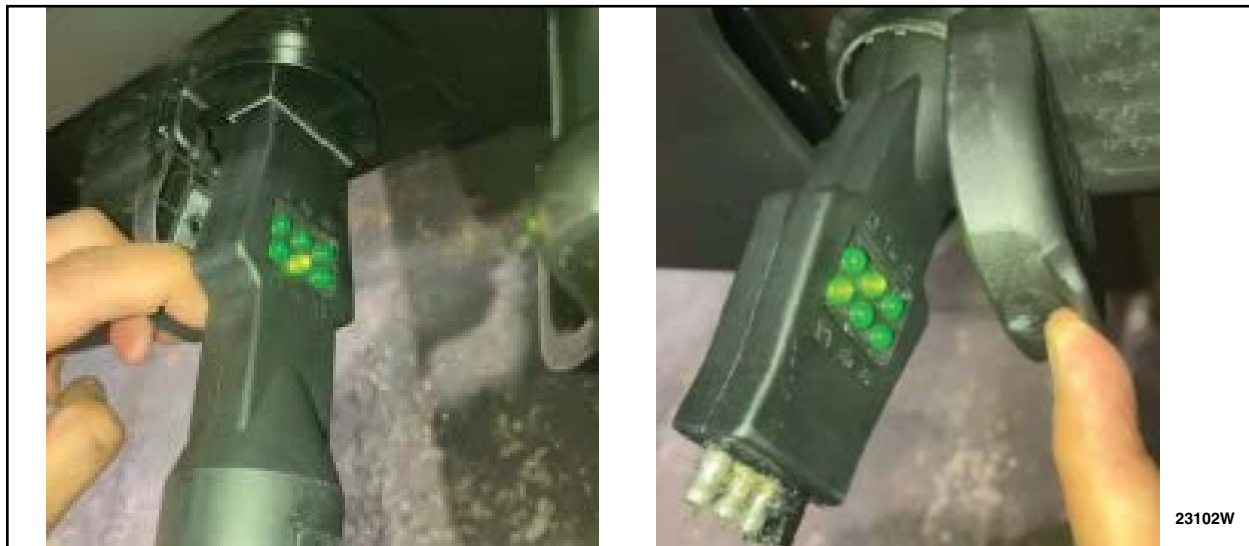
FIGURE 2

2. From the rear of the vehicle, test the trailer connector by using the tester into the 4-way or 7-way connector. On a 4-way connector, light number 5 will be visible. On a 7-way connector lights numbers 2 and 4 will be visible. See Figure 2. Did the correct light(s) become visible based on the connector being tested?

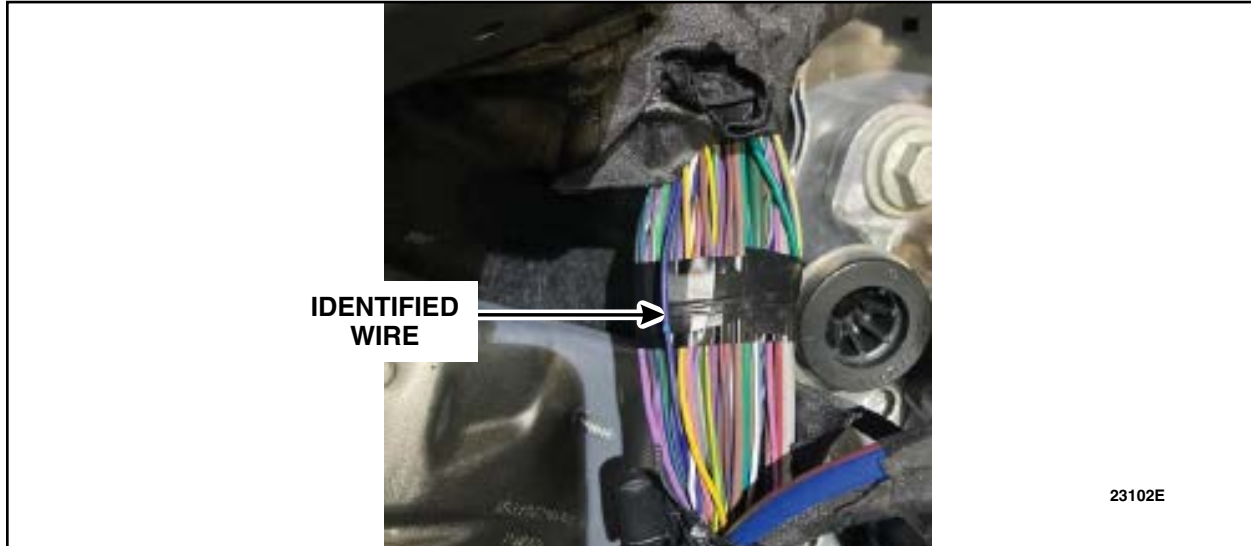
FIGURE 5

7. Identify the same wire color, blue with a gray tracer, in the wire bundle that was uncovered in Step 6. Separate the identified wire from the rest of the bundle using tape. See Figure 5.

NOTE: There are 2 wires that are blue with a gray tracer in the wire bundle. Either wire will work.

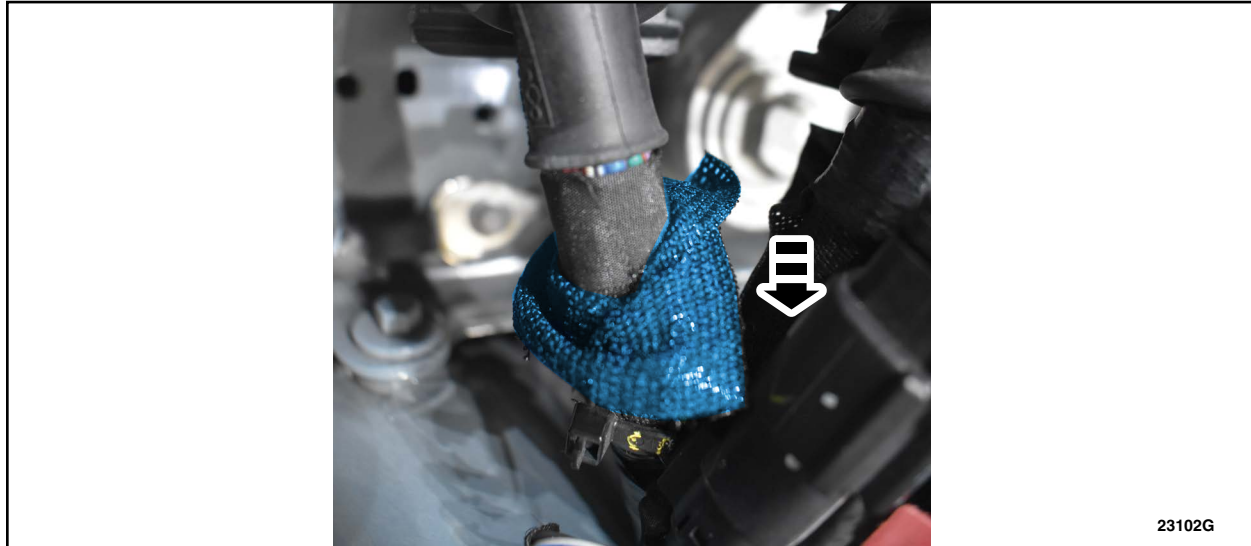
FIGURE 7

10. Remove tape from Power Distribution Box (PDB) connector C1035A, and roll down the wire covering to the tie strap. See Figure 7.

NOTE: C1035A connector is black, when plugged into the PDB it is located on the left side.

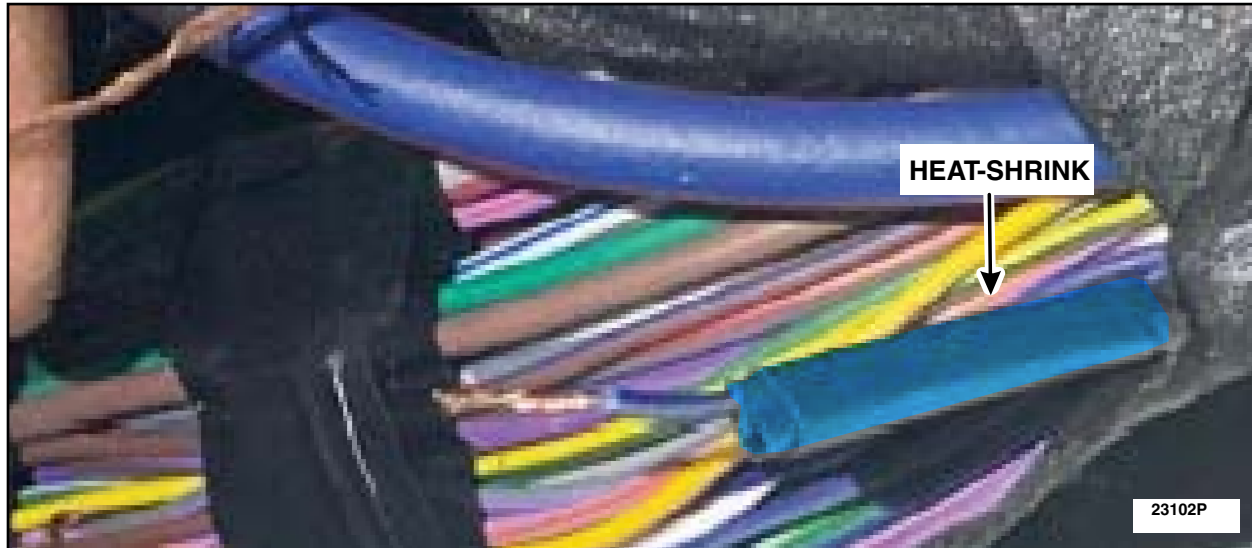
FIGURE 15

18. Place 30 mm of heat-shrink on each exposed wire. See Figure 15.

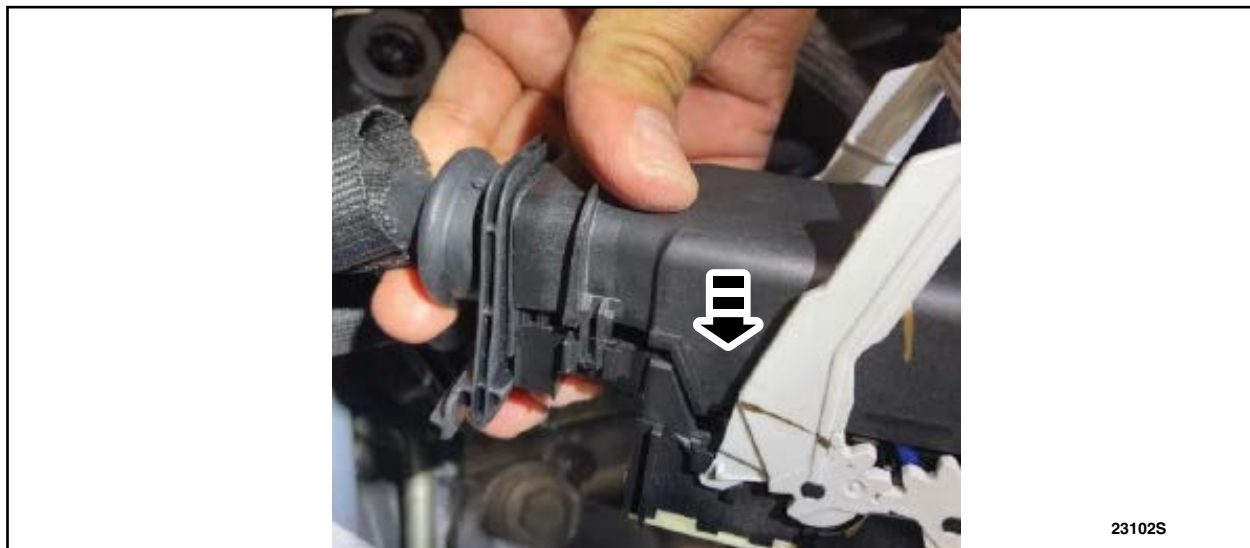
FIGURE 18

21. Clip the C1035A connector cover in place, ensuring that no wires are caught. See Figure 18.

NOTE: Ensure that the plastic eyelet is well positioned and that a click is heard when the cover is put into place.

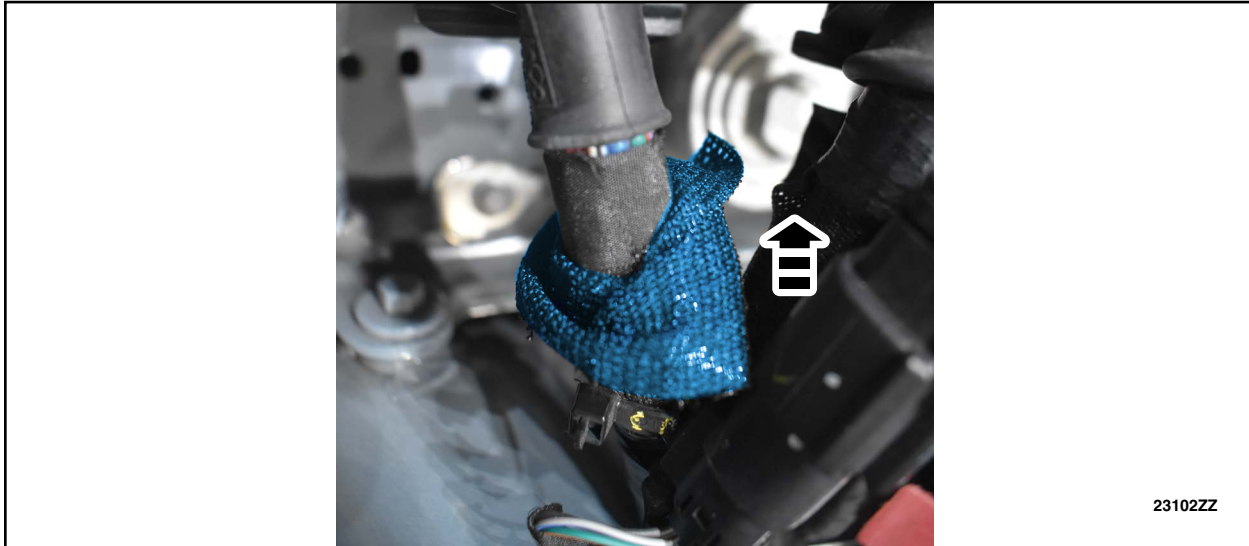
FIGURE 19

22. Reposition wire covering. See Figure 19.

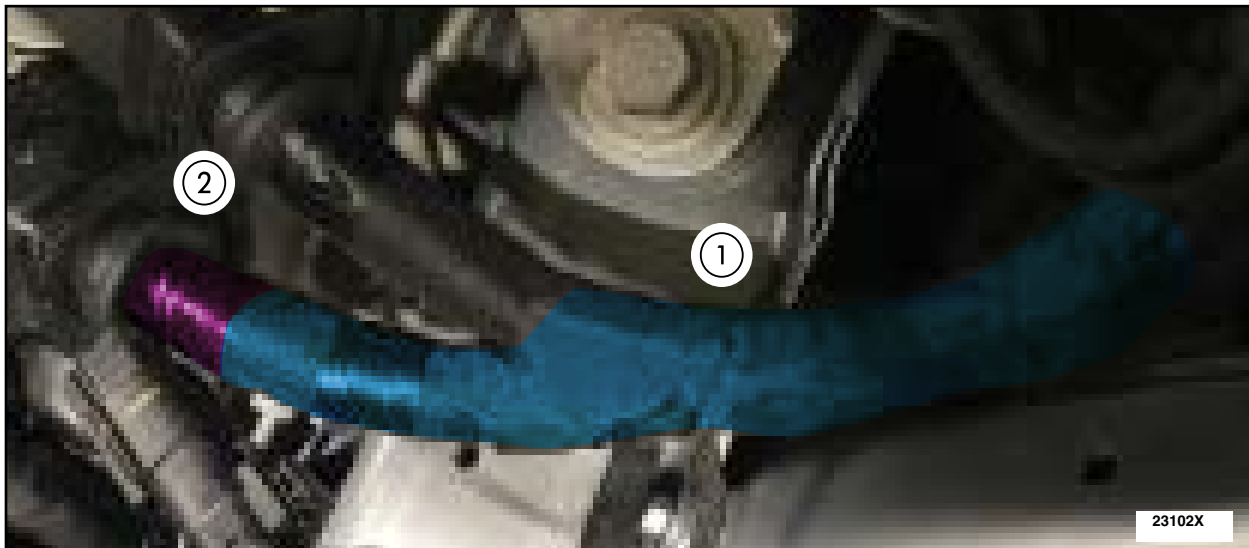
FIGURE 20

23. Apply anti-abrasive tape to the wire branch, covering all exposed wires. Apply vinyl tape to secure the grommet point as well. See Figure 20.

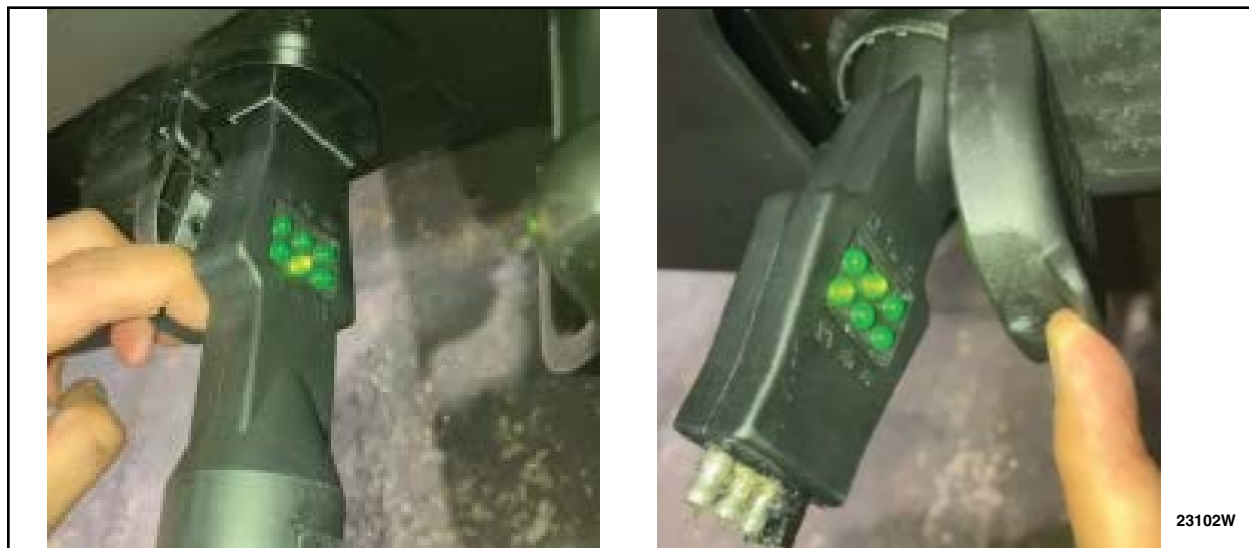
FIGURE 22

26. From the rear of the vehicle, test the trailer connector by using the tester into the 4-way or 7-way connector. On a 4-way connector, light number 5 will be visible. On a 7-way connector lights numbers 2 and 4 will be visible. See Figure 22. Did the correct light(s) become visible based on the connector being tested?
