May 2023  
FL851A  
NHTSA #23V-208

## Subject: Active Brake Assist Exterior Lighting Functions

**Models Affected: Specific model years 2020-2021 Freightliner Cascadia; and Western Star 49X vehicles manufactured January 16, 2019, through March 27, 2020.**

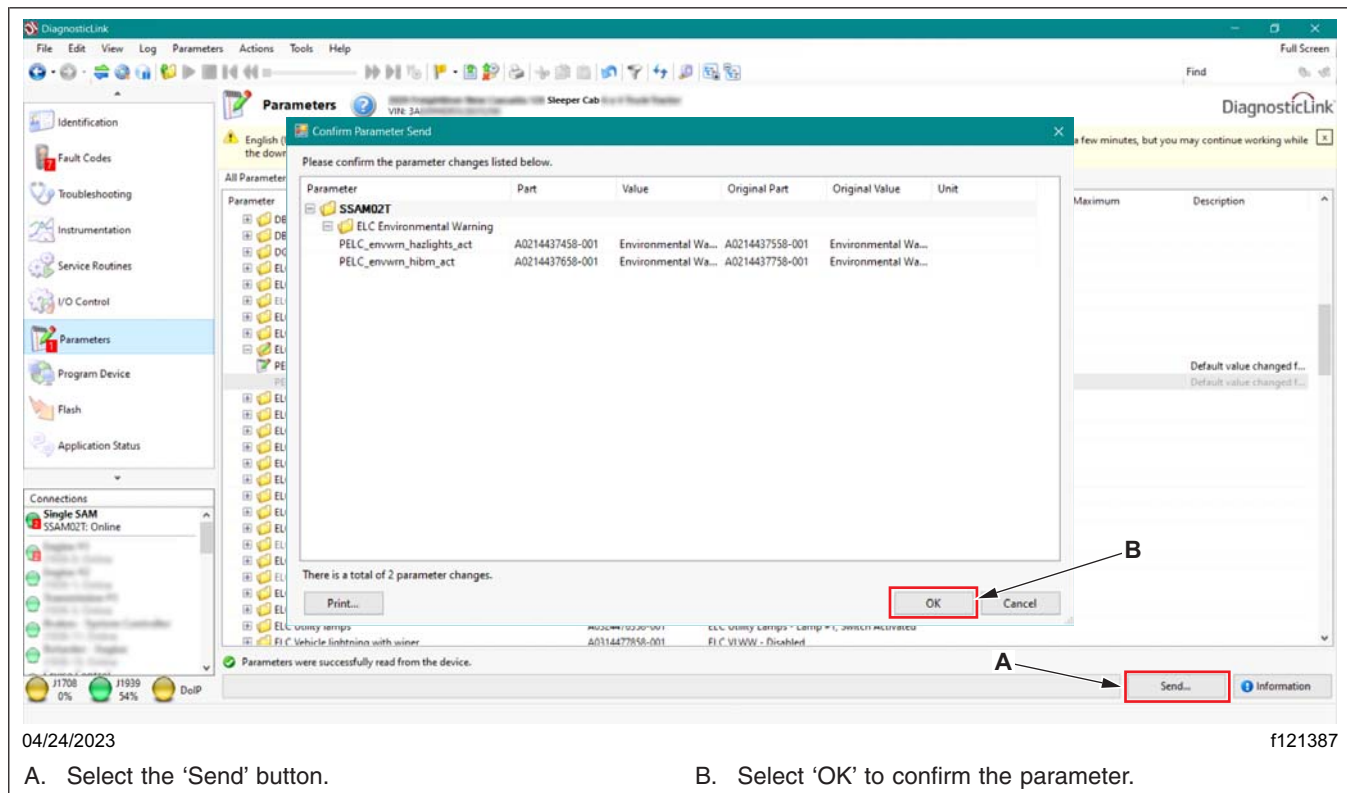
10. Select the 'Send' button to write the parameter change to the vehicle. A window will open asking to confirm the parameter change. Select 'OK.' See **Fig. 5**.

**Fig. 5, Writing the Parameter Changes to the Vehicle**

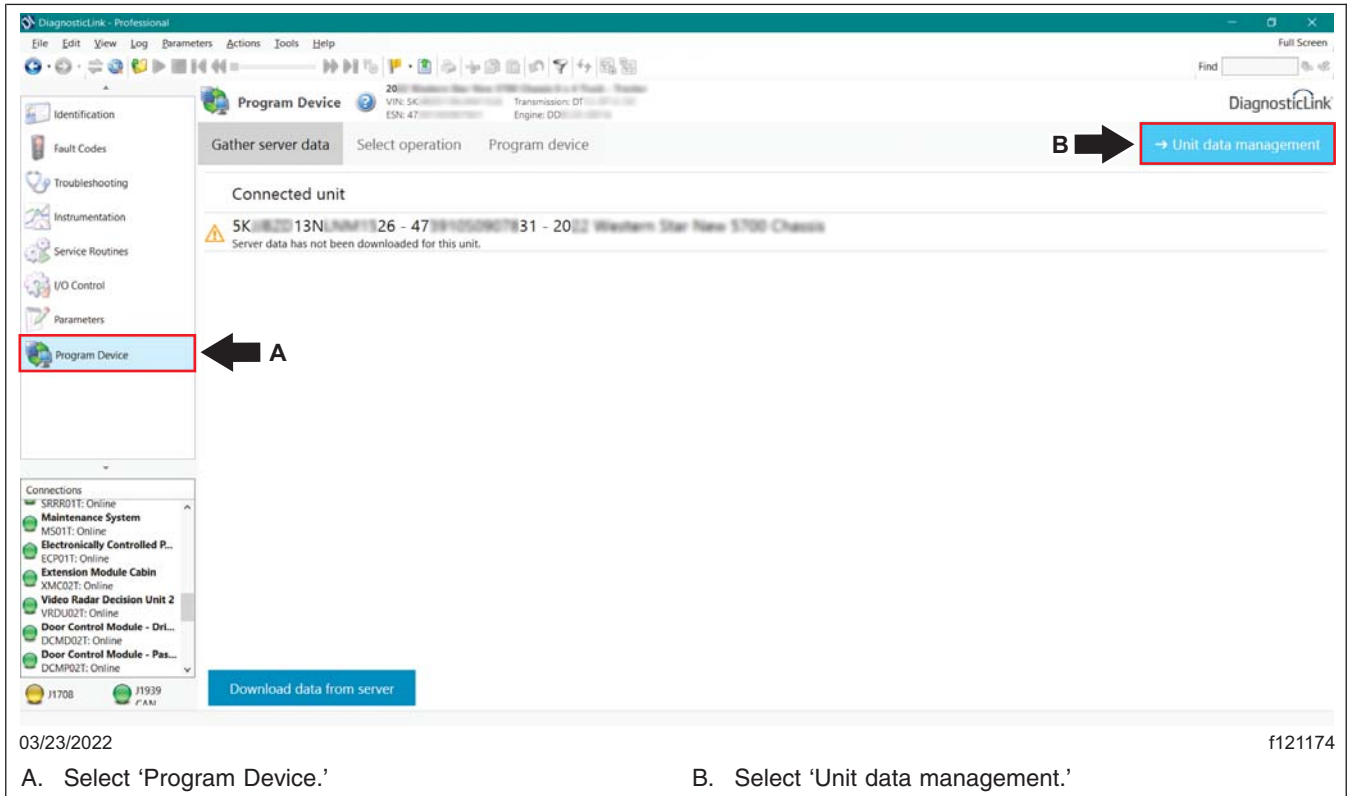
11. Once the parameter change is complete, go to the 'Program Device' tab. Select 'Unit data management' in the upper-right corner. See **Fig. 6**.

**Fig. 6, Selecting Unit Data Management**

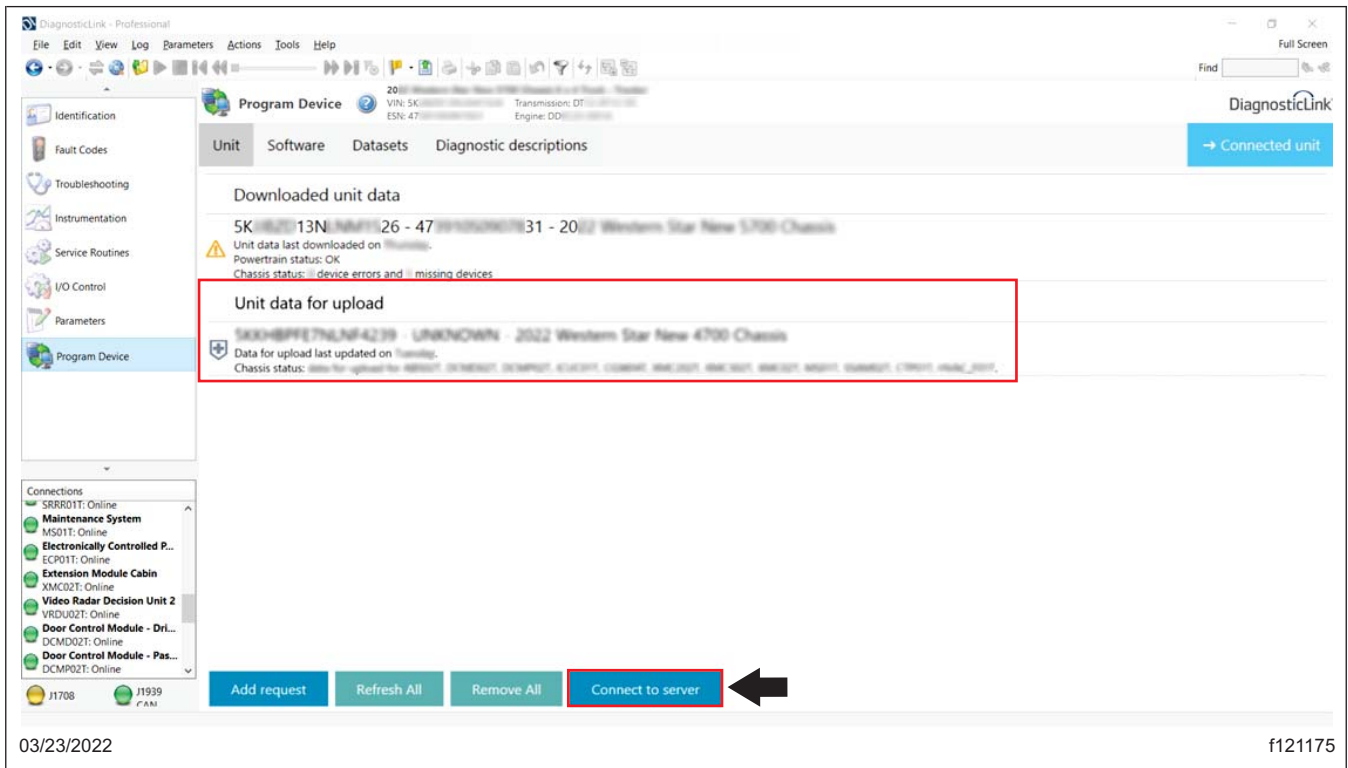
- The information corresponding to the VIN should appear under 'Unit data for upload.' Select 'Connect to server' to upload the new parameters. See [Fig. 7](#).

Fig. 7, Uploading the New Parameters
