Aftersales Field Action Bulletin

Document ID: 8-23-NA-35-005
Bulletin Title: VF8 FRS 9.6 MHU software update campaign
Released by: VF - GRSC
Date of issue: EN Version 1.0 / 02 Jun 2023
Applies to: VF Aftersales, Dealers and Showrooms

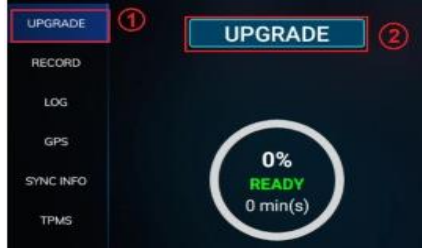
2	Open MHU Engineering APP and login using TOTP.
3	Select UPGRADE page and select UPGRADE button. The application will find all the available software files in the USB and show as a list.

4	Select the correct software file name in the list then select UPDRADE button.
5	After the update is completed, perform knob reset.
