SUBJECT: NEW VEHICLE DEMONSTRATION / DELIVERY HOLD - Safety Recall 23S33 Certain 2019-2020 Model Year Fusion Energi PHEV vehicles - Supplement #1 Battery Replacement

CERTAIN MODEL YEAR 2019-2020 FUSION PHEV VEHICLES — HIGH VOLTAGE BATTERY REPLACEMENT

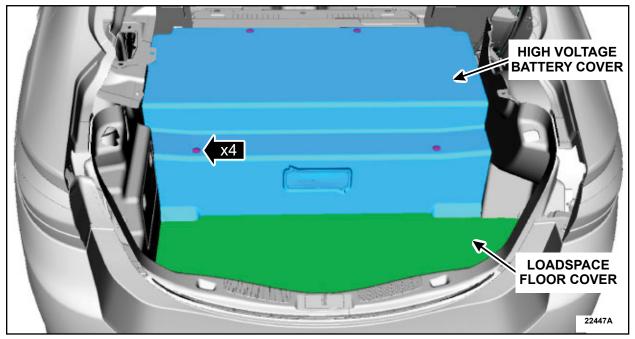
FIGURE 1

- **NOTE:** If you do not have the special tools referenced in the Workshop Manual (WSM) to perform the FSA repair, please contact 1-800 ROTUNDA and choose option 3 to place an order.
- 1. Disconnect the high voltage battery. Follow the WSM procedures in Section 414-03A.
- 2. Disconnect the 12 volt (V) battery. Follow the WSM procedures in Section 414-01.
- 3. Remove the rear seat cushion. Follow the WSM procedures in Section 501-01B.
- 4. Remove the retainers, the loadspace floor cover and the battery cover. See Figure 1.

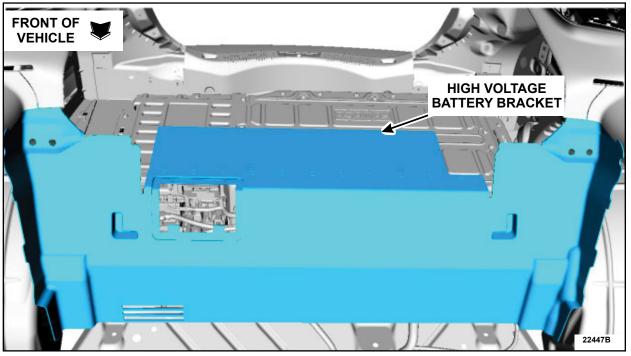
FIGURE 2

5. Remove the high voltage battery bracket. See Figure 2.

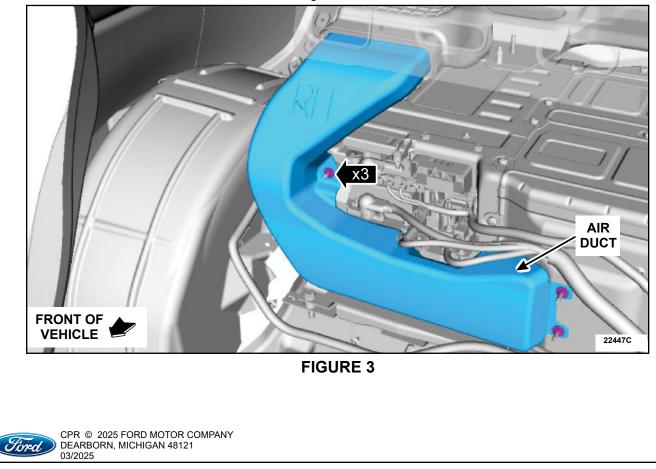
6. Remove the retainers and the air duct. See Figure 3.

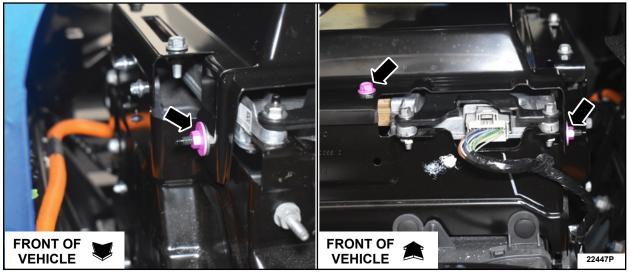
FIGURE 5

CPR © 2025 FORD MOTOR COMPANY DEARBORN, MICHIGAN 48121 03/2025 9. Remove the rear bolt and two side nuts from the Battery Energy Control Module (BECM) cover. See Figure 5.

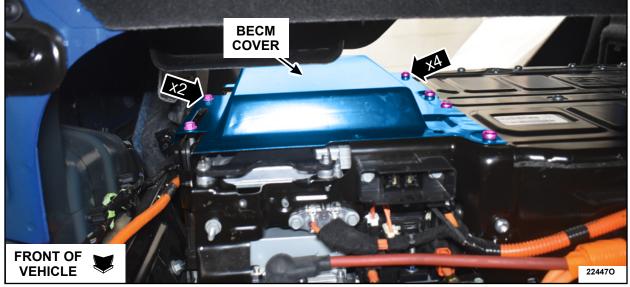
10. Remove the BECM cover and the retainers. See Figure 6.

NOTE: Do NOT discard the BECM cover as it will need to be reused in later steps.

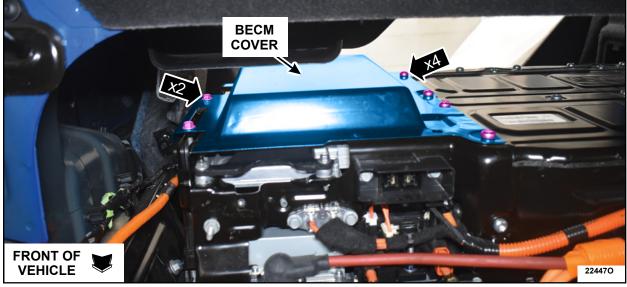
FIGURE 7

12. Install the BECM cover and the retainers. See Figure 7.

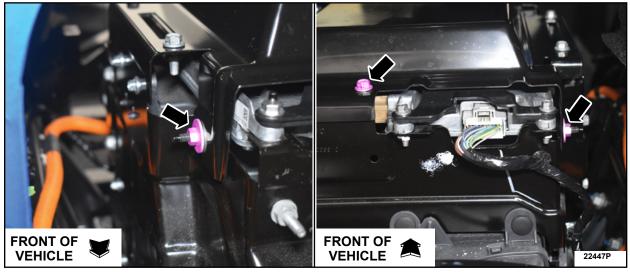
- 13. Install the rear bolt and the two side nuts. See Figure 8.
 - Torque: 10.2 lb. ft (13.8 Nm)

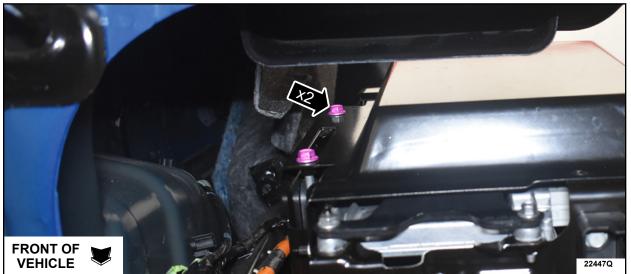
FIGURE 9

- 14. Tighten the two side bolts. See Figure 9.
 - Torque: 10.2 lb. ft (13.8 Nm)

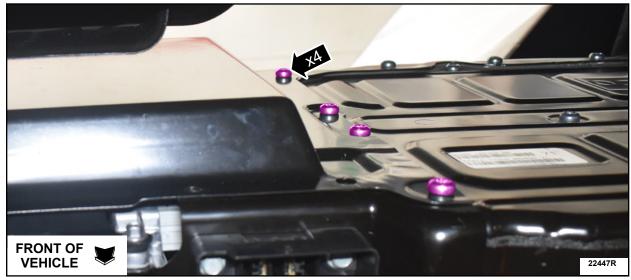
FIGURE 10

15. Tighten the four torx bolts. See Figure 10.

• Torque: 12.7 lb. ft (17.3 Nm)

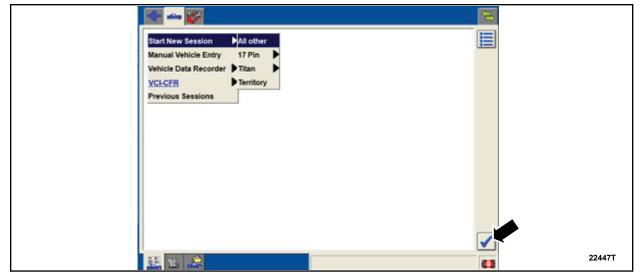
FIGURE 11

- 17. Select Start New Session and then All Other followed by the Tick. See Figure 11.
 - If you are prompted with a message that **"a previous session exists**" and asked to resume it, select the red **'X**'.
 - If prompted that "there are multiple previous sessions" and asked to resume one from a list, select none of the above.

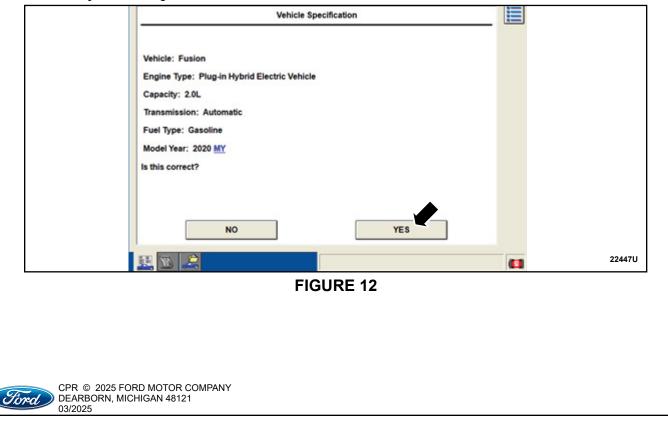
18. Verify that the vehicle model and model year on the vehicle identification screen are correct, then select '**yes'**. See Figure 12.

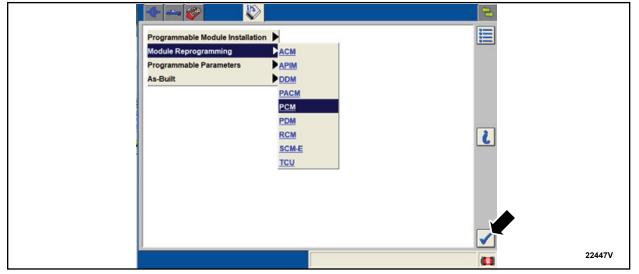
FIGURE 13

19. Navigate to the **toolbox**, **Module Programming**, **Module Reprogramming** menu and select the **Powertrain Control Module (PCM)**. See Figure 13.

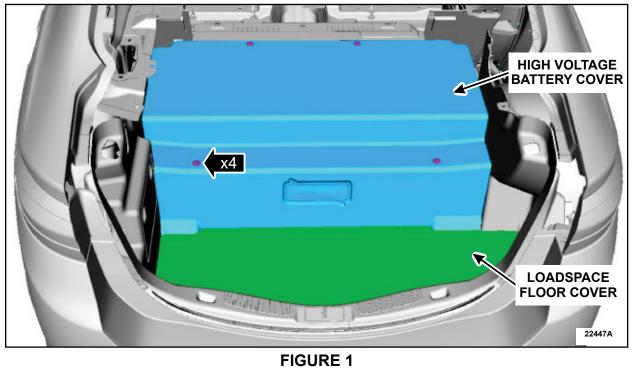
- 1. Disconnect the high voltage battery. Follow the WSM procedures in Section 414-03A.
- 2. Disconnect the 12 volt (V) battery. Follow the WSM procedures in Section 414-01.
- 3. Remove the rear seat cushion. Follow the WSM procedures in Section 501-10B.
- 4. Remove the retainers, the loadspace floor cover and the battery cover. See Figure 1.

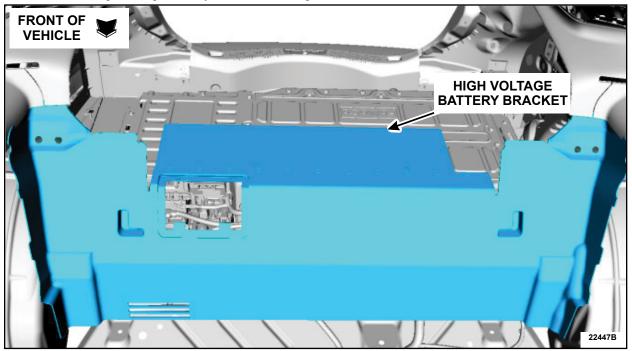
FIGURE 2

CPR © 2025 FORD MOTOR COMPANY DEARBORN, MICHIGAN 48121 03/2025 5. Remove the high voltage battery bracket. See Figure 2.

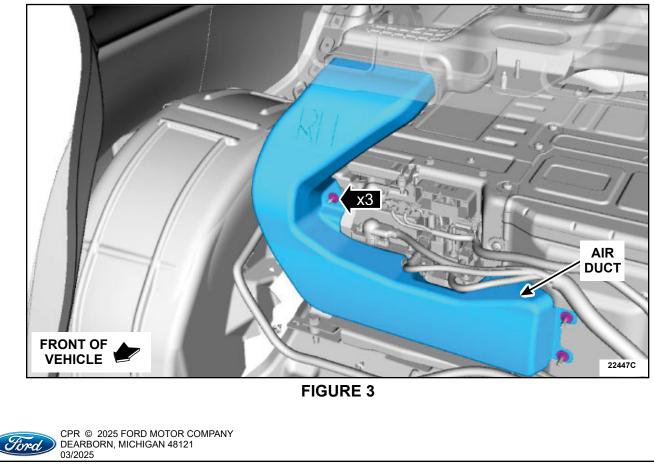
6. Remove the retainers and the air duct. See Figure 3.

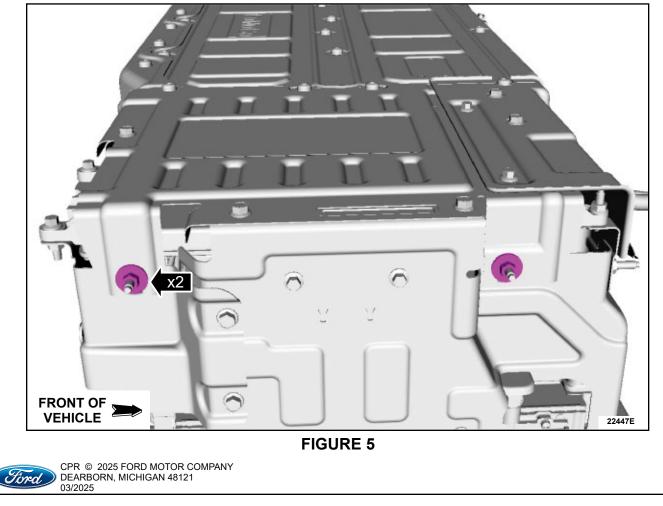
8. Loosen the retainers on the passenger side of the high voltage battery cover.. See Figure 5.

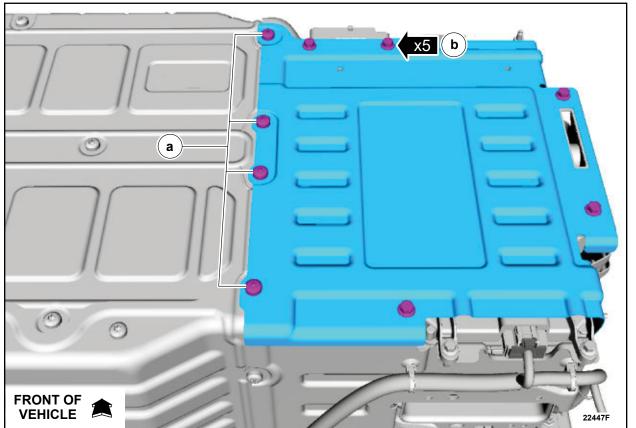
FIGURE 6

- 9. Remove the retainers and the high voltage battery cover. See Figure 6.
 - a. Torx bolts.
 - b. Hex bolts.

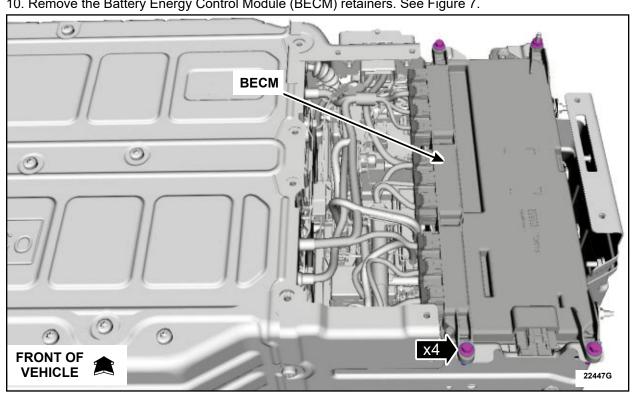
FIGURE 7

10. Remove the Battery Energy Control Module (BECM) retainers. See Figure 7.

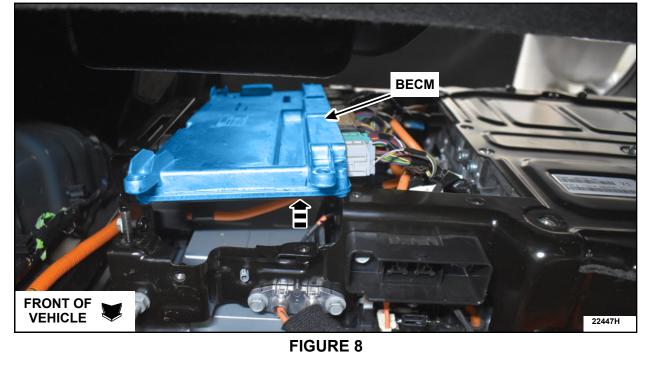
11. Position the BECM upwards. See Figure 8.

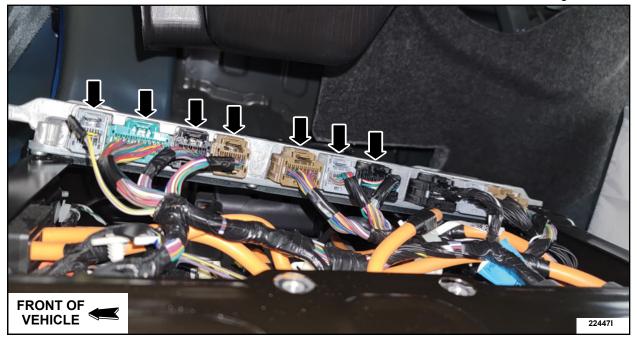
FIGURE 9

12. Disconnect the 7 electrical connectors on the front of the vehicle side of the BECM. See Figure 9.

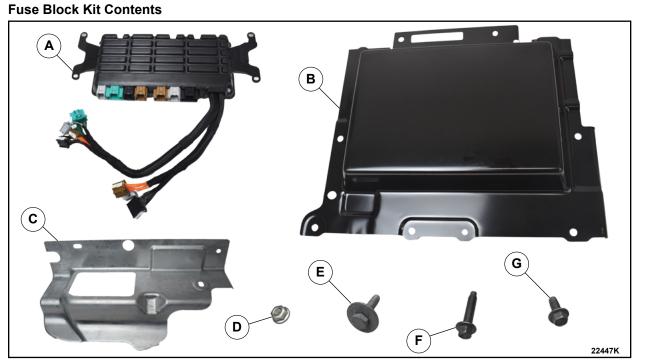
ITEM	DESCRIPTION	QTY
A	Fuse Block	1
В	BECM Cover	1
С	High Voltage Fuse Bracket (Finger-proof cover)	1
D	Nut (included in Hardware Package)	1
E	Bolt with Washer (included in Hardware Package)	1
F	Long Bolt (included in Hardware Package)	3
G	Short Bolt (included in Hardware Package)	2

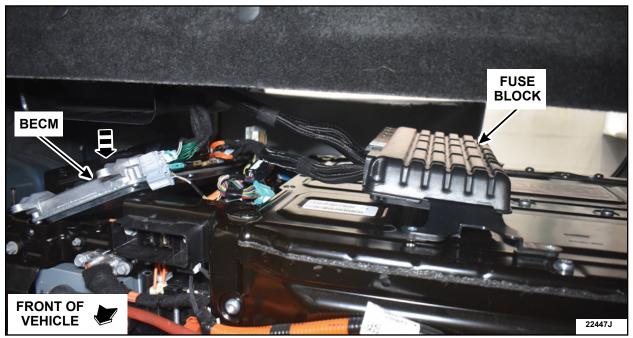
FIGURE 11

13. Position the fuse block (Item A) on the battery. Connect the 7 connectors from the fuse block to the corresponding receptacle on the BECM, then position back the BECM. See Figure 11.

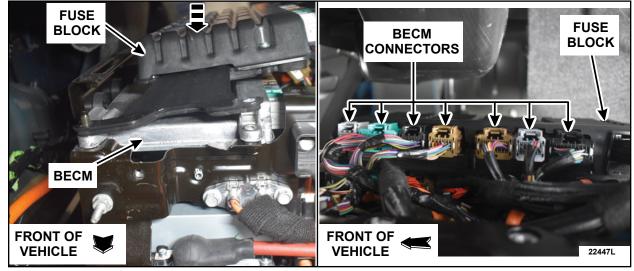
FIGURE 12

14. Position the fuse block (Item A) on top of the BECM. Connect the original 7 BECM connectors into the corresponding receptacle on the fuse block. See Figure 12.

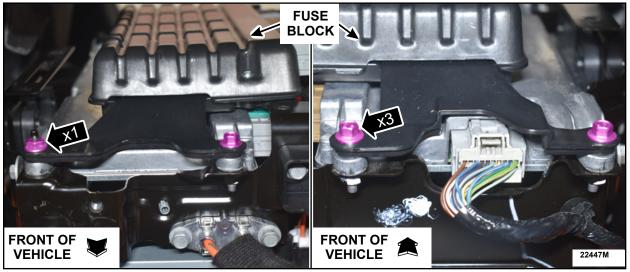
FIGURE 13

- 15. Install the *new* nut (Item D) and the long bolts (Item F). See Figure 13.
 - Torque: 8.9 lb. ft (12.1 Nm)

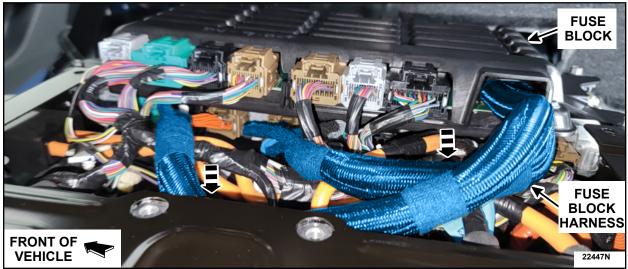
16. Position the fuse block harness down into the BECM cavity. See Figure 14.

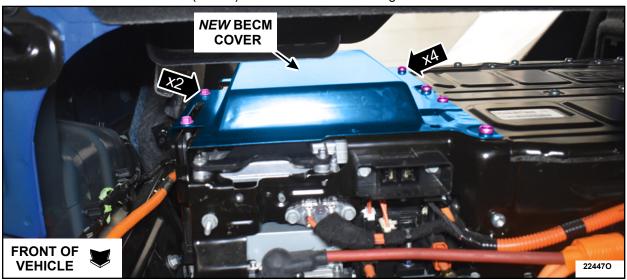
FIGURE 15

17. Install the new BECM cover (Item B) and the retainers. See Figure 15.

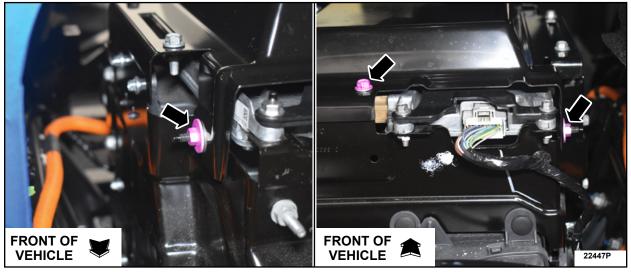
18. Install the rear bolt and the two side nuts. See Figure 16.

• Torque: 10.2 lb. ft (13.8 Nm)

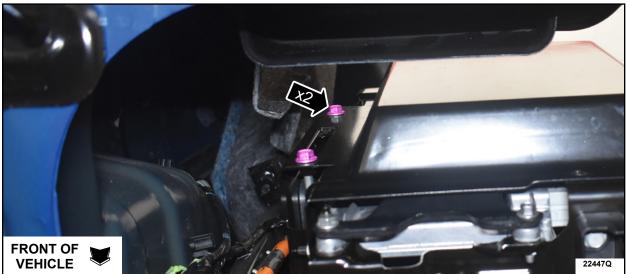
FIGURE 17

- 19. Tighten the two side bolts. See Figure 17.
 - Torque: 10.2 lb. ft (13.8 Nm)

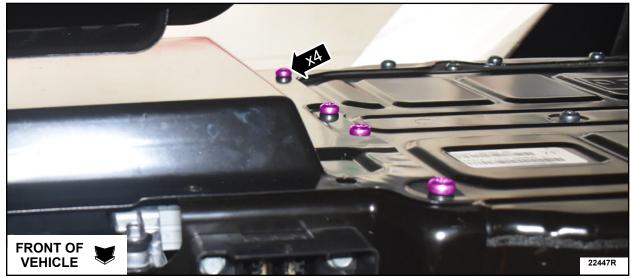
- 20. Tighten the four torx bolts. See Figure 18.
 - Torque: 12.7 lb. ft (17.3 Nm)

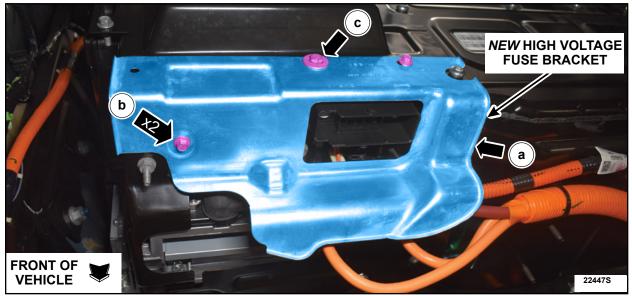
FIGURE 19

21. Install the *new* high voltage fuse bracket. See Figure 19.

a. Position the *new* high voltage fuse bracket (Item C).

- b. Install the short bolts (Item G)
- c. Install the bolt with washer (Item E)
- Torque: 10.2 lb. ft (13.8 Nm)

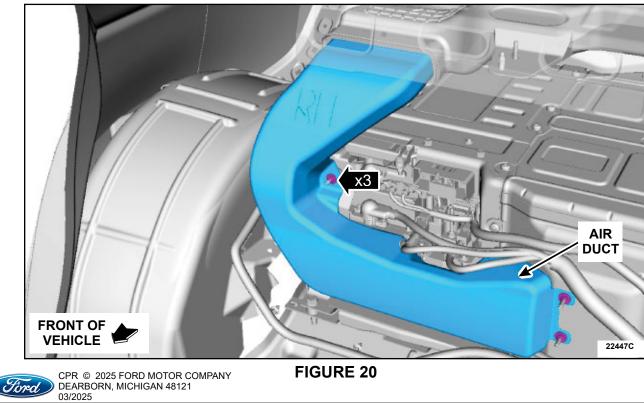
22. Install the air duct and the retainers. See Figure 20.

• Torque: 62 lb.in (7 Nm)

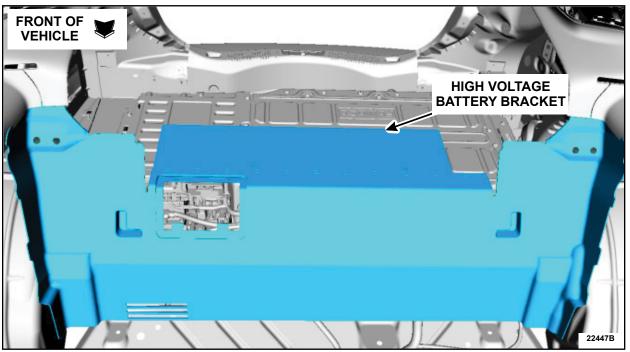
FIGURE 21

23. Install the high voltage battery bracket. See Figure 21.

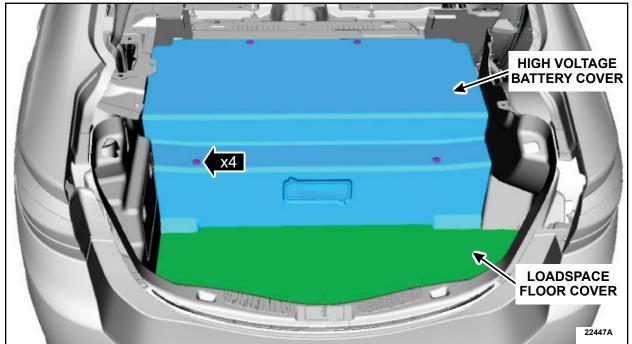
FIGURE 22

24. Install the battery cover, loadspace floor cover and the retainers. See Figure 22.
