December 2023  
FL979A-F  
NHTSA #23V-467  
Transport Canada #2023-372  
REVISED (May 2024)

## **Subject: Freightliner eCascadia e-Axle Ring Gear**

**Models Affected: Specific model years 2023-2024 Freightliner eCascadia vehicles manufactured between January 19, 2023, through April 13, 2023.**

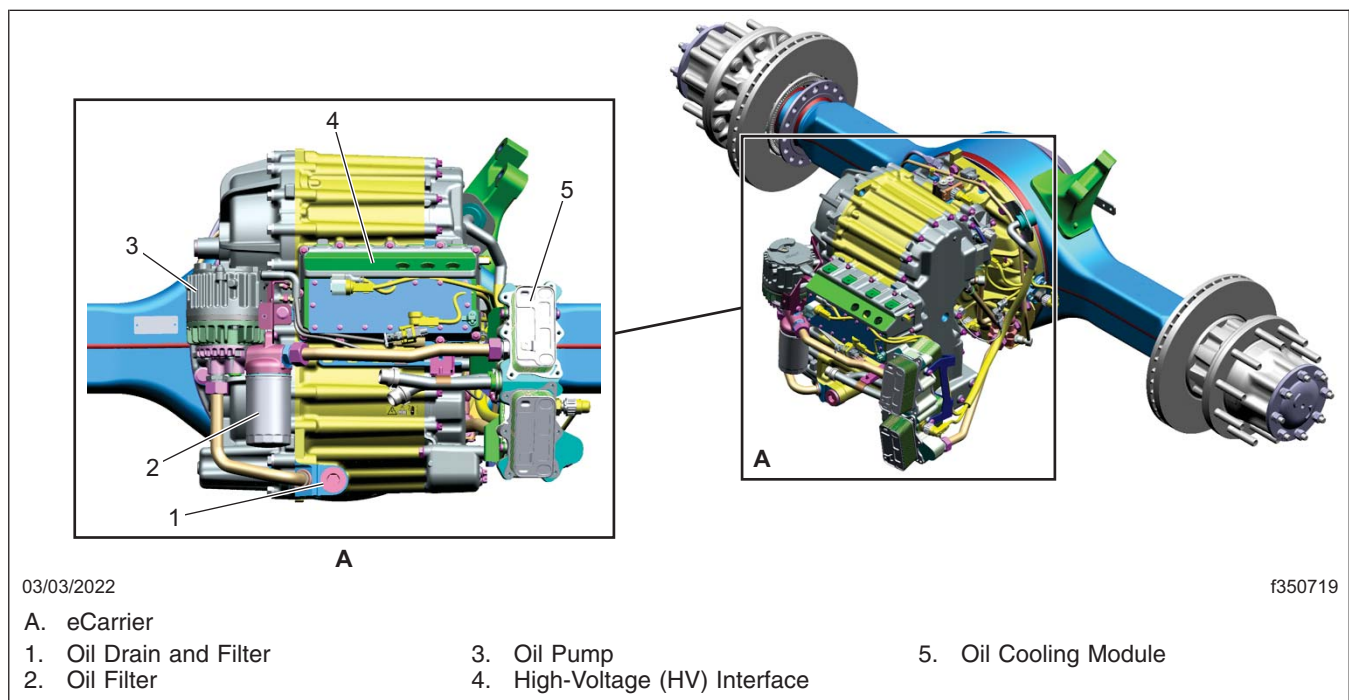
The eCarrier components are shown in [Fig. 1](#).

**Fig. 1, eCarrier Components**

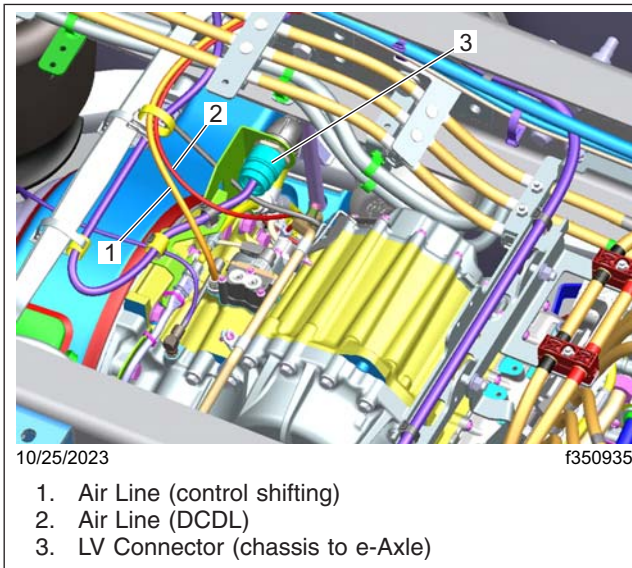
- Lift the vehicle. Remove all the tires on the axle being replaced, then lower the vehicle to the ground. For instructions to raise and lower the vehicle, see **Section 00.05** of the *eCascadia Workshop Manual*.
- Disconnect the low-voltage (LV) chassis harness from the e-Axle. See **Fig. 2**.

**Fig. 2, Location of the LV Connector**

17. Disconnect the air lines, shown in **Fig. 2** (page 8), from the eCarrier.

50. Install both the ABS sensors.
  51. Connect the air lines, shown in **Fig. 2** (page 8), to the eCarrier.
  52. Connect the LV chassis harness, shown in **Fig. 2** (page 8), to the e-Axle.

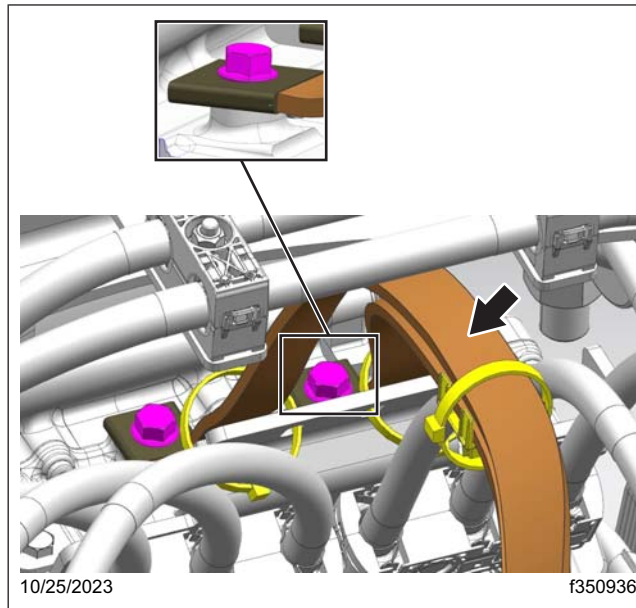
- Disconnect the flat grounding cables straps, shown in **Fig. 3**, from the e-Axle.

**Fig. 3, Flat Grounding Cables Straps**

60. Connect the flat ground cable straps, shown in **Fig. 3** (page 8), to the e-Axle.

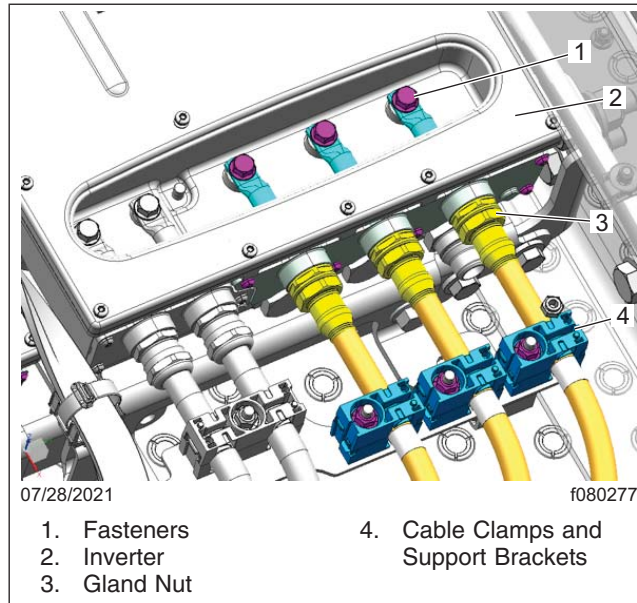
11. Remove the HV cable clamps and the mounting fasteners from the HV cable support brackets. Then, remove the support brackets. See [Fig. 4](#).

**Fig. 4, Inverter Side HV Cables**

14. Remove the fasteners that secure the HV cables from the e-Axle to the rear side of the inverter. See [Fig. 4](#) and [Fig. 6](#).

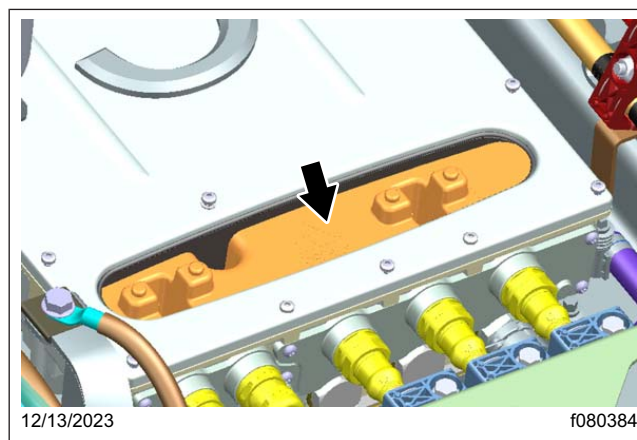
13. Remove the delayed access cover, shown in [Fig. 5](#).

**Fig. 5, Delayed Access Cover**

61. Install the zip ties on the flat ground cable straps.
62. Tighten the flat ground cable straps 18 lbf-ft (24 N·m).
63. Install the height control rod.
64. Install the wheel and tire. For instructions, see **Group 40** of the *eCascadia Workshop Manual*.
65. Remove the e-Axle cart.
66. Connect the coolant lines, shown in **Fig. 9** (page 11), to the e-Axle.
67. Install the drive wheel fairings. For instructions, see **Section 31.04** of the *eCascadia Workshop Manual*.
68. Fill the eCarrier and housing with fluid until the oil level reaches the fill plug threads. For instructions, see **Section 35.03** of the *eCascadia Maintenance Manual*.
69. Commission the vehicle (Gen 2). For instructions, see **Section 08.08, Subject 100** of the *eCascadia Workshop Manual*.
70. Install the delayed access cover, shown in **Fig. 5** (page 9).

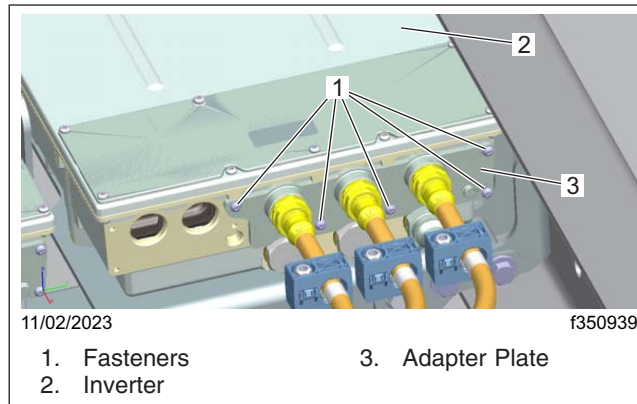
**Fig. 6, Fasteners on the Rear Side of the Inverter**

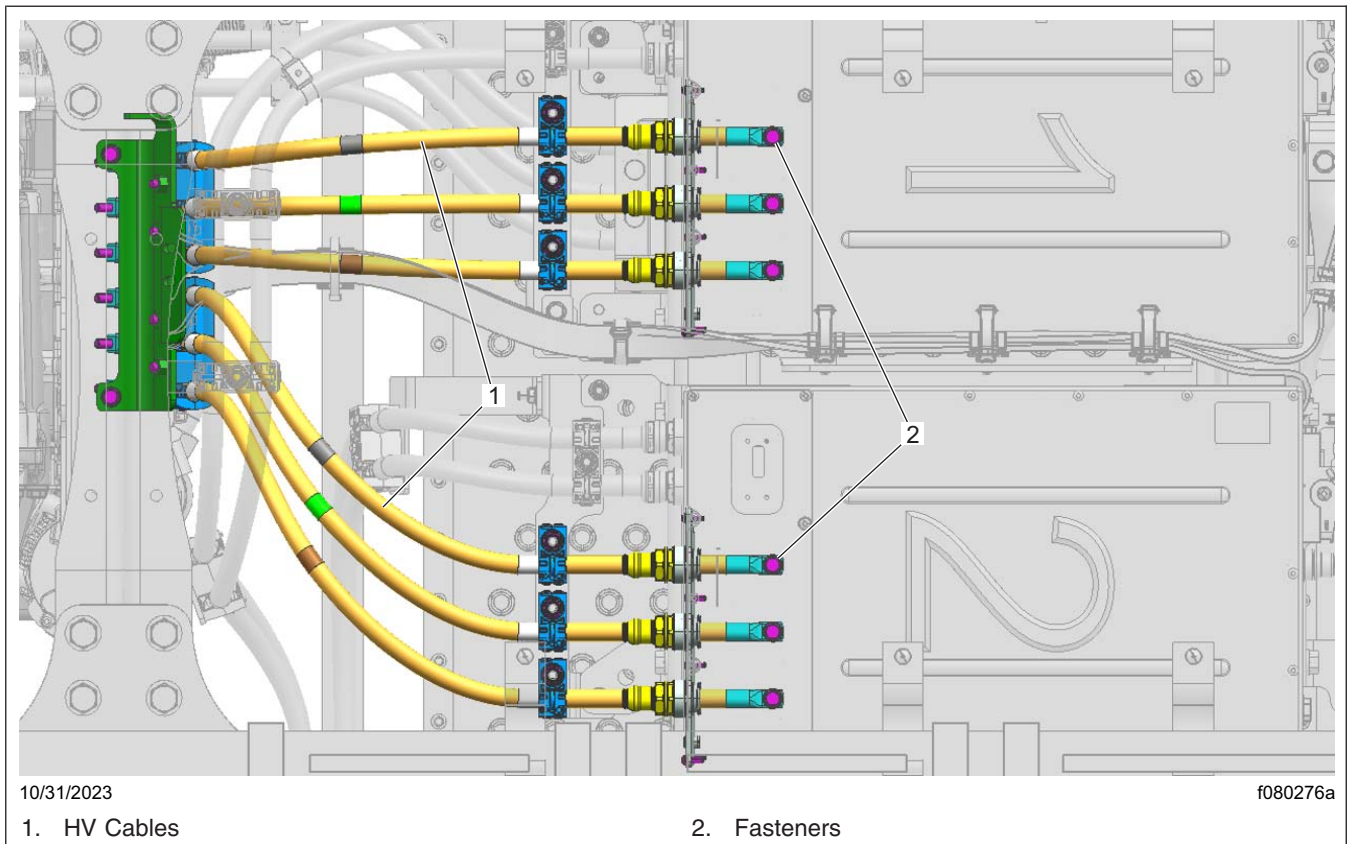
15. Remove the HV cable lug fasteners located inside the inverters 1 and 2. See [Fig. 7](#).

**Fig. 7, HV Cables Connecting the Inverter and the Forward Rear Axle**

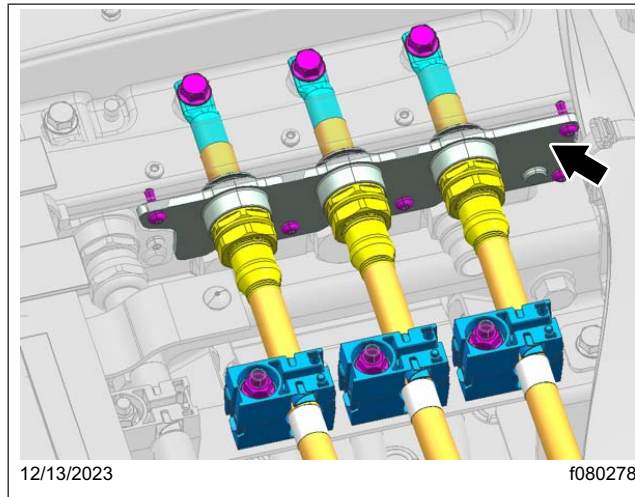
16. Pull the cables out from the rear of the inverters. See **Fig. 8**.

**Fig. 8, Location of the Adapter Plate**

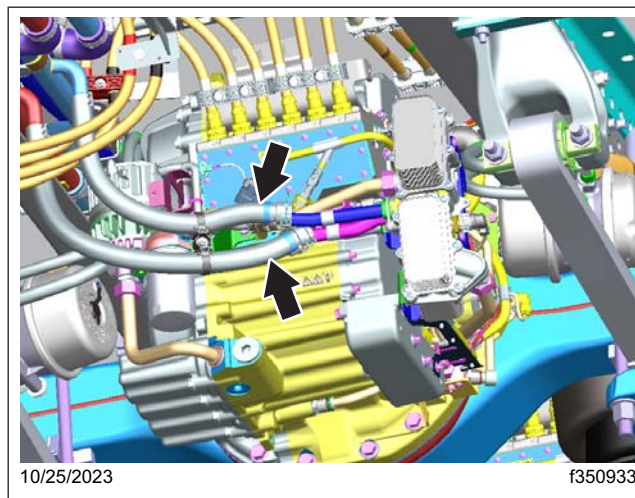
20. Disconnect the coolant lines, shown in **Fig. 9**, from the e-Axle, and let the fluid drain out.

**Fig. 9, Location of the Coolant Lines**

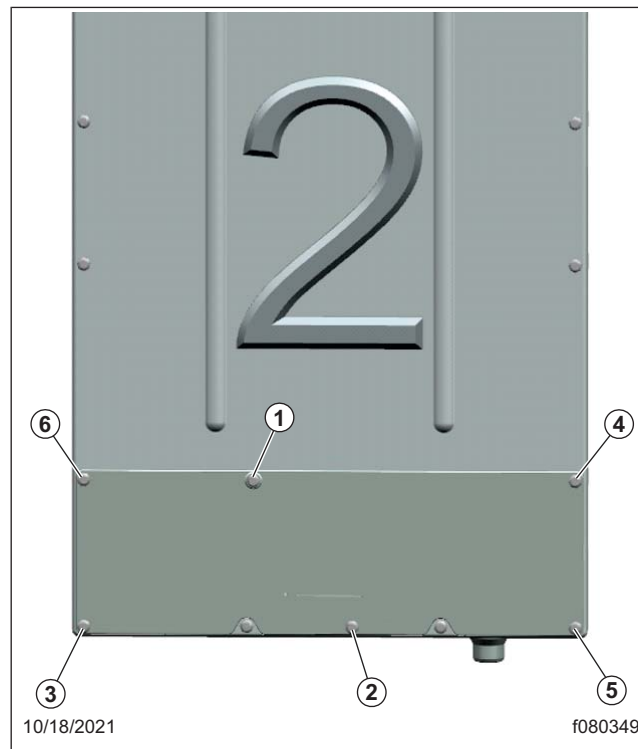
71. Install the inverter access cover and tighten all the fasteners 44 lbf-in (497 N·cm) in the sequence shown in **Fig. 10**. For detailed instructions, see **Section 08.02, Subject 050** of the *eCascadia Workshop Manual*.

**Fig. 10, Inverter Access Cover Tightening Sequence**

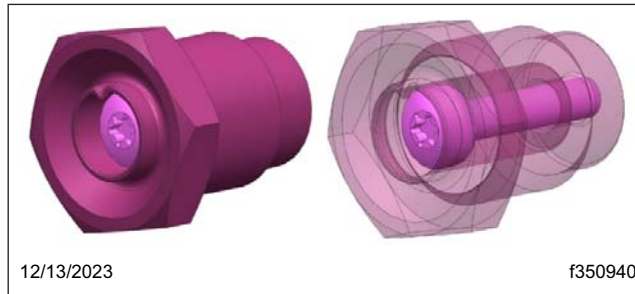
75. Use a 30-mm socket to remove the neutral tool from the shift location. See [Fig. 11](#).

**Fig. 11, Neutral Tool**

72. Install the two rear deck plates and tighten the fasteners 11 to 15 lbf-ft (15 to 20 N·m).
73. Run DiagnosticLink® for the resolver re-learn function on the inverters 1 and 2.
74. Use a long T30 Torx® driver to loosen the center bolt of the neutral tool from the shift location.
75. Use a 30-mm socket to remove the neutral tool from the shift location. See **Fig. 11**.

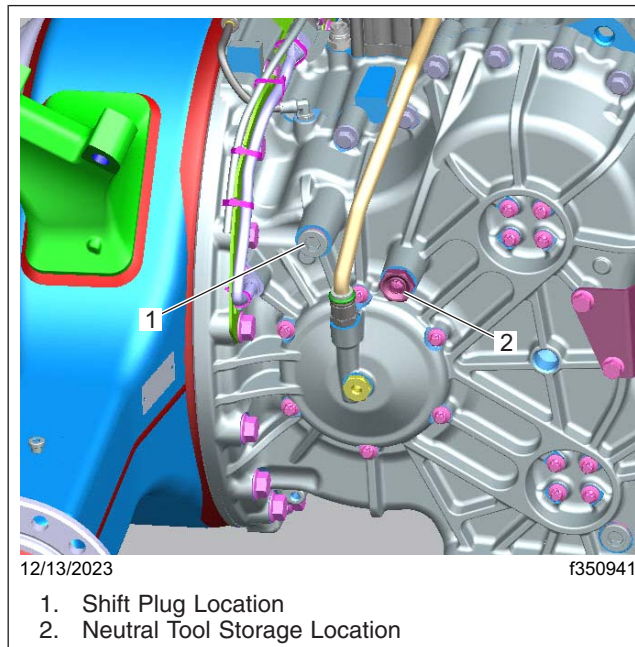
77. Install the new crush washer on the shift plug, and install the plug in the shift location. Tighten the tool 76 to 94 lbf·ft (103 to 127 N·m). See [Fig. 12](#).

**Fig. 12, Shift Plug and Neutral Tool**

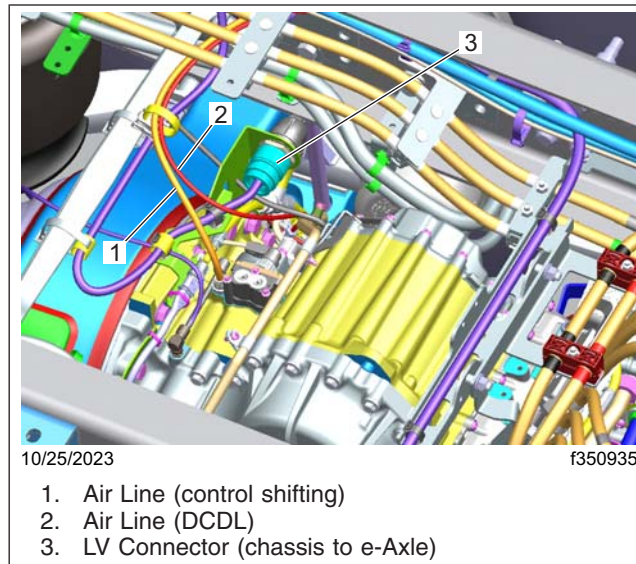
8. Disconnect the low-voltage (LV) chassis harness from the e-Axle. See **Fig. 13**.

**Fig. 13, Location of the LV Connector**

16. Disconnect the cable gland connections.
17. Remove the cables from the e-Axle.
18. Disconnect the air lines, shown in [Fig. 13](#) (page 15), from the eCarrier.
19. Lift the vehicle to the desired working height.
20. Cut the zip ties on the coolant hoses.
21. Disconnect the coolant lines from the e-Axle, and let the fluid drain out. See [Fig. 18](#).

50. Install all the air brake chamber lines at the caliper side.
51. Install both the ABS sensors.
52. Connect the air lines, shown in **Fig. 13** (page 15), to the eCarrier.

53. Connect the LV chassis harness, shown in **Fig. 13** (page 15), to the e-Axle.
54. Install the HV cables to the eAxle HV interface.
55. Connect the cable glands to the eCarrier.

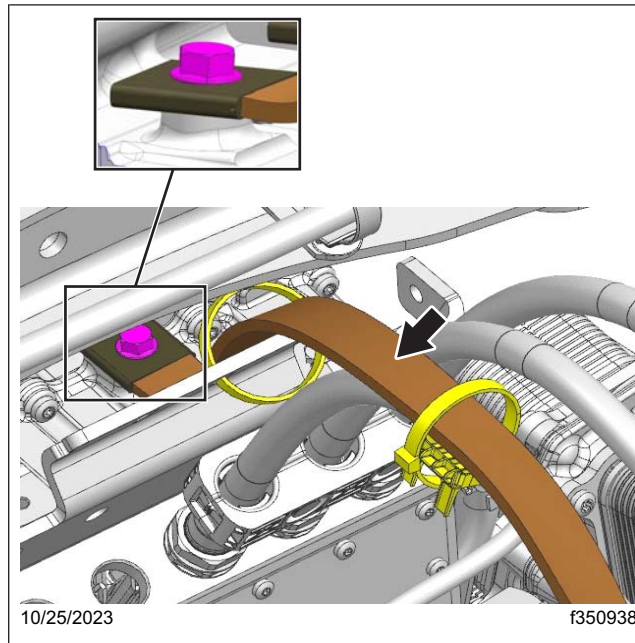
9. Disconnect the flat grounding cables straps, shown in [Fig. 14](#), from the e-Axle.

**Fig. 14, Flat Grounding Cables Straps**

64. Connect the flat ground cable straps, shown in **Fig. 14** (page 16), to the e-Axle.
65. Install the zip ties on the flat ground cable straps.
66. Tighten the flat ground cable straps 18 lbf·ft (24 N·m).

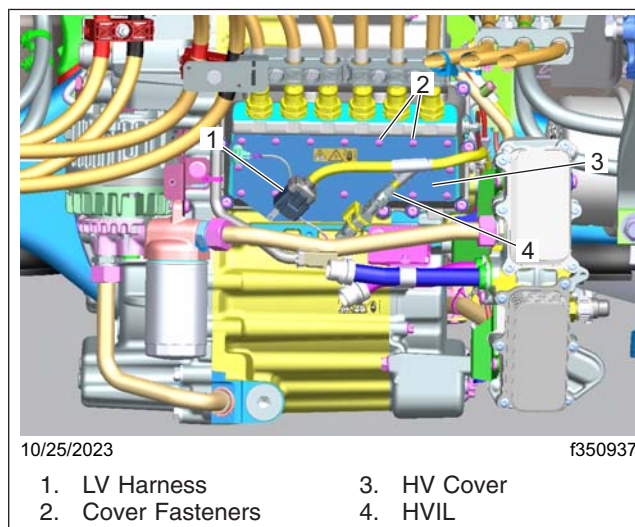
11. Disconnect the high-voltage interlock (HVIL) and the LV harness from the HV cover. See [Fig. 15](#).

**Fig. 15, Location of the HVIL**

12. Remove the HV cover fasteners and remove the HV cover. See [Fig. 15](#).

58. Tighten the lug fasteners 17 lbf·ft (23 N·m).
59. Clean the gasket material from the HV header, then position a new gasket on the HV header.
60. Install the HV cover and fasteners to the HV interface on the e-Axle. See **Fig. 15** (page 16).

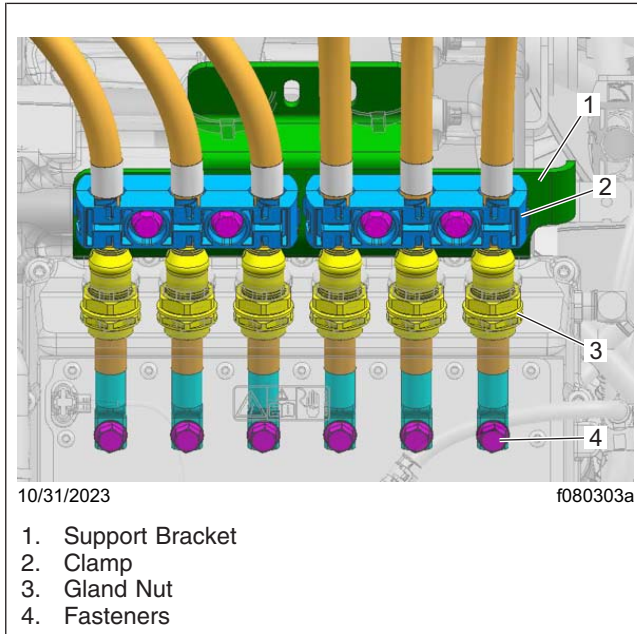
15. Remove the HV cable support bracket and the mounting fasteners that are mounted to the eCarrier. See [Fig. 16](#) and [Fig. 17](#).

**Fig. 16, Axle Side HV Cable Removal**

61. Tighten the HV cover fasteners 4 lbf·ft (5 N·m).
62. Connect the LV to the e-Axle HV cover.
63. Install the support bracket on top of the eCarrier. Then, install the HV cable clamps. See **Fig. 16** (page 17).

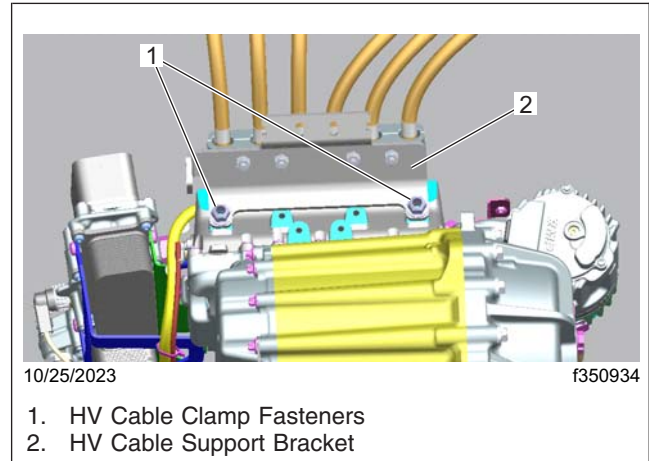
**Fig. 17, HV Cable Support Bracket**

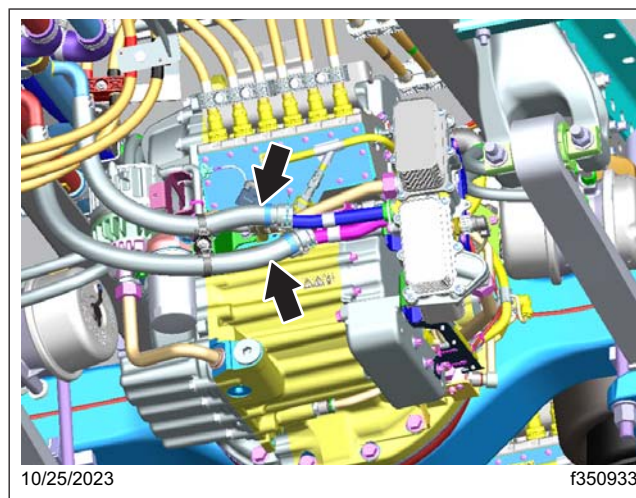
**Fig. 18, Location of the Coolant Lines**

70. Connect the coolant lines, shown in **Fig. 18** (page 17), to the e-Axle.
71. Install the drive wheel fairings. For instructions, see **Section 31.04** of the *eCascadia Workshop Manual*.

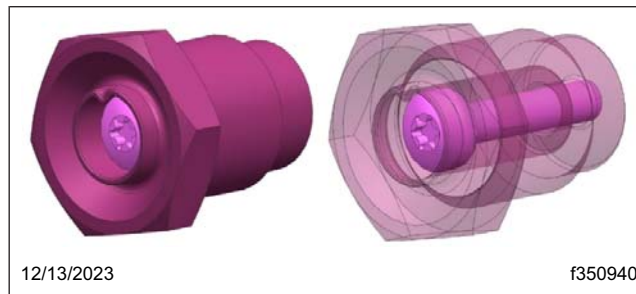
75. Use a long T30 Torx® driver to loosen the center bolt of the neutral tool from the shift location.
76. Use a 30-mm socket to remove the neutral tool from the shift location. See **Fig. 19**.

**Fig. 19, Neutral Tool**

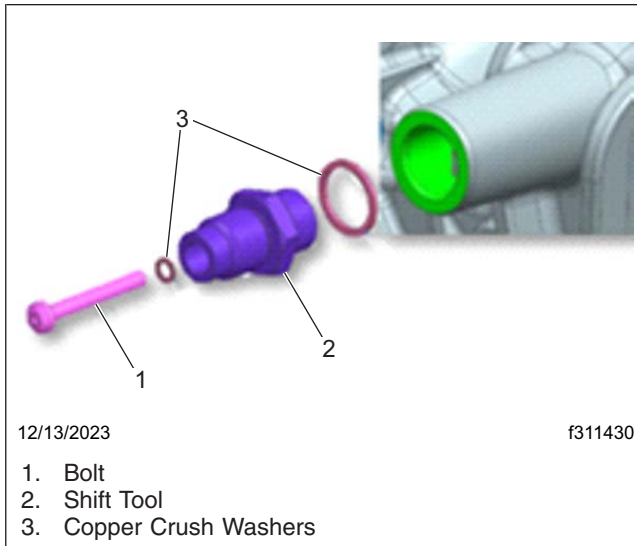
79. Install the new crush washer on the second gear tool, and install the tool in the shift location. Tighten the tool 76 to 94 lbf-ft (103 to 127 N·m). See [Fig. 20](#) and [Fig. 21](#).

**Fig. 20, Gear Shift Tool**

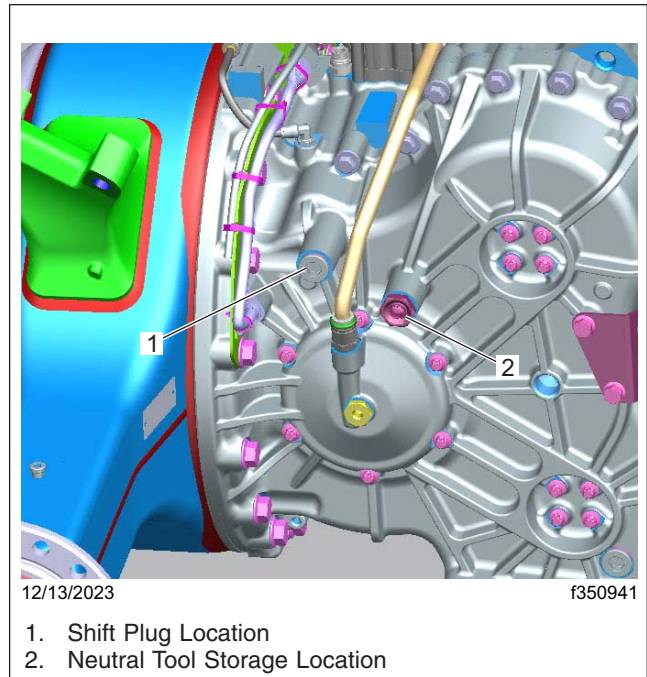
**Fig. 21, Shift Plug and Neutral Tool**
