November 2023
FL979A-F
NHTSA #23V-467
Transport Canada #2023-372
REVISED NOTICE

Subject: Freightliner eCascadia e-Axle Ring Gear

Models Affected: Specific model years 2023-2024 Freightliner eCascadia vehicles manufactured between January 19, 2023, through April 13, 2023.

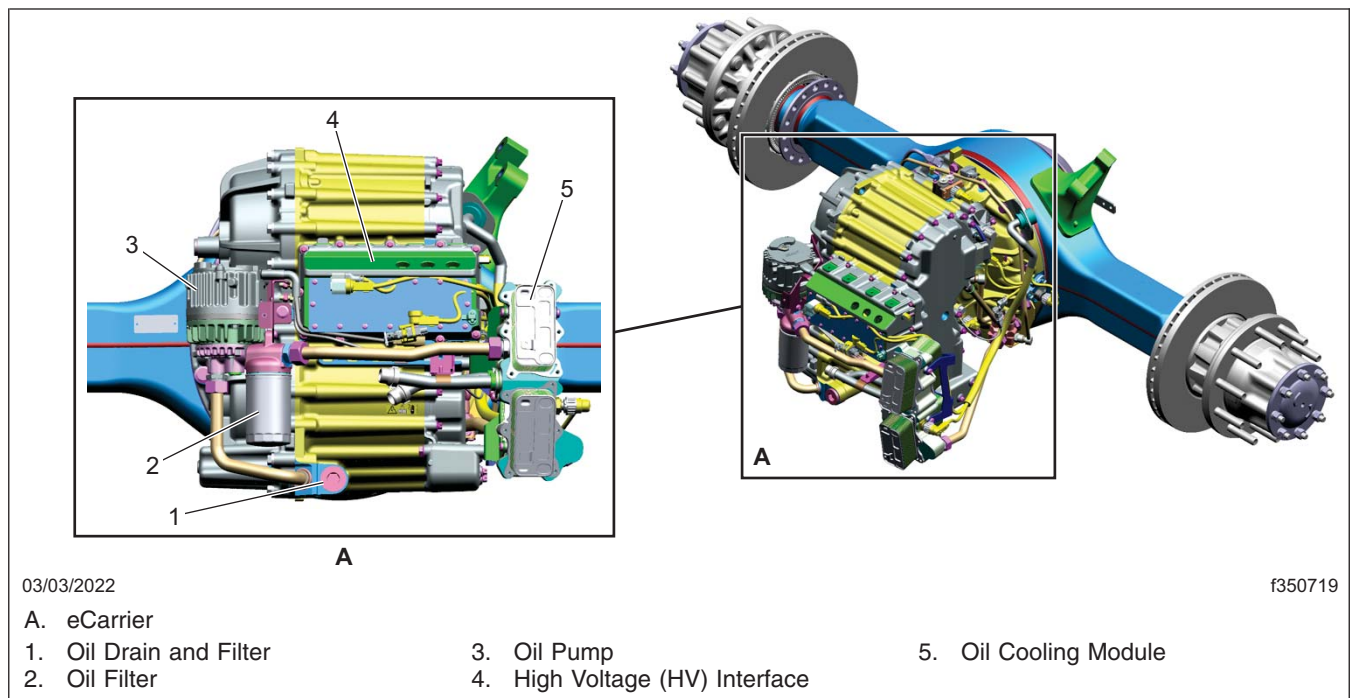
See [Fig. 1](#) for the eCarrier components.

Fig. 1, eCarrier Components

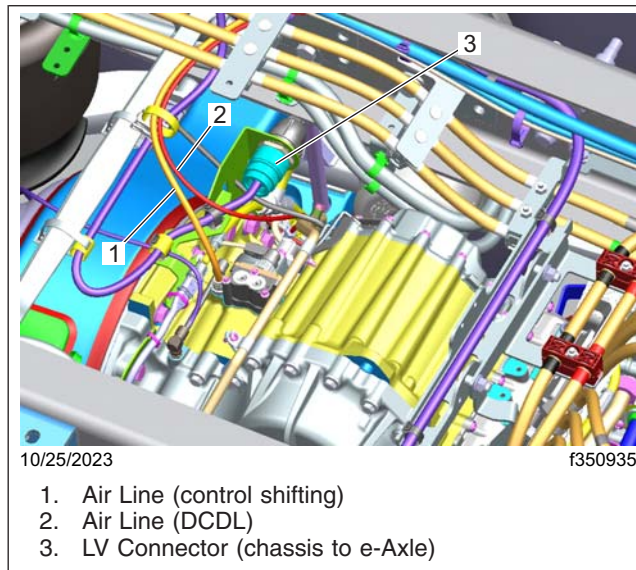
- Lift the vehicle. Remove all the tires on the axle being replaced, then lower the vehicle to the ground. For instructions to raise and lower the vehicle, see **Section 00.05** of the *eCascadia Workshop Manual*.
- Disconnect the low voltage (LV) chassis harness from the e-Axle. See **Fig. 2**.

Fig. 2, Location of the LV Connector

16. Pull the cables out from the rear of the inverters. See [Fig. 8](#).
17. Disconnect the air lines from the eCarrier. See [Fig. 2](#).
18. Lift the vehicle to the desired working height.
19. Cut the zip ties on the coolant hoses.
20. Disconnect the coolant lines from the e-Axle, and let the fluid drain out. See [Fig. 9](#).

48. Install both the ABS sensors.
 49. Connect the air lines to the eCarrier. See **Fig. 2**.
 50. Connect the LV chassis harness to the e-Axle. See **Fig. 2**.

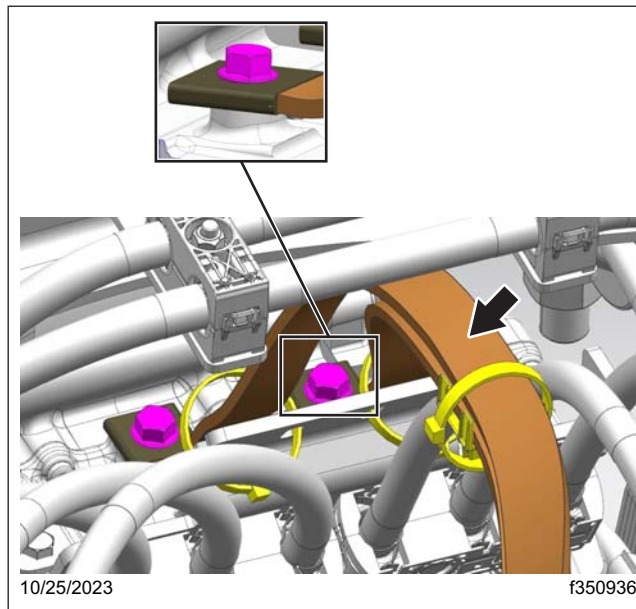
- Disconnect the flat grounding cables straps from the e-Axle. See **Fig. 3**.

Fig. 3, Flat Grounding Cables Straps

60. Connect the flat ground cable straps to the e-Axle. See [Fig. 3](#).

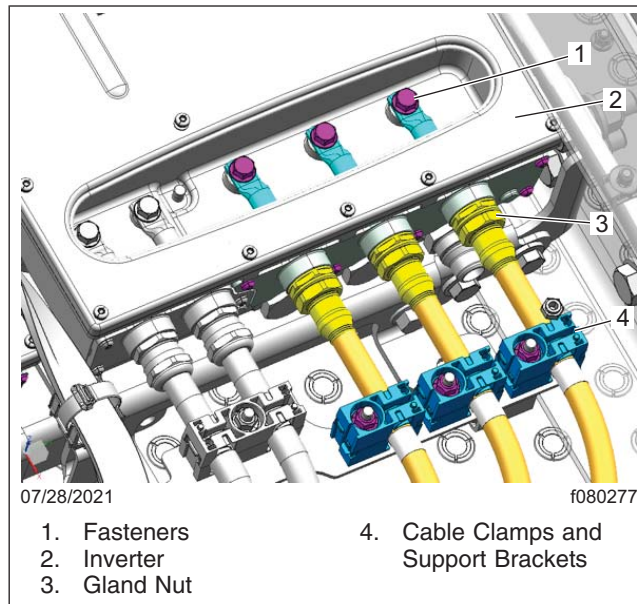
11. Remove the high voltage (HV) cable clamps and the mounting fasteners from the HV cable support brackets. Then, remove the support brackets. See [Fig. 4](#).

Fig. 4, Inverter Side High Voltage Cables

14. Remove the fasteners that secure the HV cables from the e-Axle to the rear side of the inverter. See [Fig. 6](#) and [Fig. 4](#).

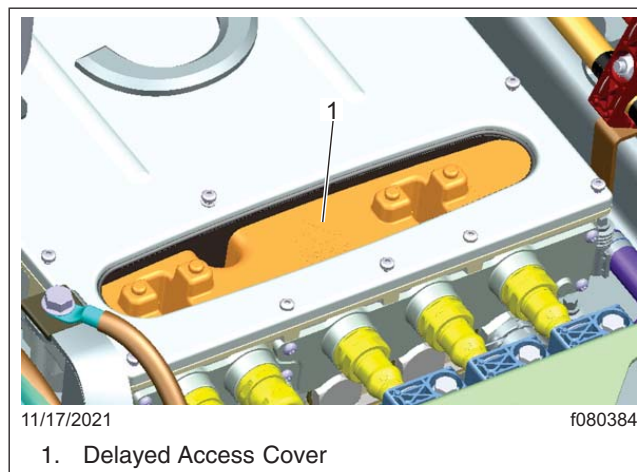
13. Remove the delayed access cover. See [Fig. 5](#).

Fig. 5, Delayed Access Cover Removal

57. Install the delayed access cover. See [Fig. 5](#).

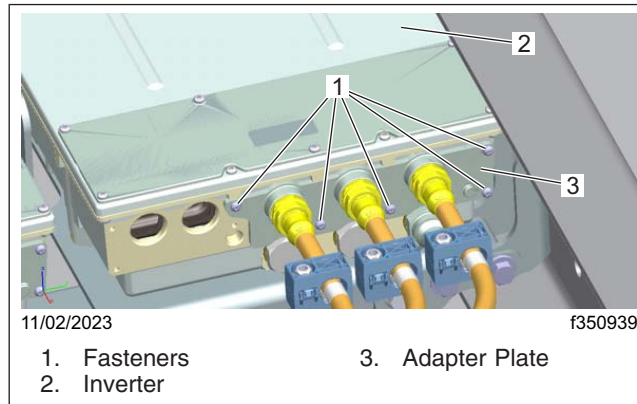
Fig. 6, Fasteners on the Rear Side of the Inverter

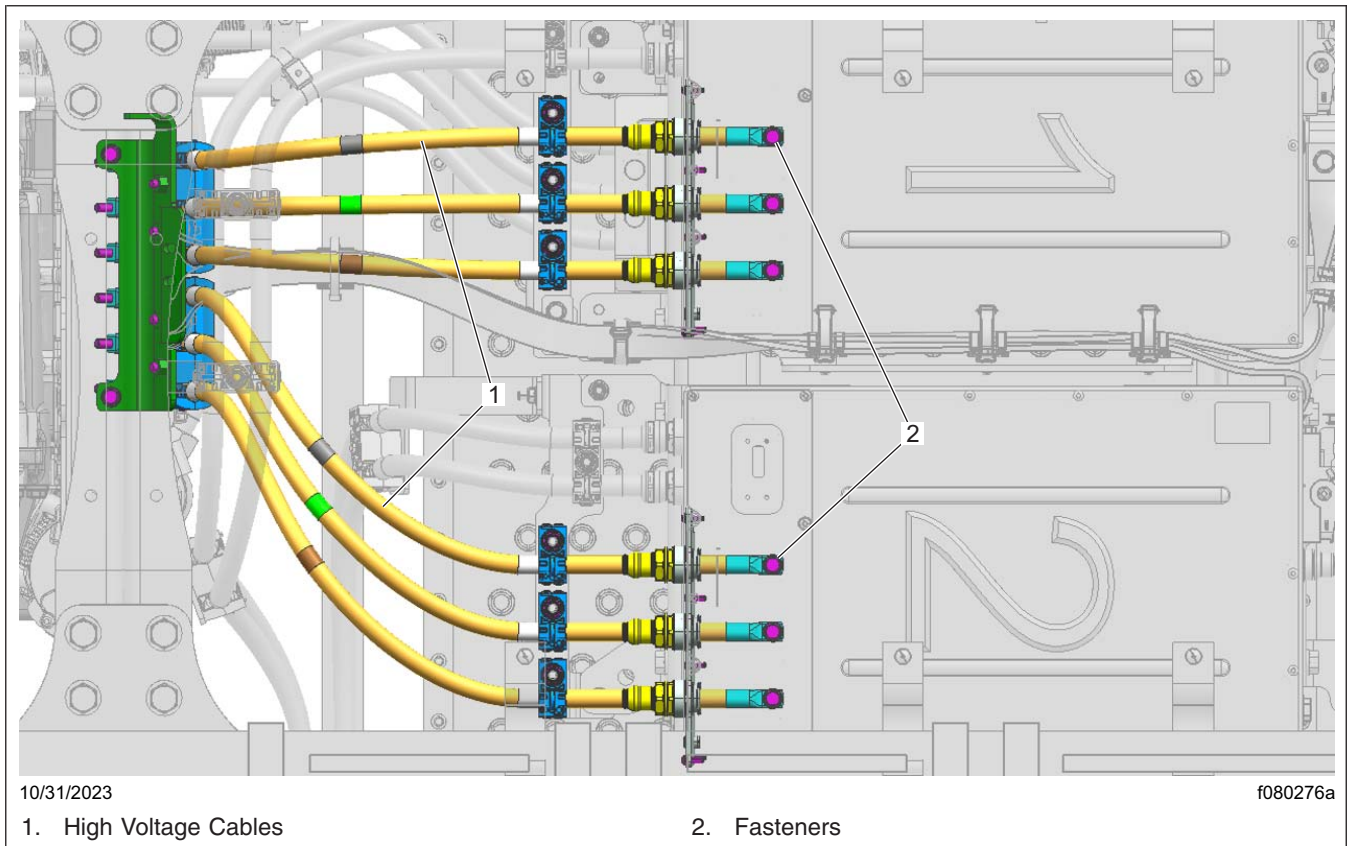
15. Remove the high voltage cable lug fasteners located inside the inverters 1 and 2. See [Fig. 7](#).

Fig. 7, High Voltage Cables Connecting Inverter and Forward Rear Axle

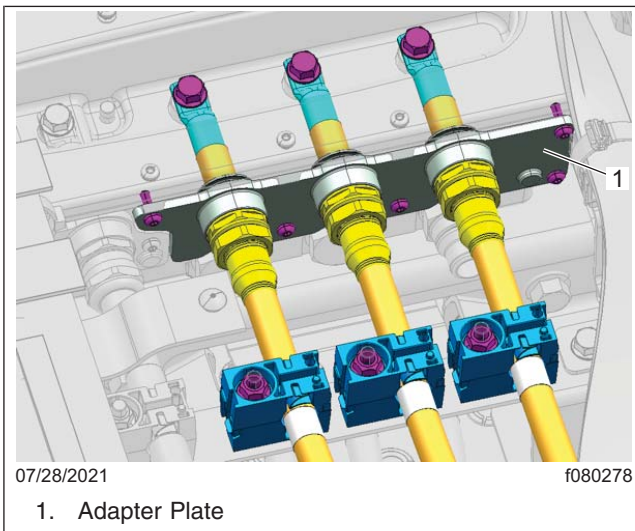
Fig. 8, Location of the Adapter Plate

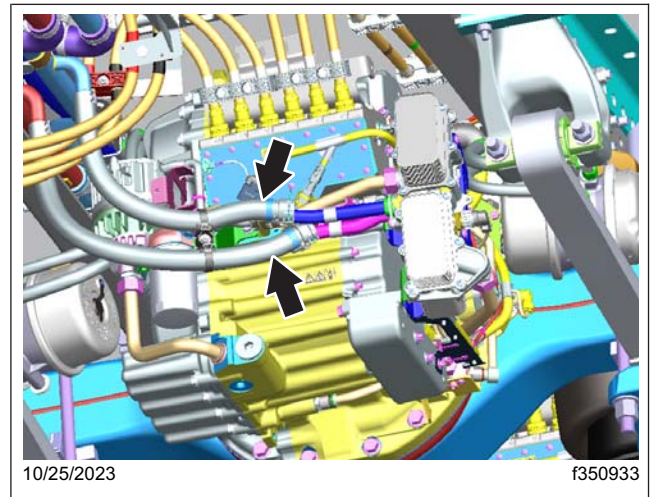
Fig. 9, Location of the Coolant Lines

67. Connect the coolant lines to the e-Axle. See [Fig. 9](#).

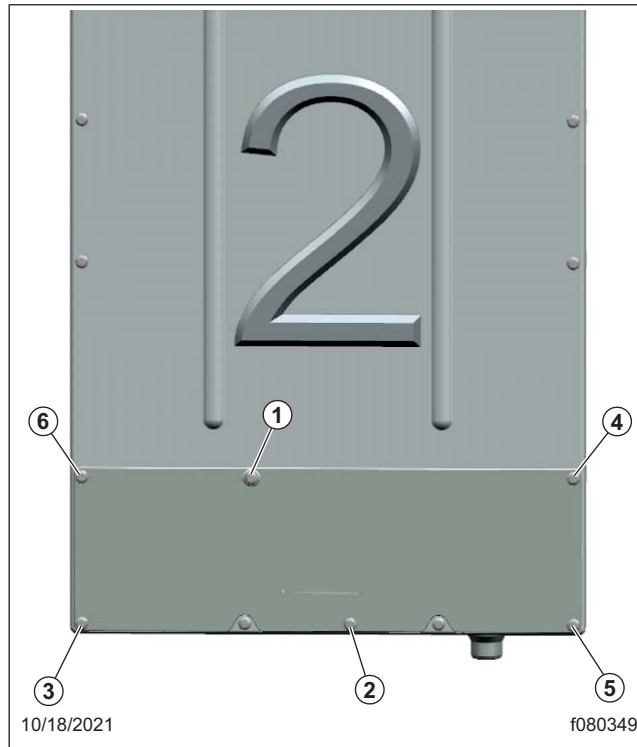
58. Install the inverter access cover and tighten all fasteners 44 lbf-in (497 N-cm) in the sequence shown in [Fig. 10](#). See [Section 08.02, Subject 050](#) of the *eCascadia Workshop Manual* for detailed instructions.

Fig. 10, Inverter Access Cover Tightening Sequence

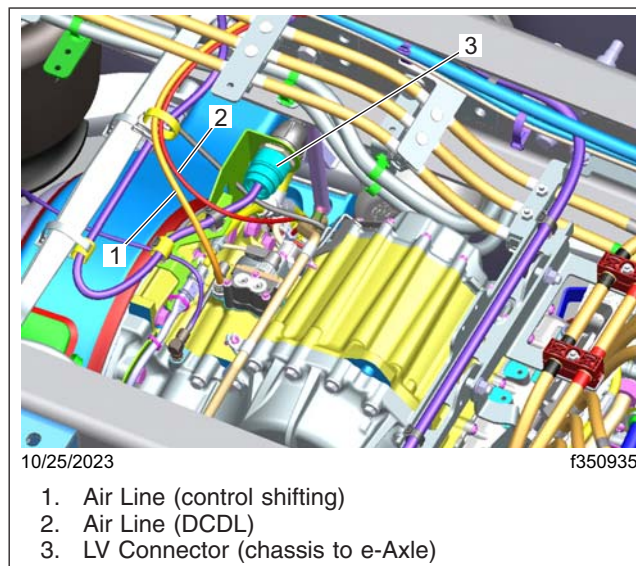
8. Disconnect the low voltage (LV) chassis harness from the e-Axle. See **Fig. 11**.

Fig. 11, Location of the LV Connector

15. Disconnect the cable gland connections.
16. Remove the cables from the e-Axle.
17. Disconnect the air lines from the eCarrier. See [Fig. 11](#).
18. Lift the vehicle to the desired working height.
19. Cut the zip ties on the coolant hoses.
20. Disconnect the coolant lines from the e-Axle, and let the fluid drain out. See [Fig. 16](#).

48. Install both the ABS sensors.
49. Connect the air lines to the eCarrier. See **Fig. 11**.
50. Connect the LV chassis harness to the e-Axle. See **Fig. 11**.

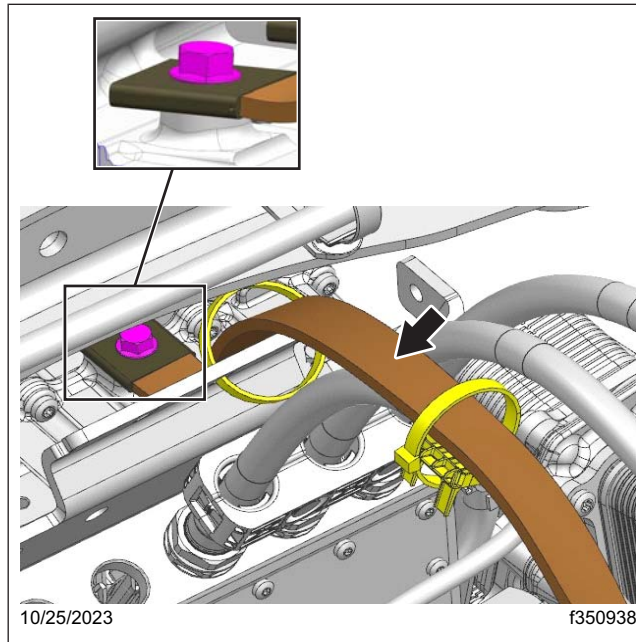
9. Disconnect the flat grounding cables straps from the e-Axle. See [Fig. 12](#).

Fig. 12, Flat Grounding Cables Straps

60. Connect the flat ground cable straps to the e-Axle. See **Fig. 12**.
61. Install the zip ties on the flat ground cable straps.
62. Tighten the flat ground cable straps 18 lbf·ft (24 N·m).

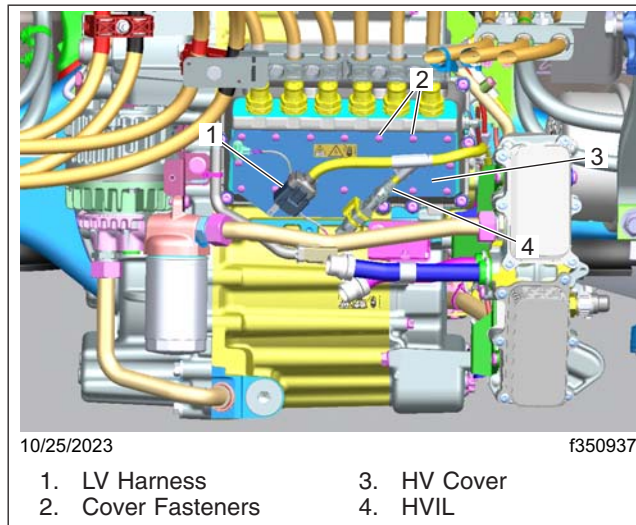
11. Disconnect the high voltage interlock (HVIL) and the LV harness from the HV cover. See [Fig. 13](#).

Fig. 13, Location of the HVIL

12. Remove the HV cover fasteners and remove the HV cover. See [Fig. 13](#).

54. Install and tighten the cable gland connections 9 lbf·ft (12 N·m).
55. Tighten the lug fasteners 17 lbf·ft (23 N·m).
56. Install the HV cover and fasteners to the HV interface on the e-Axle. See **Fig. 13**.

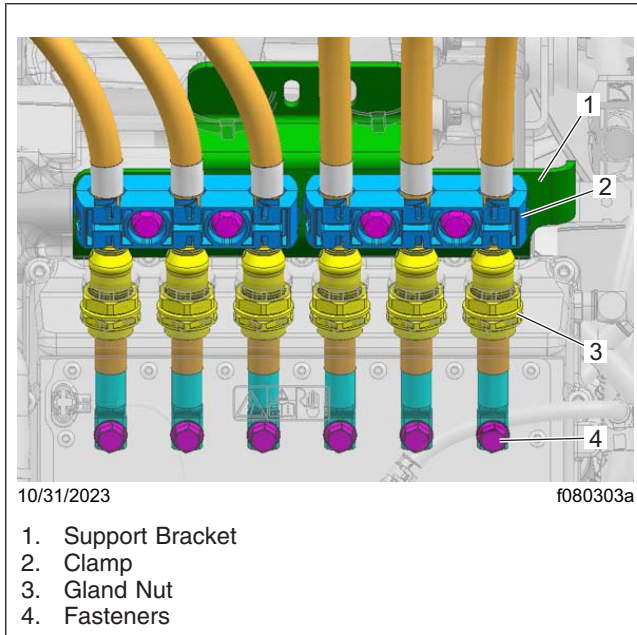
14. Remove the HV cable support bracket and the mounting fasteners that are mounted to the eCarrier. See [Fig. 14](#) and [Fig. 15](#).

Fig. 14, Axle Side High Voltage Cable Removal

57. Tighten the HV cover fasteners 4 lbf·ft (5 N·m).
58. Connect the LV to the e-Axle HV cover.
59. Install the support bracket on top of the eCarrier. Then, install the HV cable clamps. See **Fig. 14**.

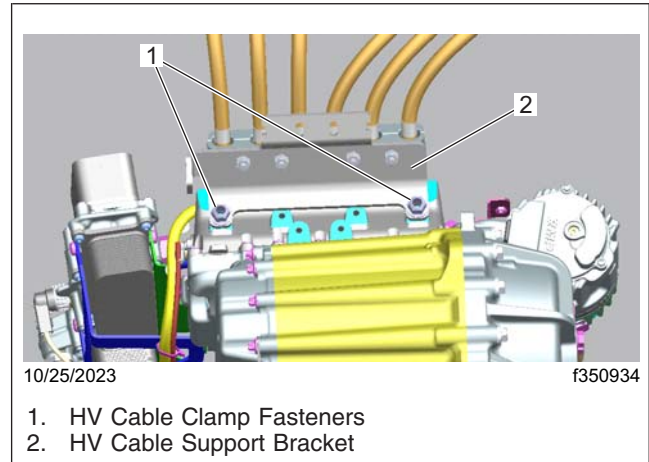
Fig. 15, HV Cable Support Bracket

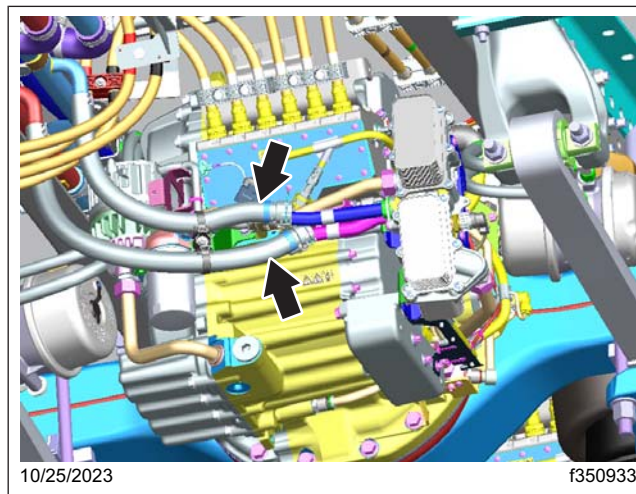
Fig. 16, Location of the Coolant Lines

66. Connect the coolant lines to the e-Axle. See **Fig. 16**.
67. Install the drive wheel fairings. For instructions, see **Section 31.04** of the *eCascadia Workshop Manual*.
